INDIVIDUAL INVENTORY FORM**NHDHR INVENTORY NUMBER: CON0160****Name, Location, Ownership**

1. Historic name: Current Name: Cicely Farm
2. District or area: _____
3. Street and number: 1 Flaghole Road
4. City or town: Concord
5. County: Merrimack
6. Current owner: Morrison Family Rev. Trust: Deane & Deanna Morrison

INDIVIDUAL INVENTORY FORM

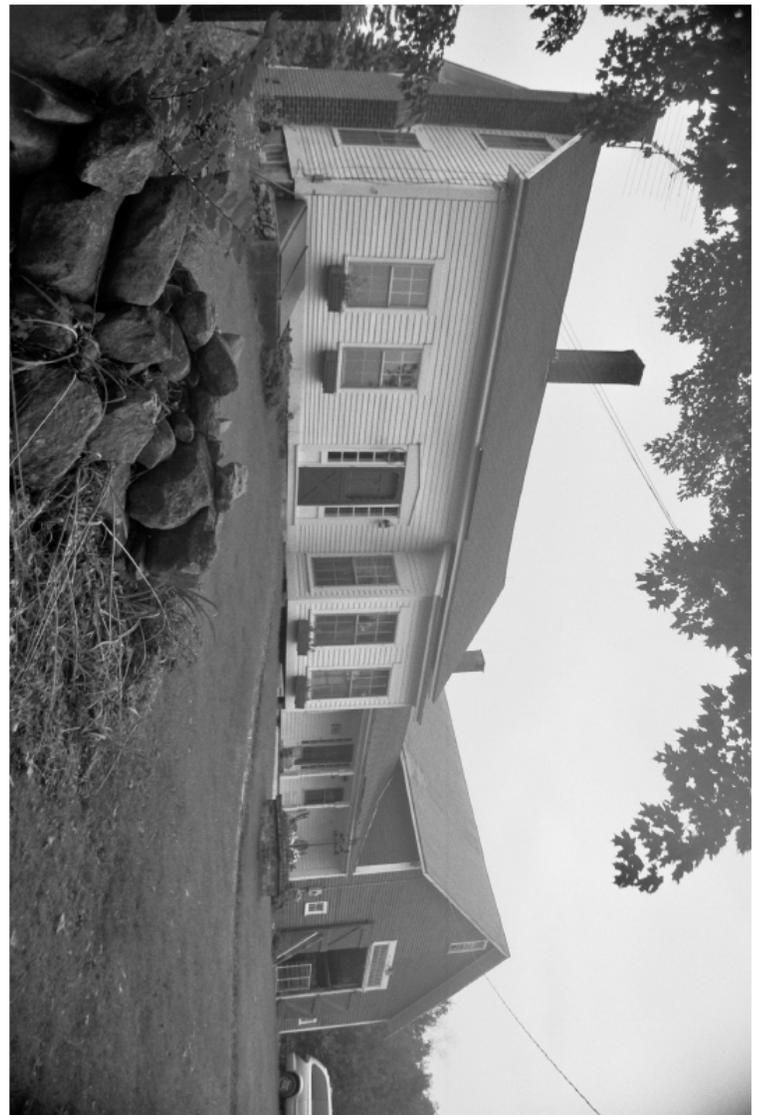
35. Photo #1
36. Date 9-30-2008
37. Roll #3 Frame #29 Direction: NW
38. Negative stored at: NHDHR

**Description:** South elevation of house and barn

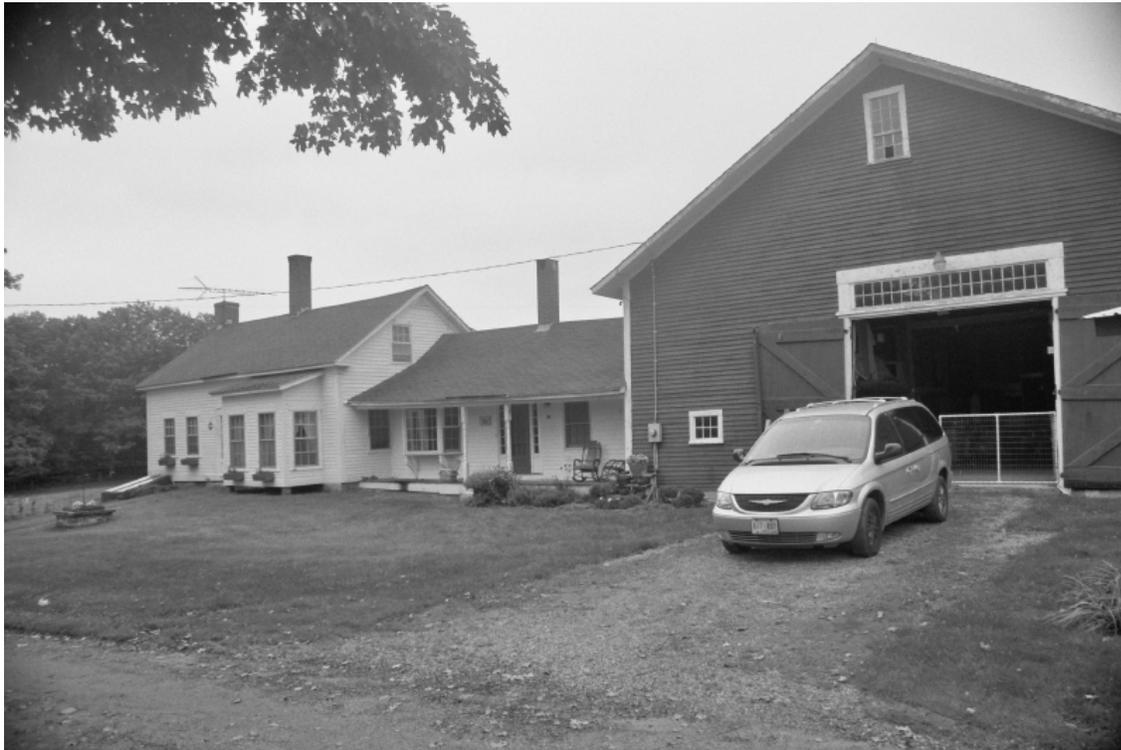
Photo 2 description: South face of house and barn
Roll: 3 Frame: 28 Direction: NW

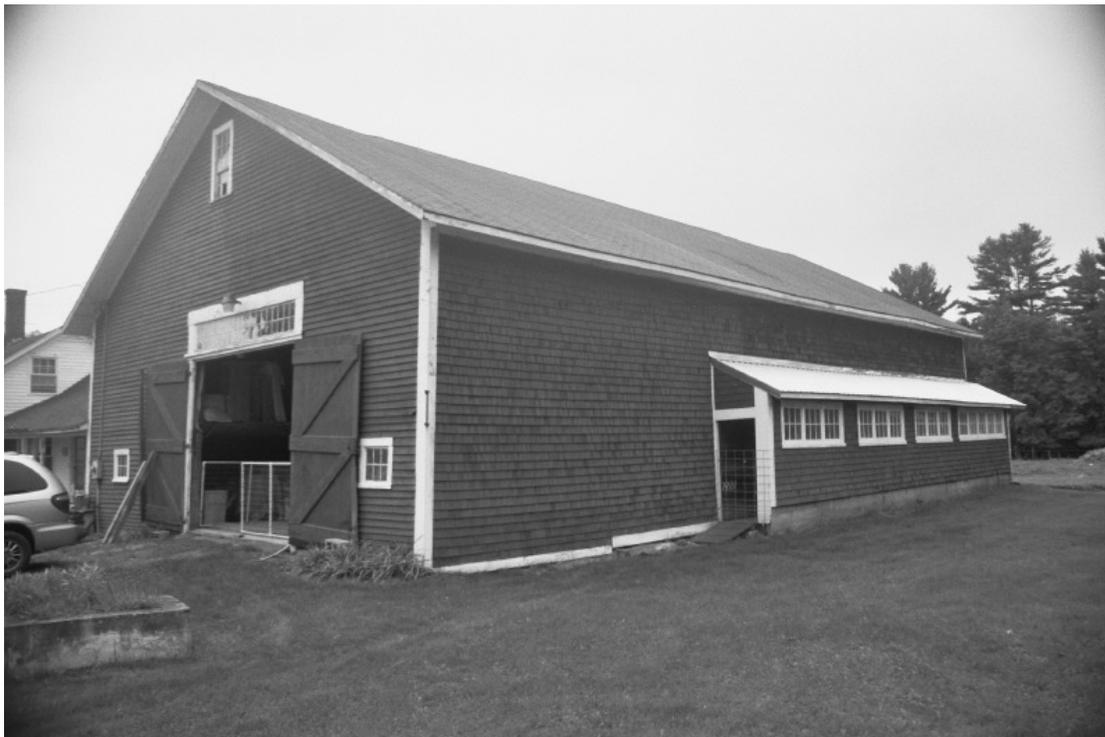
A one story, shed roof extension is attached to the rear four bays along the east side of the building. There is a concrete floor under this portion of the barn. This portion of the barn had previously been used as a milking parlor.

Photo 3 description: South and east side of barn showing shed roof extension
Roll: 3 Frame: 27 Direction: NW
