INDIVIDUAL INVENTORY FORM**NHDHR INVENTORY NUMBER: CON0193****Name, Location, Ownership**

1. Historic name: Henry Farnum-Hobbs Hill-Haller Farm
2. District or area: West Parish Rd. Agricultural Neighborhood
3. Street and number: 9 West Parish Rd.
4. City or town: Concord
5. County: Merrimack
6. Current owner: Anne Haller

INDIVIDUAL INVENTORY FORM

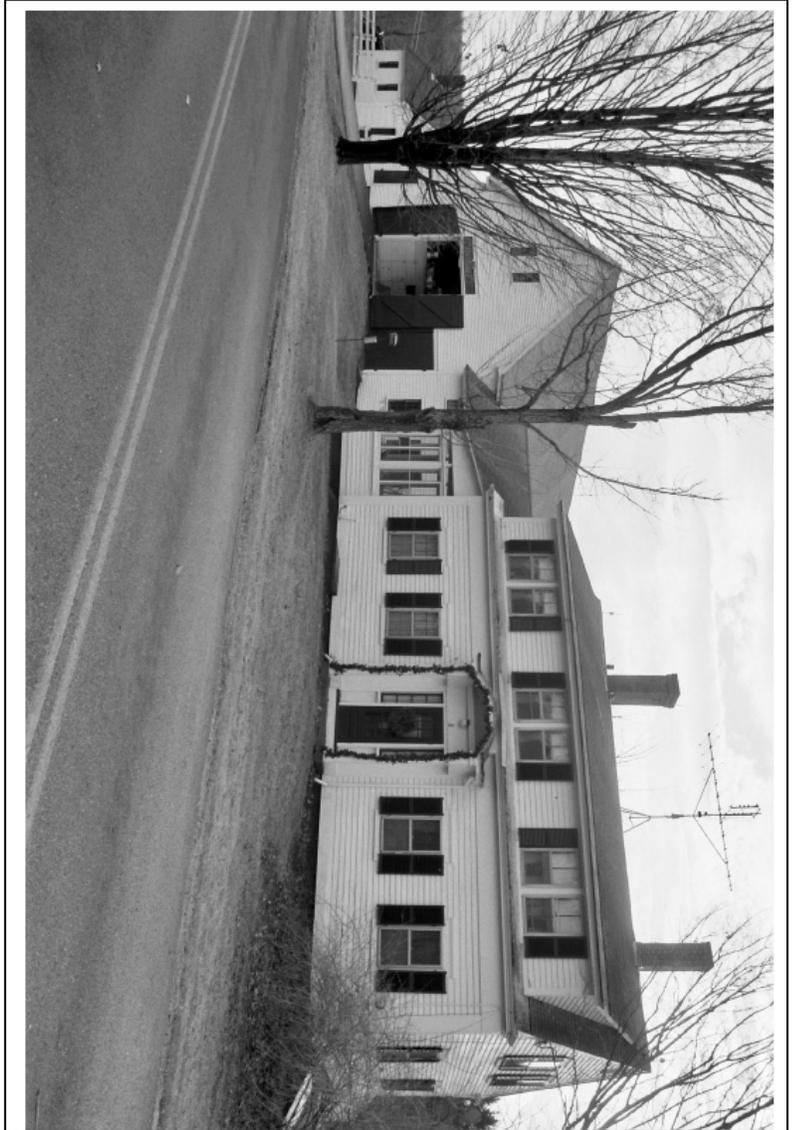
35. Photo #1
36. Date Fall 2008
37. Roll #7 Frame #15 Direction: SE
38. Negative stored at: NHDHR

**Description** View of connected farm buildings

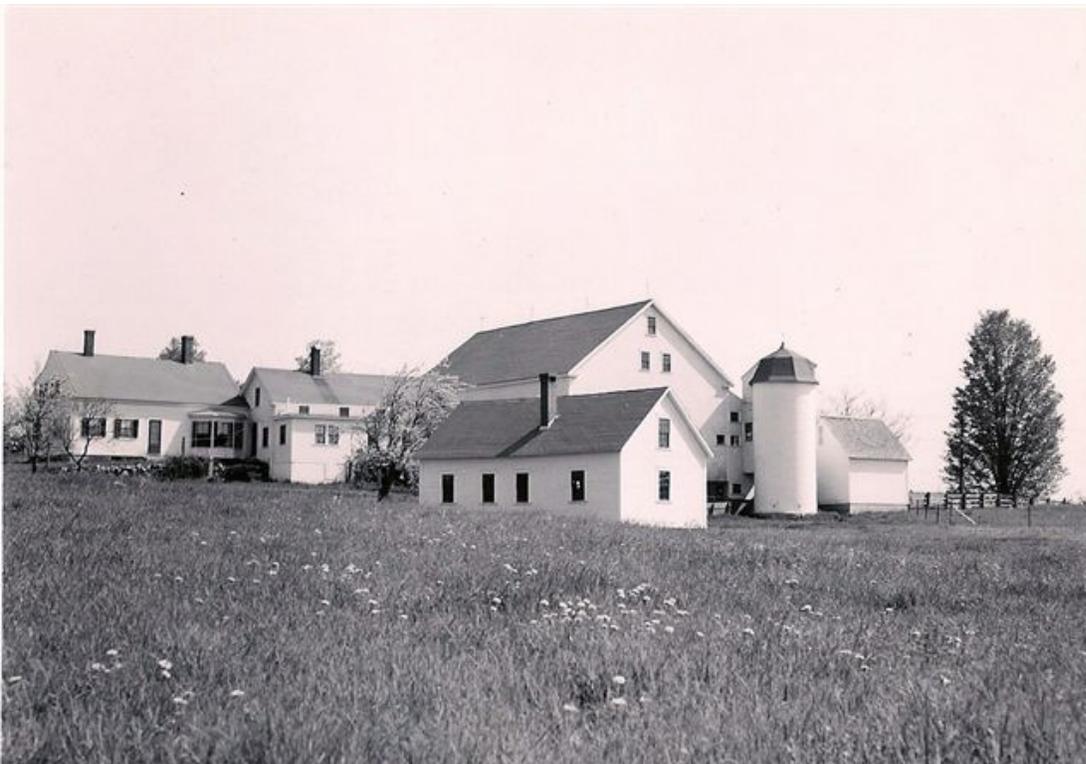
View of 9 West Parish, looking north at the rear of the farm buildings and house. Photographed 1957. *Courtesy Haller family.*

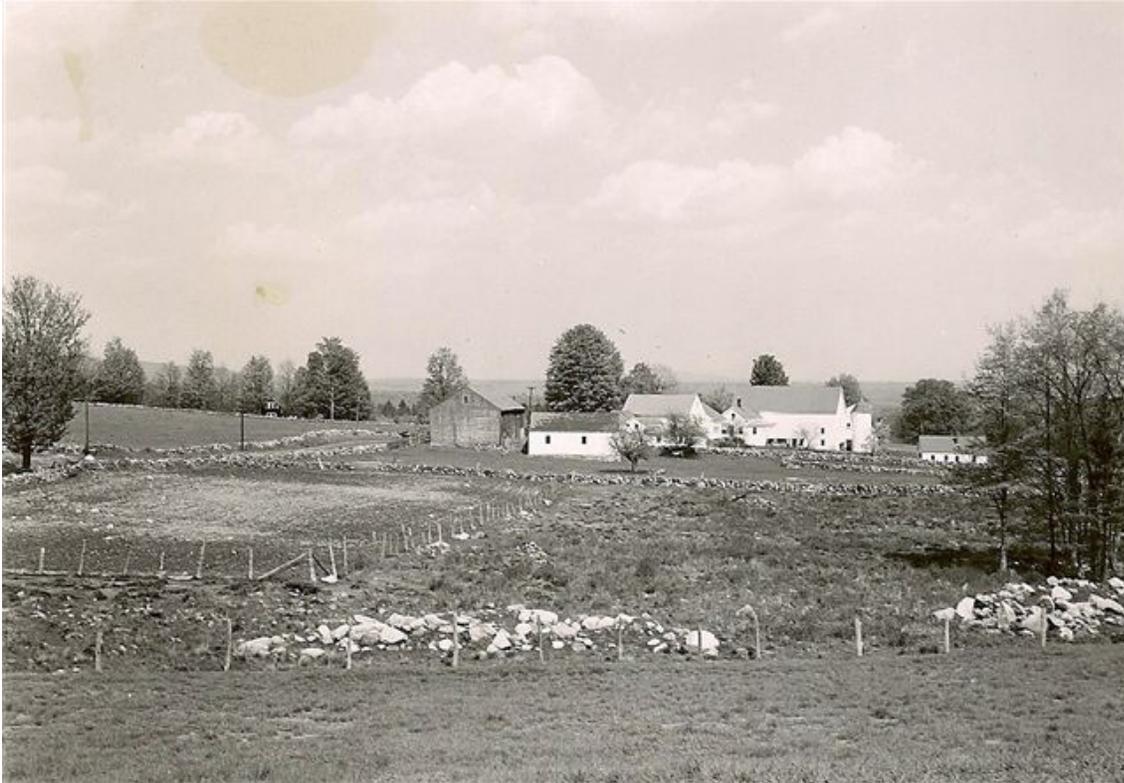
View looking east at 11 West Parish (foreground, showing barn at far right) and 9 West Parish in rear. Taken 1957. *Courtesy Haller Family.*

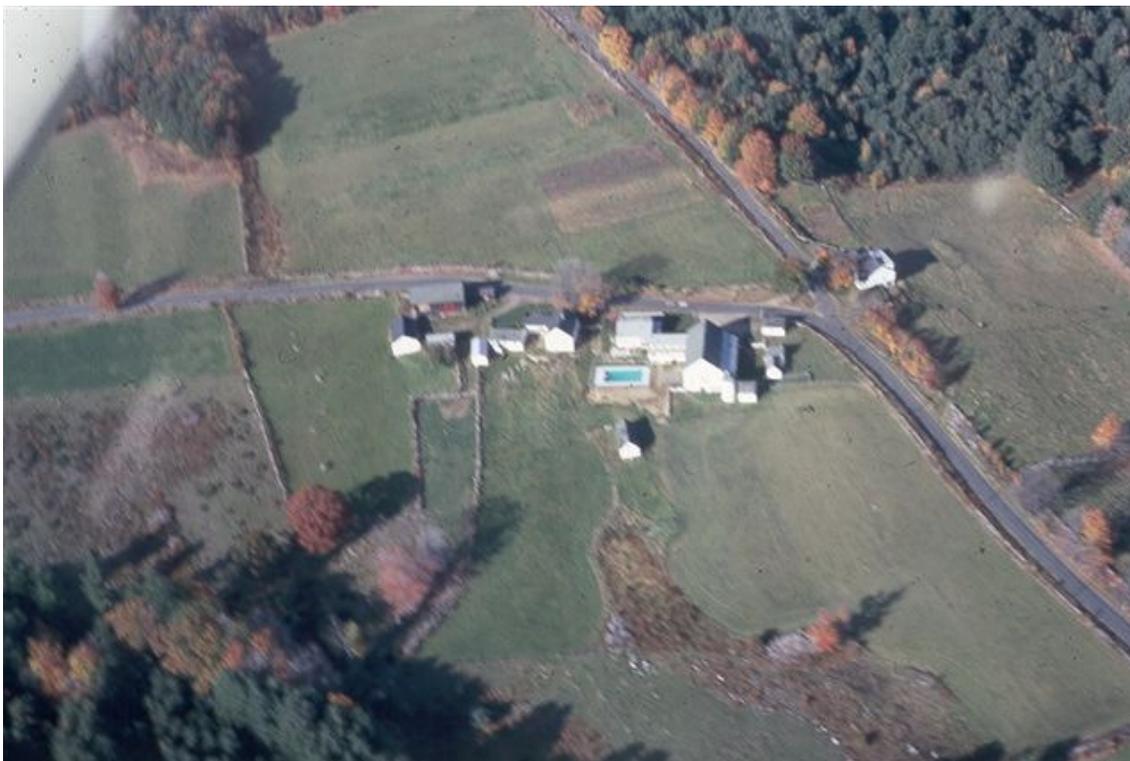
Aerial view taken in 1965 of 9 W. Parish (building complex at right), 11 W. Parish (building complex at left) and surrounding land use patterns. *Courtesy Haller Family.*

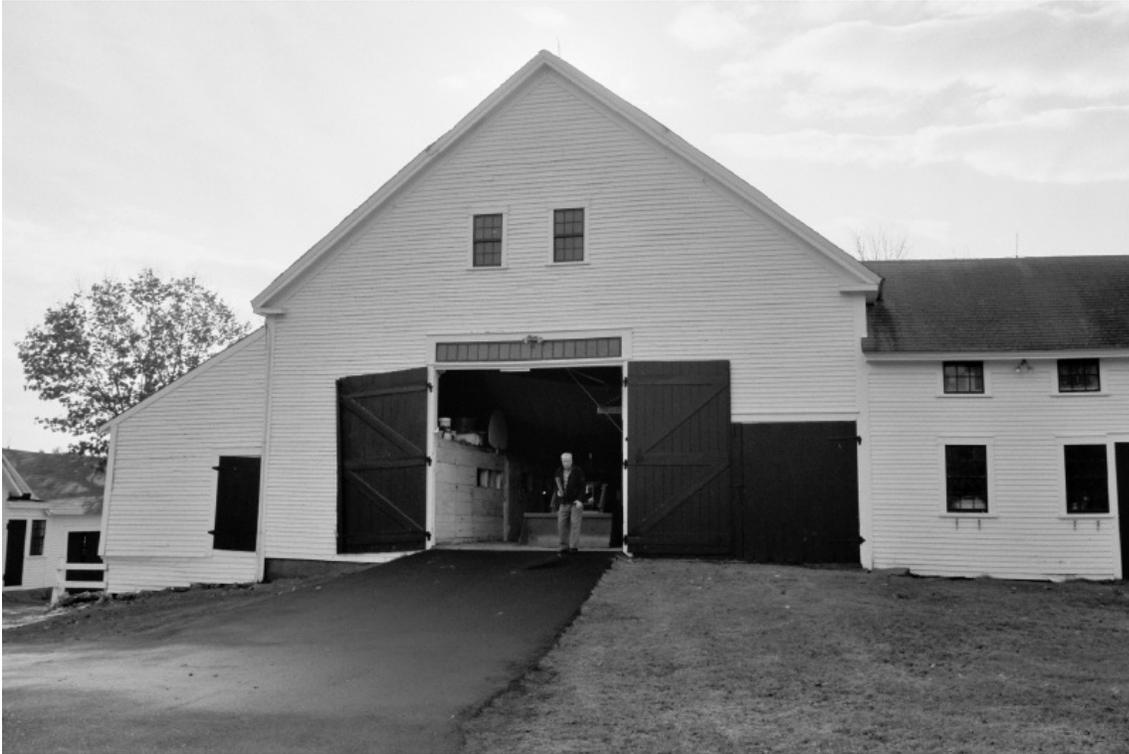
Photo 2 description: Front (north) gable end of barn & east end of kitchen-shed wing
Roll: 7 Frame: 14 Direction: S

It is a large, gable-front, timber-frame, bank barn that faces north toward the road. It has a square-rule frame, consisting of six bents, to create five interior bays. The roof frame has principal and common rafters and therefore lacks purlins. On the west side, the first (northernmost) bay is a grain room, the middle three bays are hay mows, and the fifth bay was the heifer area. There is a scaffold over the drive floor and hay loft over the east bays. Circa 1910, the barn was extended through the addition of a lean-to along the east side. The west half of the lean-to has an open tie up, with hinged floor boards down the center that function as a manure trap door. The east half is a series of cow tie-ups with white washed walls, wood gates, metal stanchions and water bowls. The south (rear) end of the lean-to leads into a silo, added ca. 1925-30s. (Ochre paint on the clapboards of the lean-to that are now an interior wall give a clue to the paint color of the barn in the early 20th c.) The north wall of the silo is a series of trap doors to access the silage. The silo rests on a stone foundation capped with concrete, is sheathed in novelty siding and terminates in an octagonal roof. A dormer in the roof was used for corn intake.

The main entrance to the barn is slightly off-center to the left. The doors are hinged and made of vertical boards. Above them is a transom light. Two windows with 6/6 sash pierce the gable peak. Walls are sided with clapboards and trimmed with simple corner pilasters. The roof is covered with asphalt shingles; eaves are boxed. The barn has a granite block foundation, and the basement is fully accessible from the southeast. Granite block partition walls divide the basement. An opening in the foundation at the southwest corner allowed pigs to come and go.

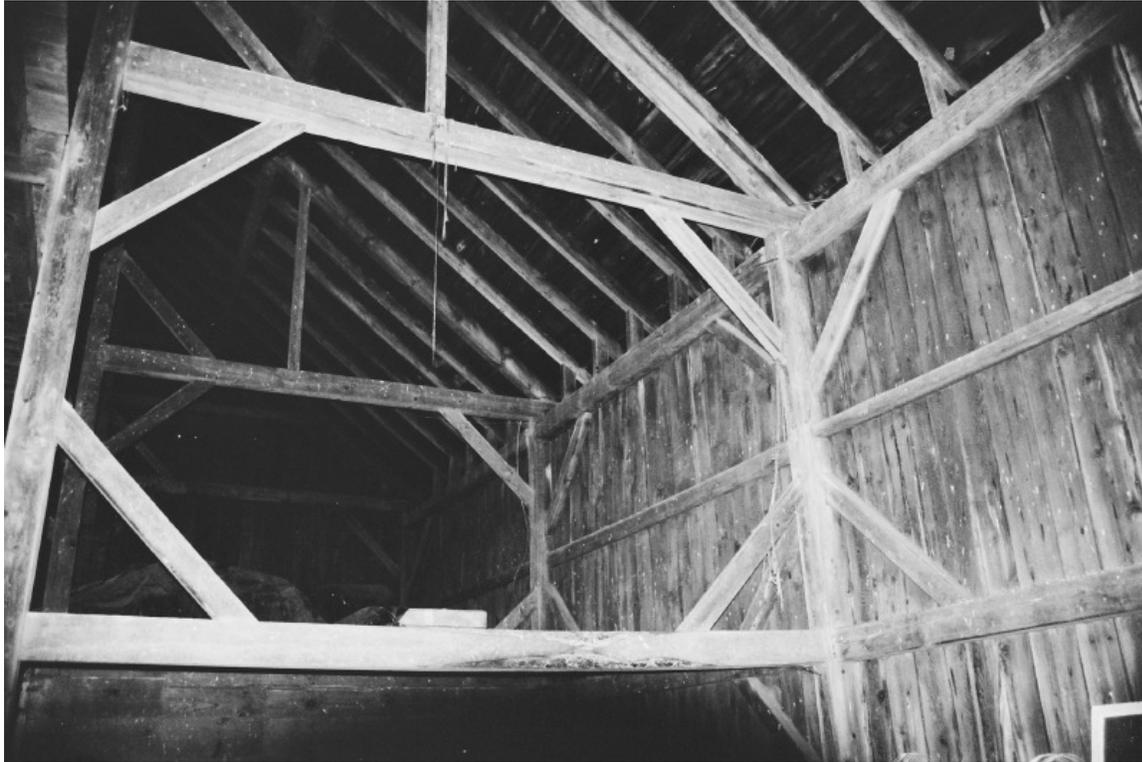
Photo 4 description: Barn frame
Roll: 5 Frame: 20A Direction: SW

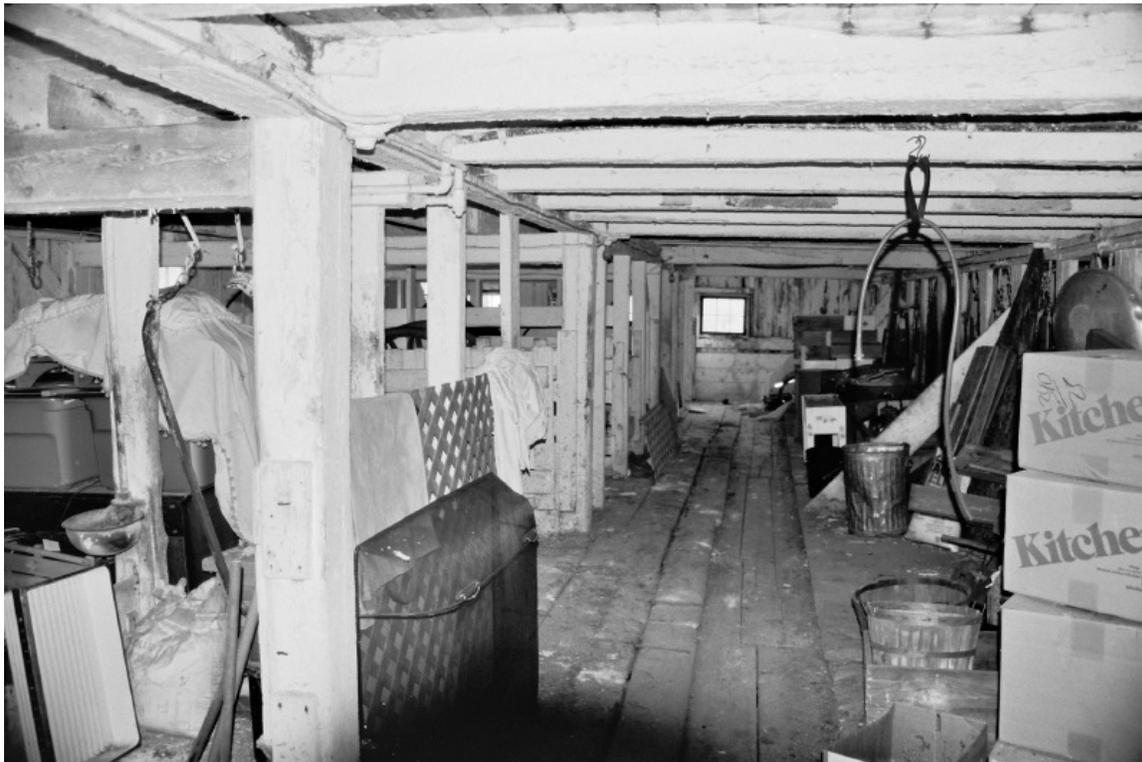
Photo 5 description: Barn lean-to, showing open tie up, with hinged floor boards
Roll: 5 Frame: 21A Direction: S

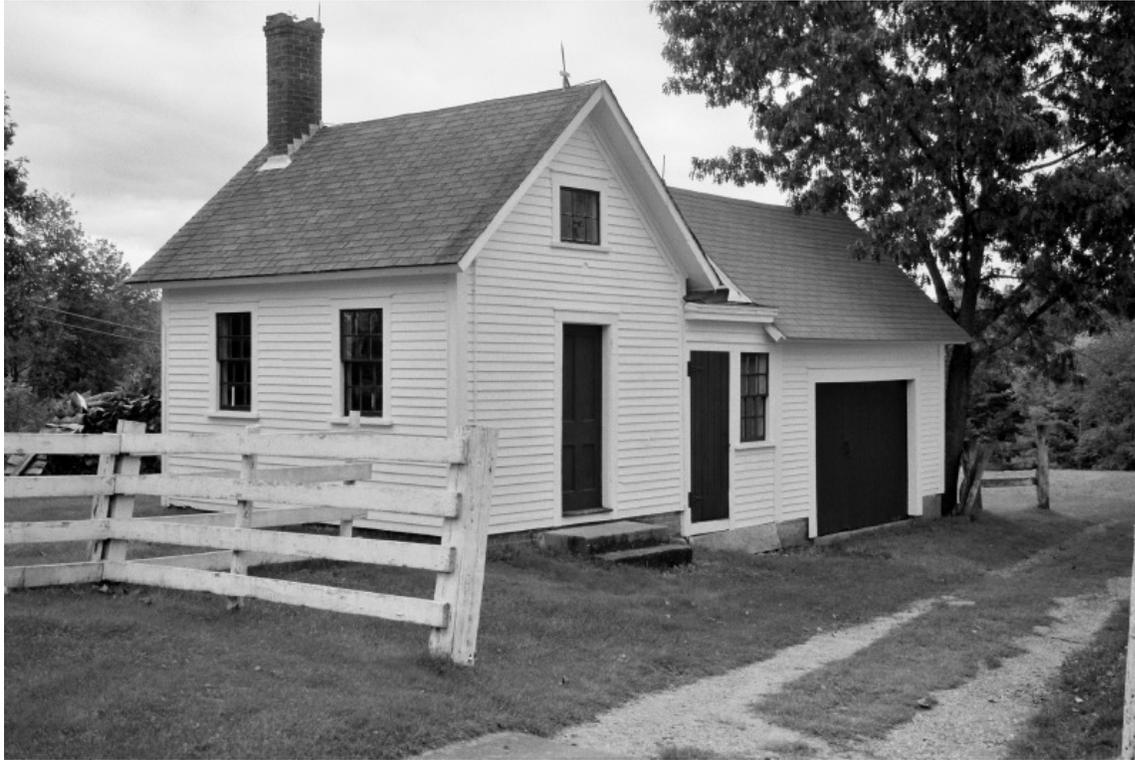
Photo 6 description: Milk house & water trough shed
Roll: 5 Frame: 22A Direction: SE

Milk Room (ca. 1910)/Water Trough (ca. late 19th c.): The milk room/water trough is two attached structures located immediately east of the barn. The milk room is at the north end and post-dates the

water trough. The clapboard-clad structure faces gable front toward the barn and rests on a brick foundation. A brick chimney rises from the rear ridge. Walls are punctured with 6/6-sash windows; the main entrance has a 19th c. four-panel door. Inside, walls are finished with bead board and the wooden trough that held the milk cans is extant. A stove sat against the east wall to keep the workers warm. A small room to the southwest holds the cooler. The water trough is a side-gabled structure that abuts the south wall of the milk room. It has a granite foundation and clapboard walls. Access is through a wide opening in the west wall. The trough pre-dates the individual metal troughs in the barn and was fed from a well dug uphill behind 25 West Parish Road.

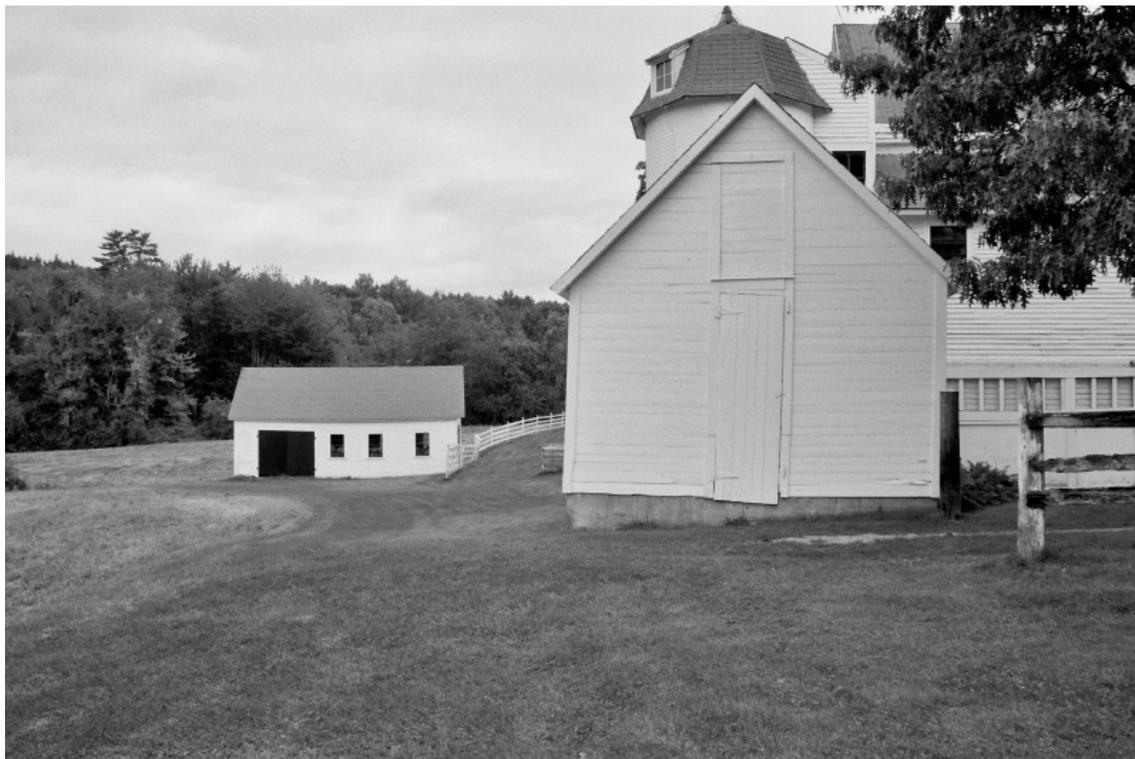
Photo 7 description: East (front) elevation of ice house. Blacksmith shop in rear.
Roll: 5 Frame: 25A Direction: W

Ice House (ca. 1920): The ice house stands just east of the silo and was used for surplus silage in the 1950s after its original function became obsolete. It is a gable-front structure on a poured concrete foundation and sided with flush boards. A narrow doorway with a vertical-board, hinged door is found on the east gable end. Like most ice houses, the structure has double interior walls to hold sawdust for insulation purposes. Its location near the milk room suggests the ice may have provided refrigeration for the milk in the early 20th c.

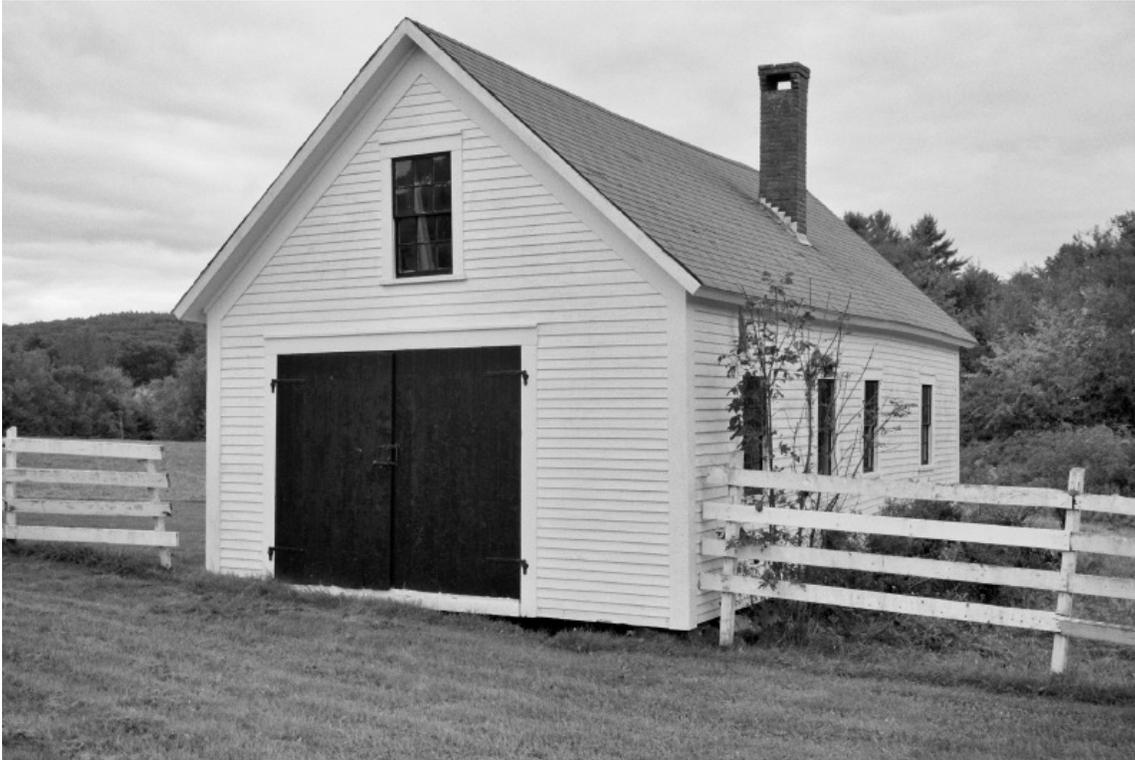
Photo 8 description: Blacksmith shop, front (north) and west elevations
Roll: 5 Frame: 24A Direction: SE

Blacksmith Shop (ca. 1850-70): This is an extremely rare building type and perhaps the best preserved in Concord. It stands southwest of the other outbuildings, to isolate it in case of fire. The building rests on a stone foundation, has clapboard siding and flat trim boards, 6/6 window sash, and a brick chimney on its west slope. Both the east and north walls have a wide opening with paired, vertical-board doors attached with strap hinges—openings sufficiently large to allow a horse to be shod inside. Inside, the framing exhibits circular saw marks and a common rafter roof. The brick forge with granite cap slabs and anvil survive, as do a variety of miscellaneous tools.

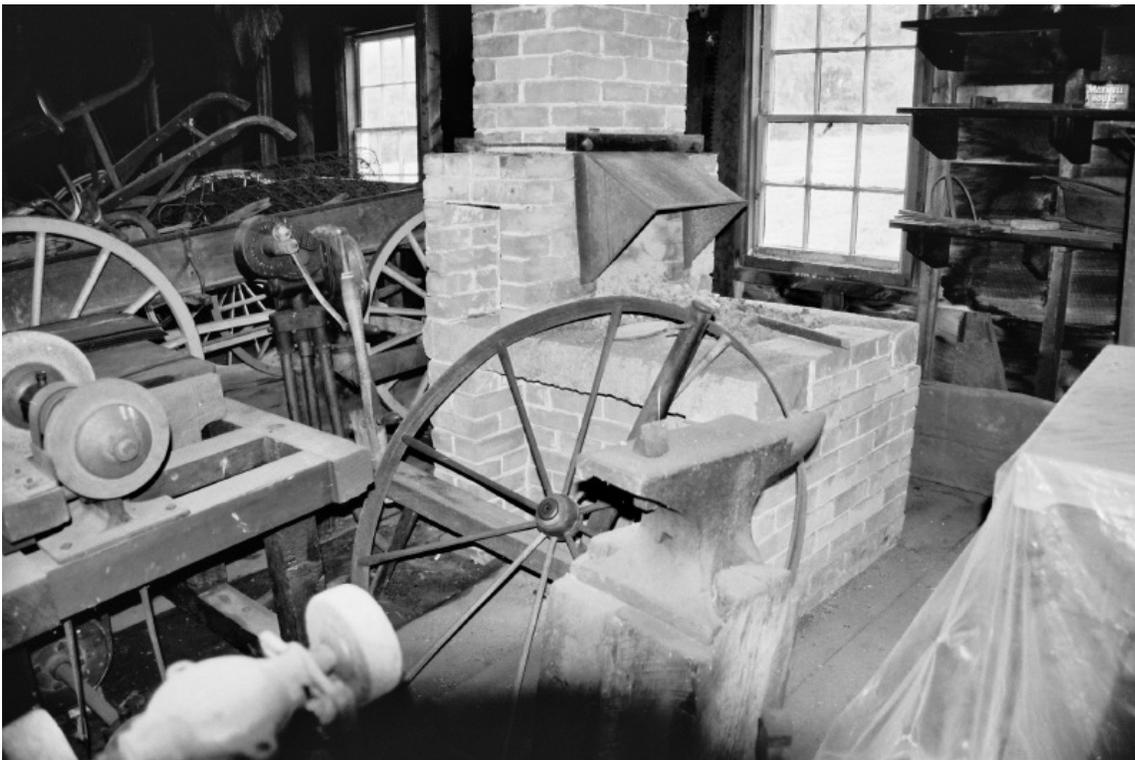
Photo 9 description: Blacksmith shop interior, showing forge
Roll: 5 Frame: 19A Direction: SW
