INDIVIDUAL INVENTORY FORM**NHDHR INVENTORY NUMBER: CON0185****Name, Location, Ownership**

1. Historic name: Sunny Glen Dairy Farm
2. District or area: _____
3. Street and number: 31 Peaceful Lane
4. City or town: Concord
5. County: Merrimack
6. Current owner: Conrad R. & Joan E. Hardy

32. Name: Roger C. Hawk
33. Organization: for Concord Heritage Commission
34. Date of survey: 9/19/2008

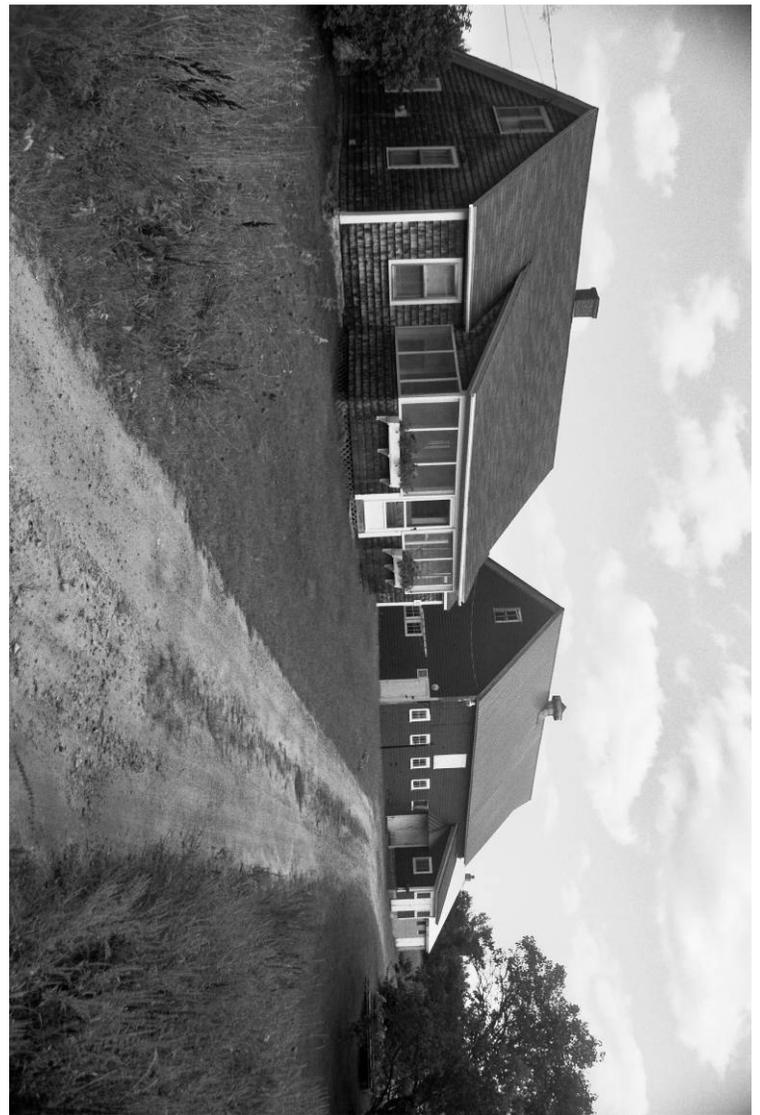
35. Photo #1
36. Date 9-19-2008
37. Roll #2 Frame #35 Direction: E
38. Negative stored at: NHDHR

**Description: Front (southwest) view of house and barn**

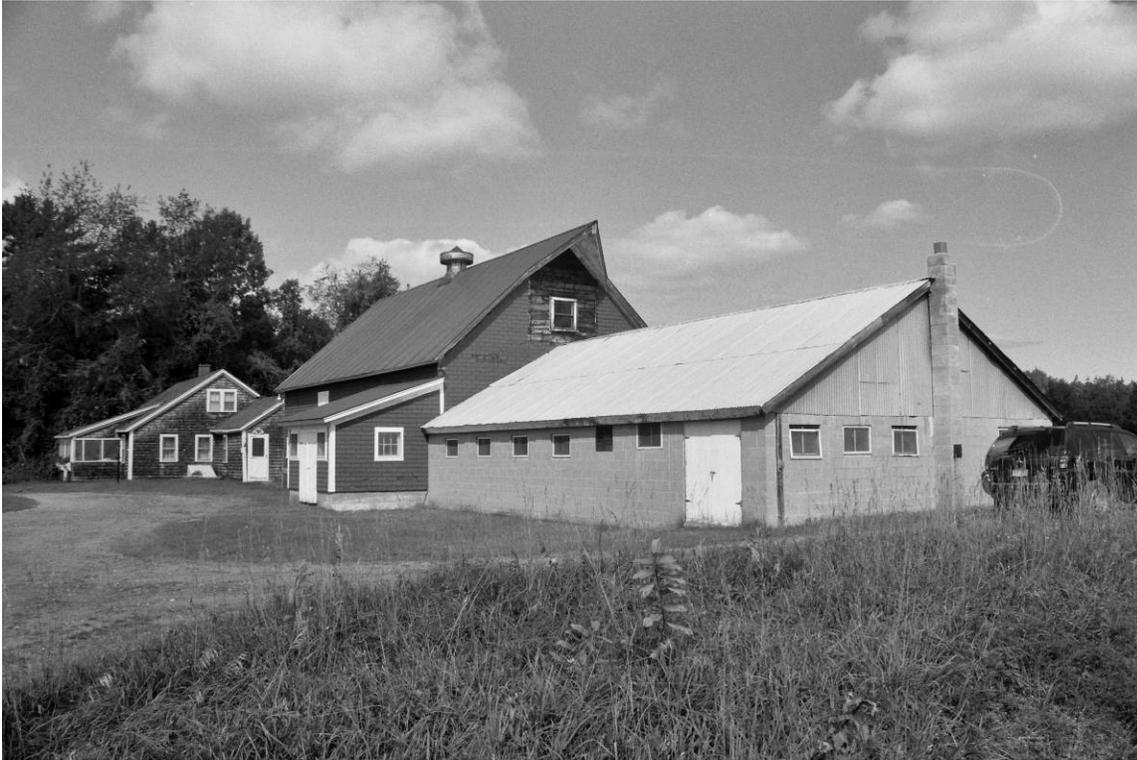
Photo 2 description: House, barn and barn addition
Roll: 2 Frame: 33 Direction: NW

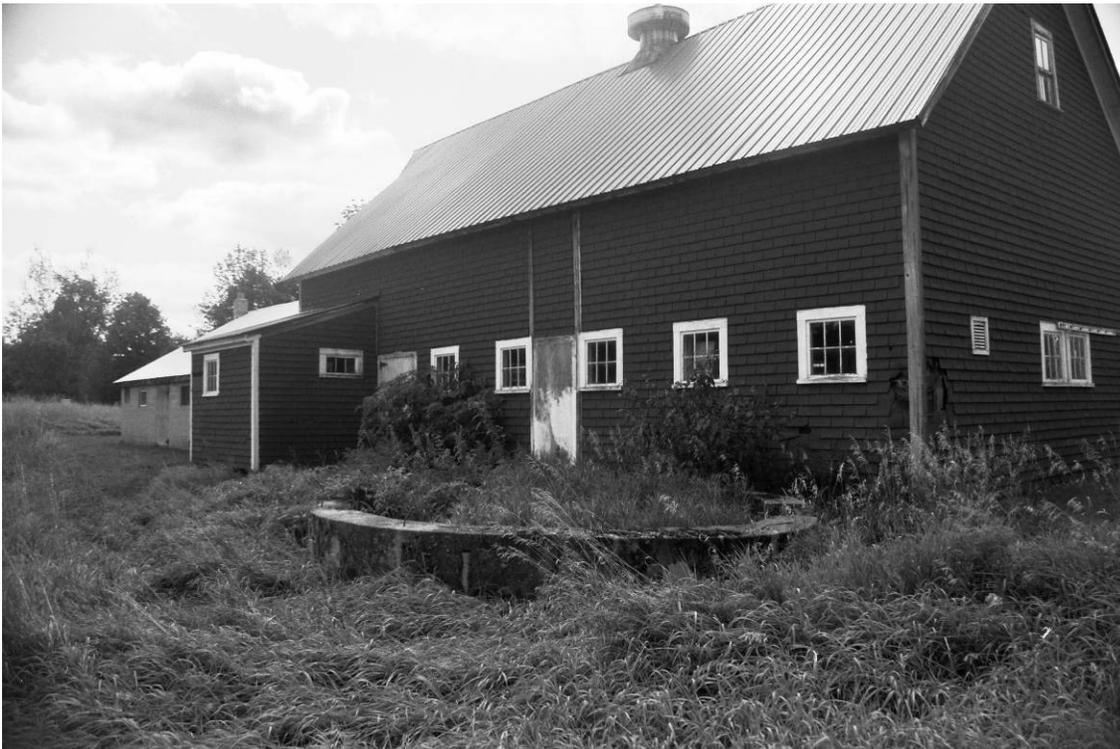
Barn (ca. 1900): This gable front, 6 bay, post and beam structure is constructed of 6x6 circular sawn beams with 2x6 roof framing and horizontal roof sheathing. The foundation is stone on grade with a poured concrete first floor which still retains most of its milking parlor features. The barn is clad in asphalt shingles on the side walls and pre-formed metal roofing. There is a large central metal ventilator on the ridge. The westerly gable end has a 2/2 double hung window. All of the first floor windows are 6-light fixed windows. Small shed roof extensions have been constructed on the southeast and northeast corners of the original barn. The southeast corner extension was used as a milk room. The southeast gable end has a projecting ridgepole; the hay door has been boarded in and a window has been set into the opening. A grain silo foundation still exists a few feet off of the northern corner of the barn.

Photo 3 description: Northeast side of barn showing silo foundation
Roll: 2 Frame: 36 Direction: SE

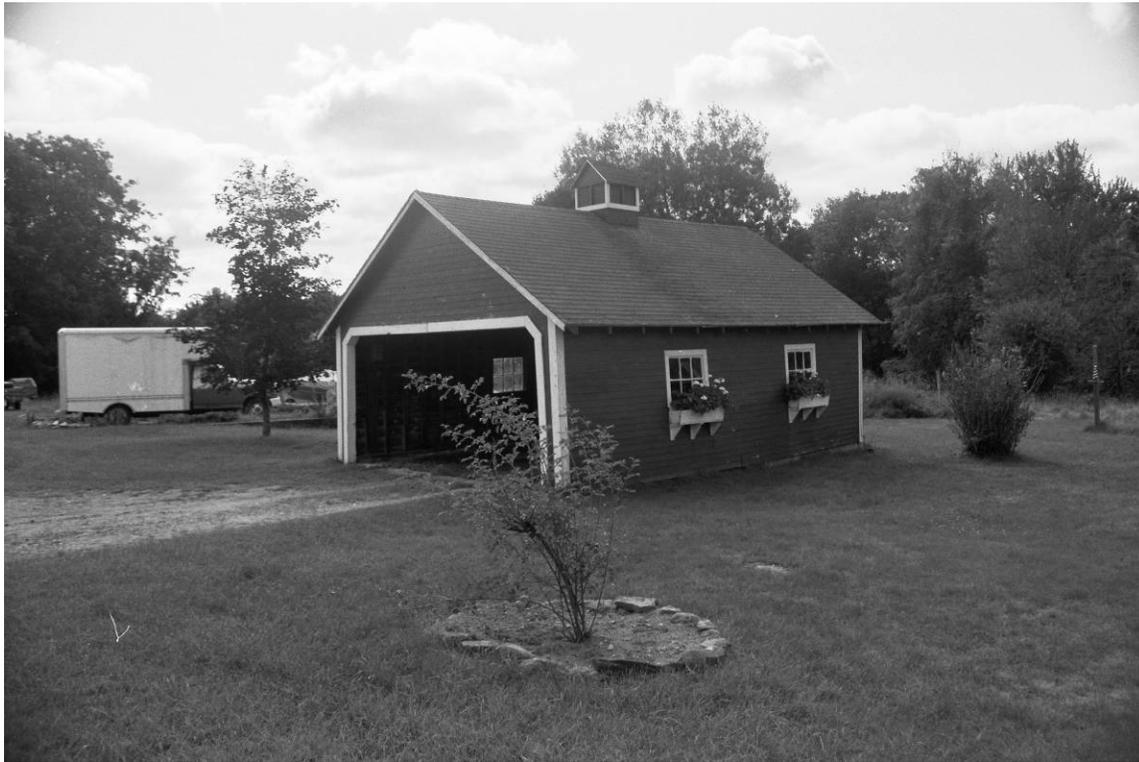
Roll: 2 Frame: 34 Direction: SE

Garage (mid-20th century): A two stall garage is situated about 50 feet south of the main barn. It has a concrete foundation, earth floor and an asphalt shingle roof. It is framed with 2x4 lumber. There are pairs of 6-light windows on the east and west sides and a small decorative cupola on the roof ridge. The siding is wood clapboard.

Photo 4 description: Detached garage
