INDIVIDUAL INVENTORY FORM

NHDHR INVENTORY NUMBER: CON0168

Address: 36 Ferrin Rd. Date taken: 9-18-2008 Negative stored at: NHDHR

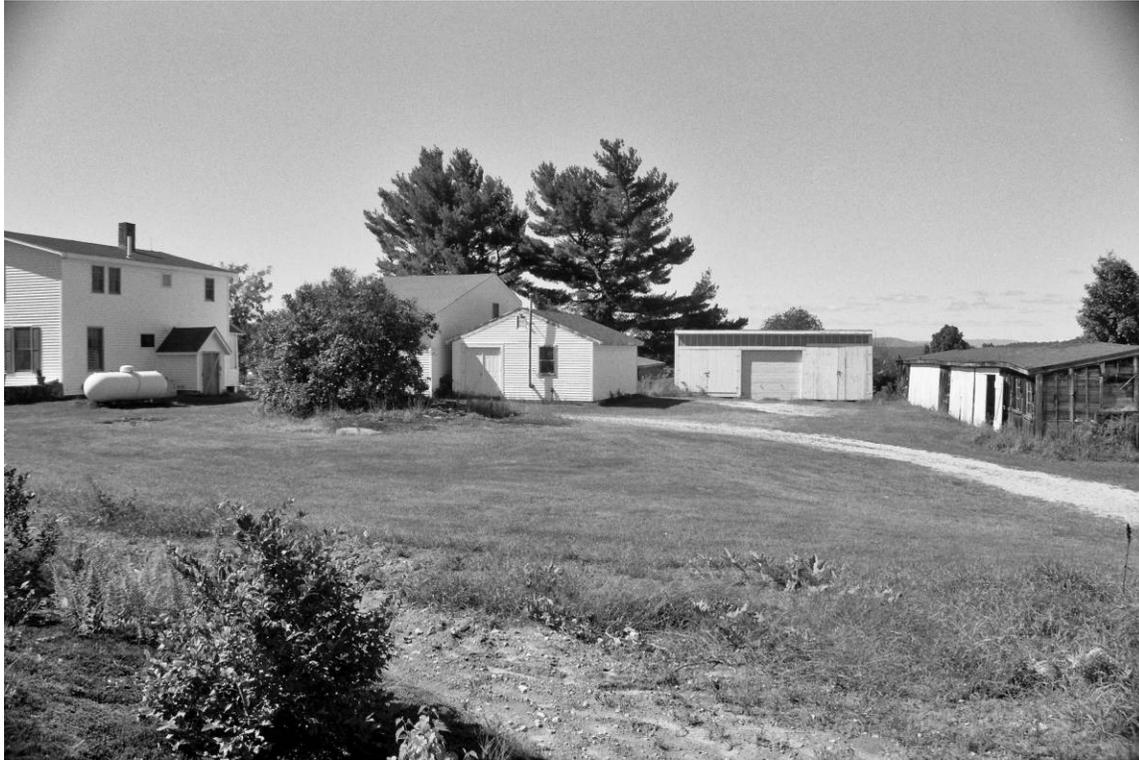
Photo 2 description: (Left to right) Rear of house, shop, shed roof tractor barn and 1970s hen house
Roll: 2 Frame: 31 Direction: W

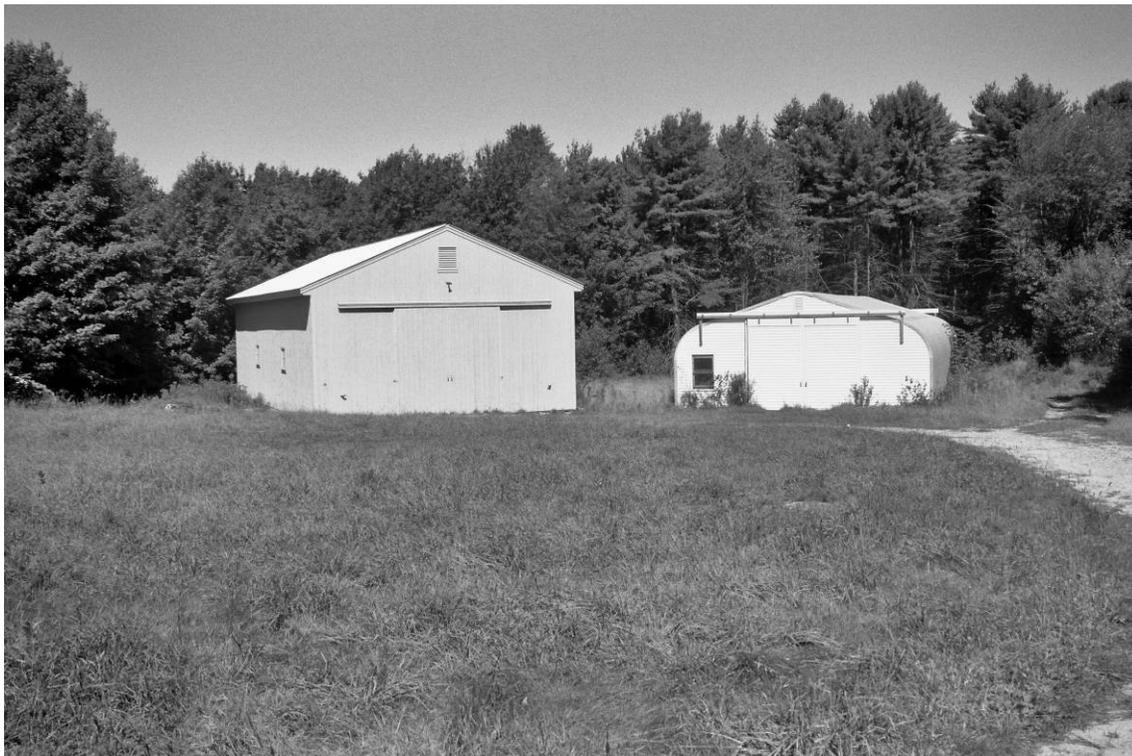
Photo 3 description: New barn and steel equipment building
Roll: 2 Frame: 30 Direction: N
