**INDIVIDUAL INVENTORY FORM****NHDHR INVENTORY NUMBER: CON0169****Name, Location, Ownership**

1. Historic name: White Farm
2. District or area: \_\_\_\_\_
3. Street and number: 52 Fisk Road
4. City or town: Concord
5. County: Merrimack
6. Current owner: John W. & Cynthia Phillips

32. Name: Roger C. Hawk
33. Organization: for Concord Heritage Commission
34. Date of survey: 8/20/2008

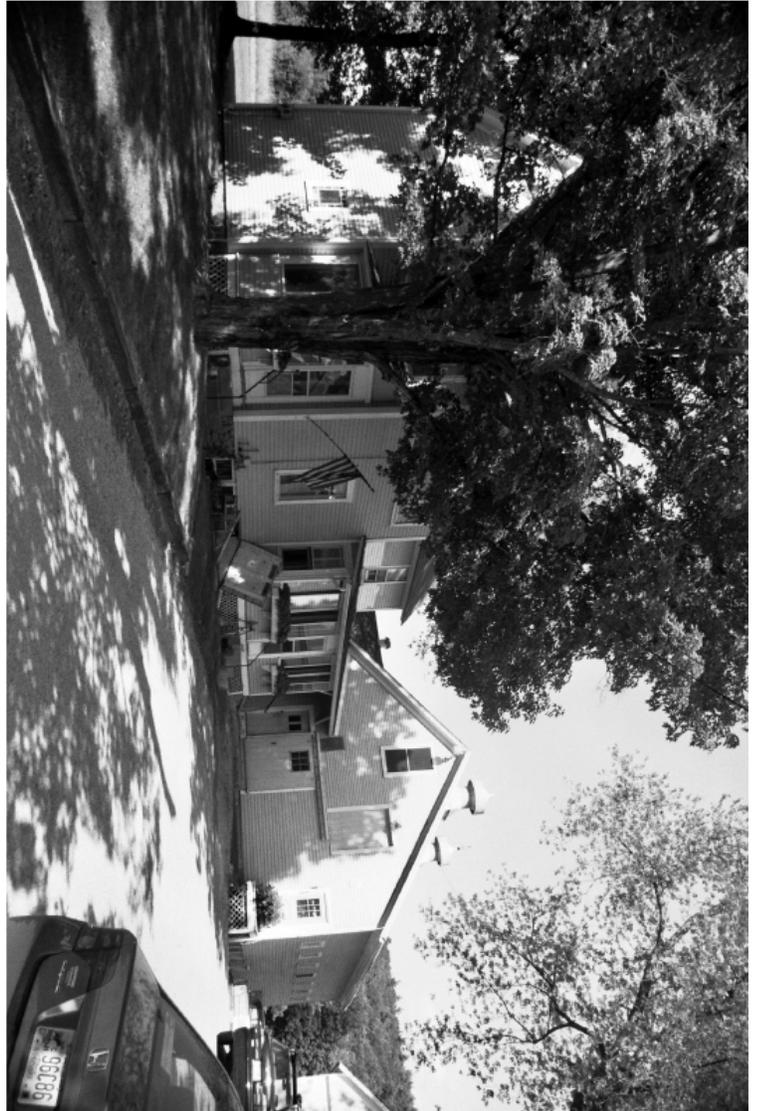
35. Photo #1
36. Date 8/20/2008
37. Roll #1      Frame #30      Direction: NE
38. Negative stored at: NHDHR

**Description:** Front (south) elevation of house, west elevation of barn

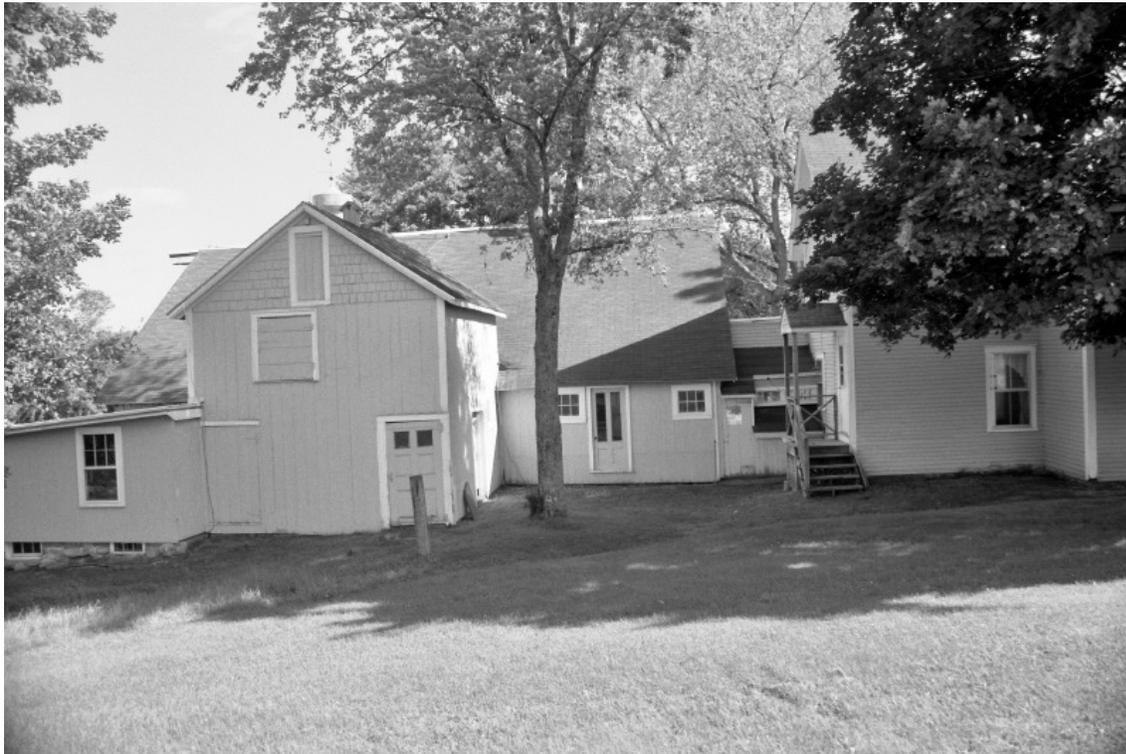
**Shed Roof Extensions (ca. mid-20<sup>th</sup> century):** Two shed roof additions have been constructed off the northern corner of the barn. The earlier of these additions lies in the corner between the barn and the gable roof addition. It has a stone foundation, vertical barn board siding and a formed metal roof. The second shed addition connects to the main barn at its northeast corner. This addition rests on a concrete block foundation. It is also clad with a formed metal roof and vertical barnboard siding. The southerly face of this addition has two openings to house tractors and other equipment. Both shed additions have 2 x 4 stud construction.

Photo 2 description: Northerly side of barn and sheds with rear wing of house to the right  
Roll: 1 Frame: 29 Direction: SE

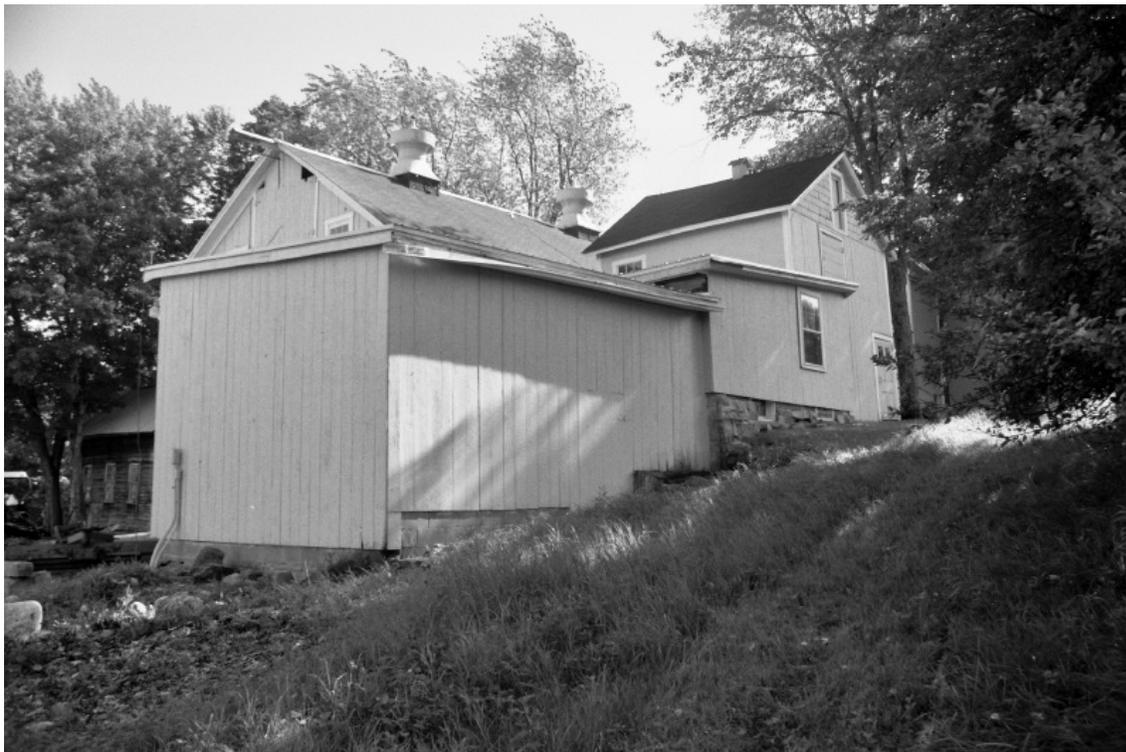
Photo 3 description: Shed additions on north side of barn with barn ventilators visible on ridgeline  
Roll: 1 Frame: 33 Direction: S

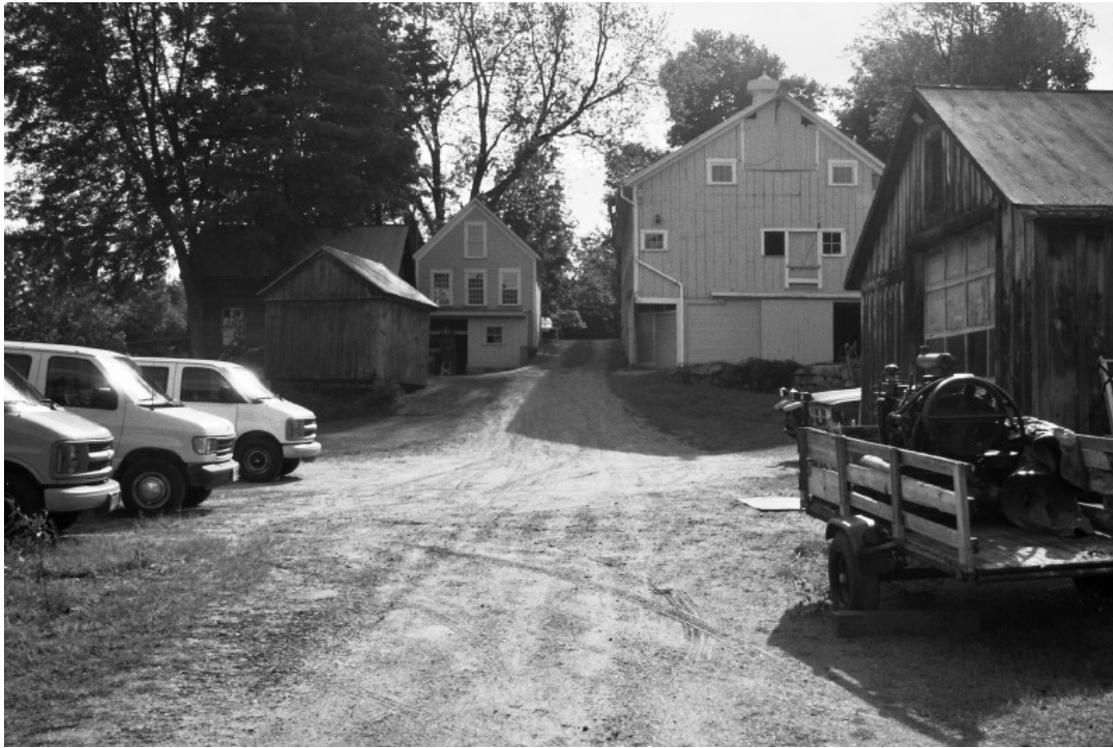
**Shop (ca. mid-20<sup>th</sup> century):** This gable roof structure lies east of the main barn complex. It rests on a concrete foundation, has a corrugated metal roof with board and batten siding. It has an overhead garage door and 2x4 frame construction. A small metal roofed shed lies immediately to the east of the shop.

Photo 4 description: Rear (northeast) view of barn and outbuildings with shop to the far right  
Roll: 1 Frame: 35 Direction: SW

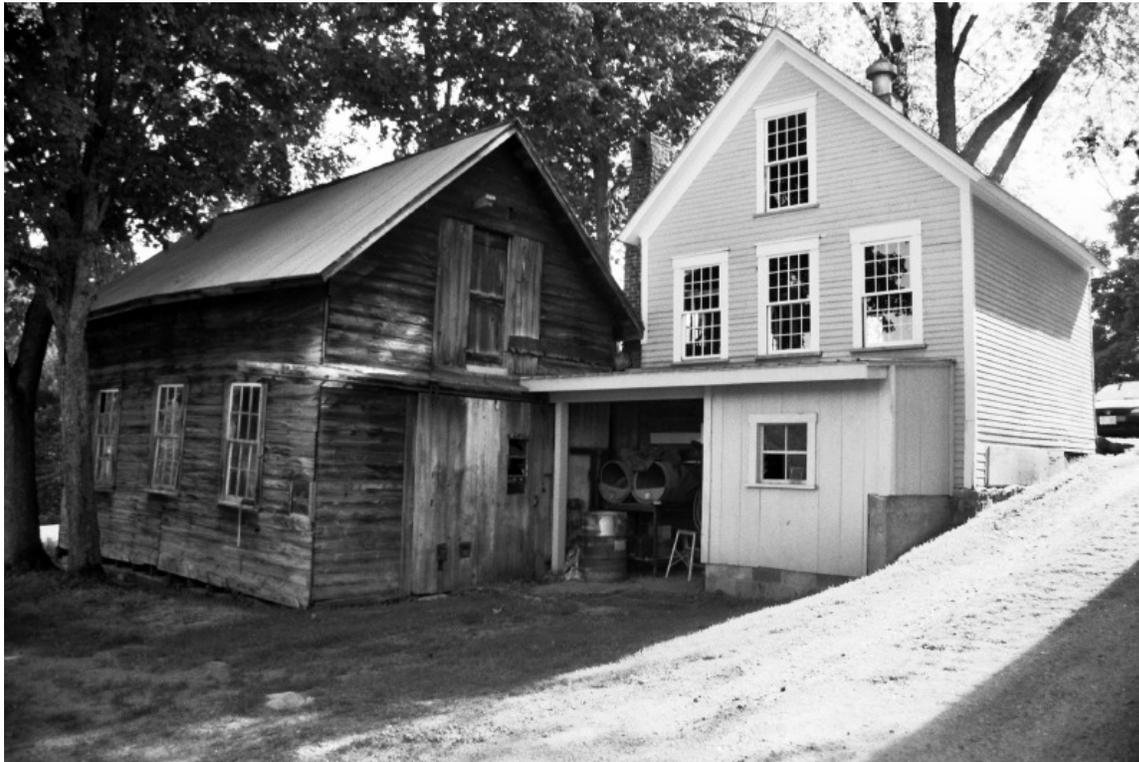
**Blacksmith Shop (ca. early 20<sup>th</sup> century):** The 1½ story, gable roof, blacksmith shop is supported by 6x6 sills and rests on a concrete pier and grade beam. It is framed with 2 x4's and has a 6x6 carrying beam running parallel to the ridgeline that supports the upper level. It has a sliding barn door on the north face and 6/6 double hung windows on east and west sides. It is clad with tongue and groove horizontal siding and a corrugated metal roof. A concrete block chimney provides ventilation for the blacksmith forge, which is situated on the south end of the structure.

Photo 6 description: Blacksmith shop and rear of garage with lower level shed roof addition  
Roll: 1 Frame: 32 Direction: SW

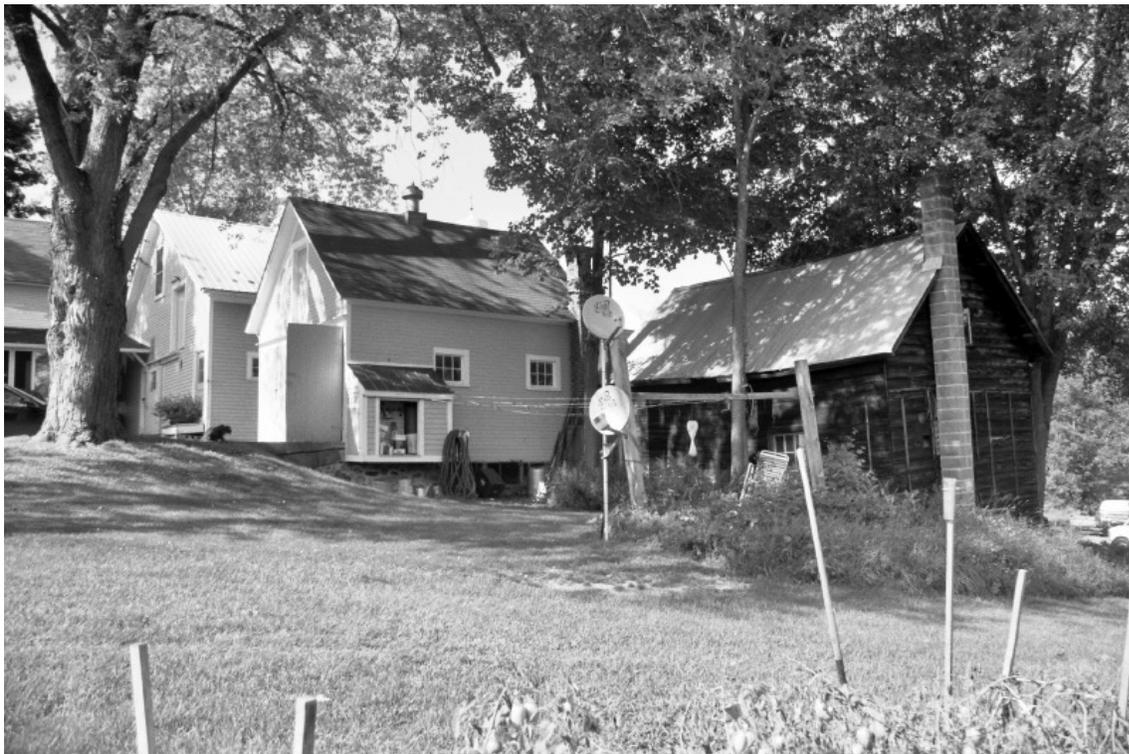
**Garage (ca. 1920s):** This 1½ story, gable front, 2 stall garage has hinged garage doors and a lower level accessed from the back (easterly) side. It sits on a mortared fieldstone foundation. It is clad with clapboards and asphalt roofing and includes a small metal ventilator centered on the roof ridge. A single double-hung window is situated in the gable end of the west face. Three 12/12 replacement windows line the main level of the east face with a single 12/12 window in the gable peak. Two, 6-light fixed sash are located on the south face. A single story shed roof addition to the lower level is situated on the east side of the garage and connects the garage to the adjacent blacksmith shop. A brick chimney is located on the southeast corner of the garage near its junction with the blacksmith shop.

Photo 7 description: Garage and blacksmith shop with barn to the left rear  
Roll: 1 Frame: 31 Direction: N

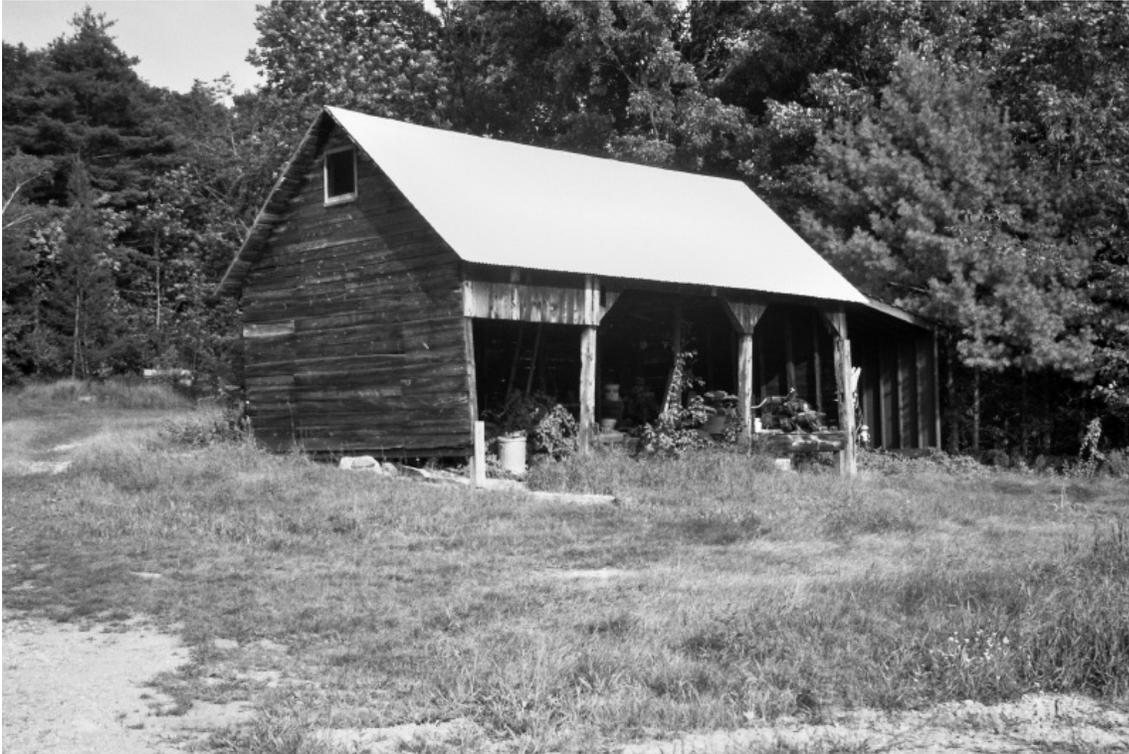
Roll: 1      Frame: 36      Direction: E

**Pole Barn (ca. mid-20<sup>th</sup> century):** Approximately 300 feet to the east of the house and barn complex, on the opposite side of Millers Brook, lies a utilitarian pole barn. Its 6x6, 2x4 and 2x6 frame rests on an exposed granite outcrop. It has weathered horizontal board siding and a corrugated metal roof. The main structure has three equipment bays and a shed roof addition on the southerly side provides a fourth bay.

Photo 8 description: Pole Barn
