## INDIVIDUAL INVENTORY FORM

NHDHR INVENTORY NUMBER: CON0145

**84 District Five Road (Rossvie Farm)**

*The following information updates the inventory form prepared for 84 District Five Road in 2003, with a focus upon its agricultural history and outbuildings. The original nomination is on file at NHDHR.*

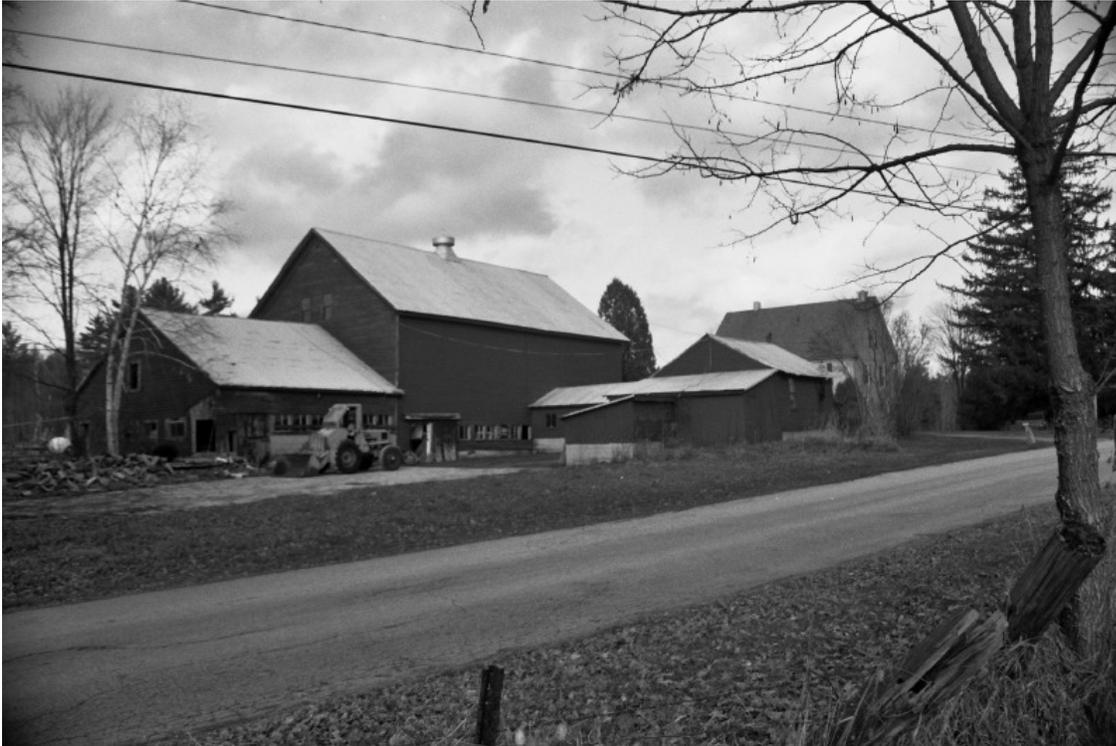
Photo 1 description: Farmstead with barn and barn addition to left, house in background  
Roll: 9 Frame: 13 Direction: NE

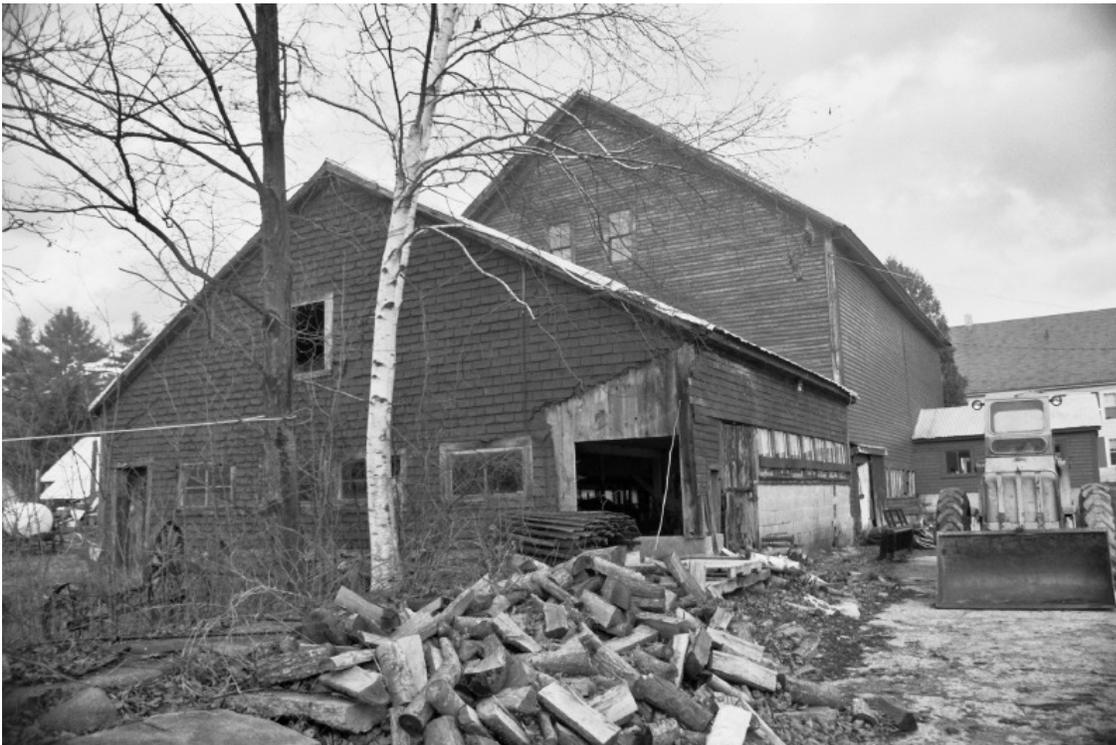
Photo 2 description: Barn addition (foreground and barn with milk room visible behind loader

Mr. Ross said that a fire had destroyed the primary dairy barn (across the street near the present sugar house) in the early 1950s before his family purchased the property. His understanding is that as a result of the fire, the prior owner constructed the milking parlor in the lower level of the main barn and barn extension. The barn has double slider doors on the east face and 6/9 windows. A large metal ventilator is centered on the ridgeline of the main roof. Wooden ventilator shafts rise up above the second floor level inside the barn to provide ventilation to the milking parlor in the basement level. A ground level, gable roof extension of the south side of the main barn appears to have been used for a milk room.

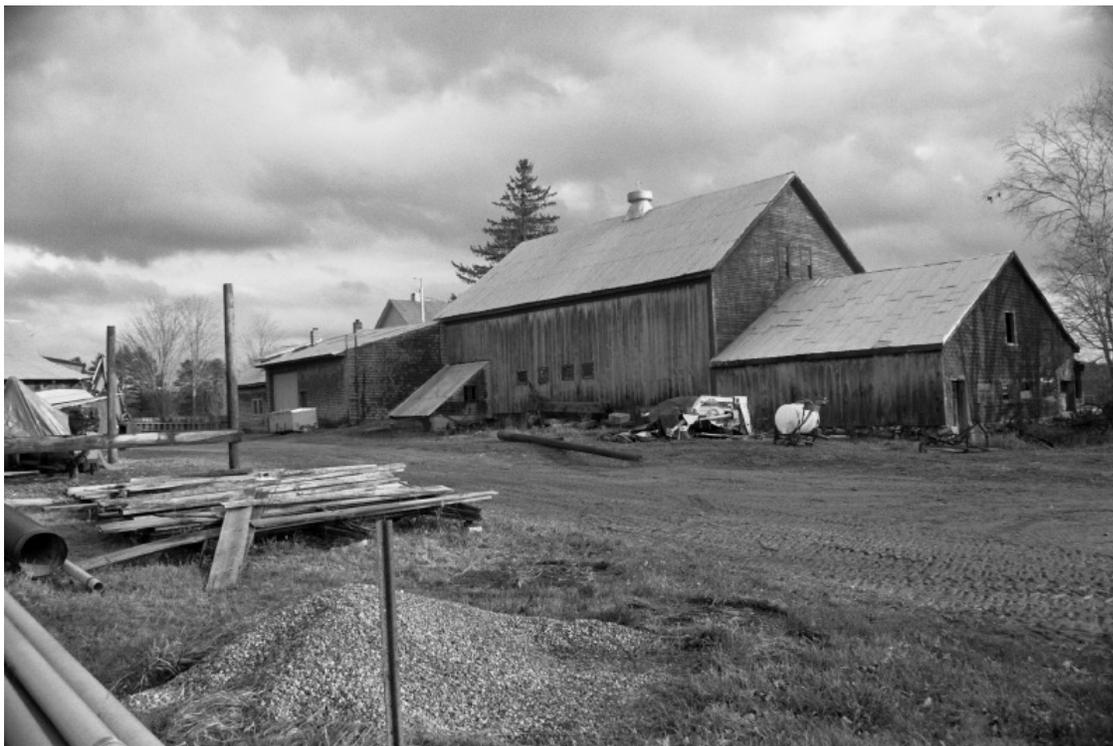
Photo 3 description: Northerly side of barn

Barn (ca. mid-1800s): This 4-bay, queen post, post and beam barn appears to have been constructed from salvaged hand hewn timbers due to the presence of many unused mortise pockets. A hay track is visible beneath the ridge of the barn; however there are no hay doors on either gable end of the building. Mr. Ross indicated that the hay track was used to move manure from the main barn to the single story barn addition at the west end of the main barn. The main barn had been used for dairy cows and horses until the mid-20<sup>th</sup> century.

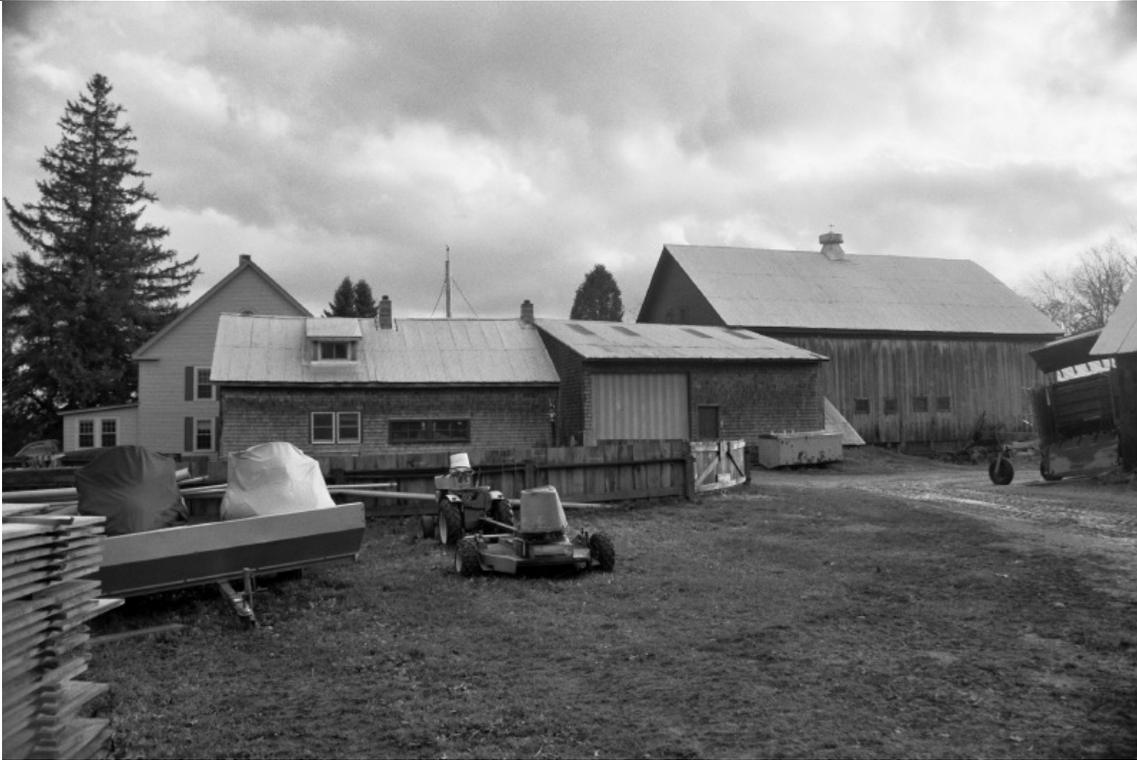
Photo 4 description: Northerly side of house (left) ellway (center) and barn (right)

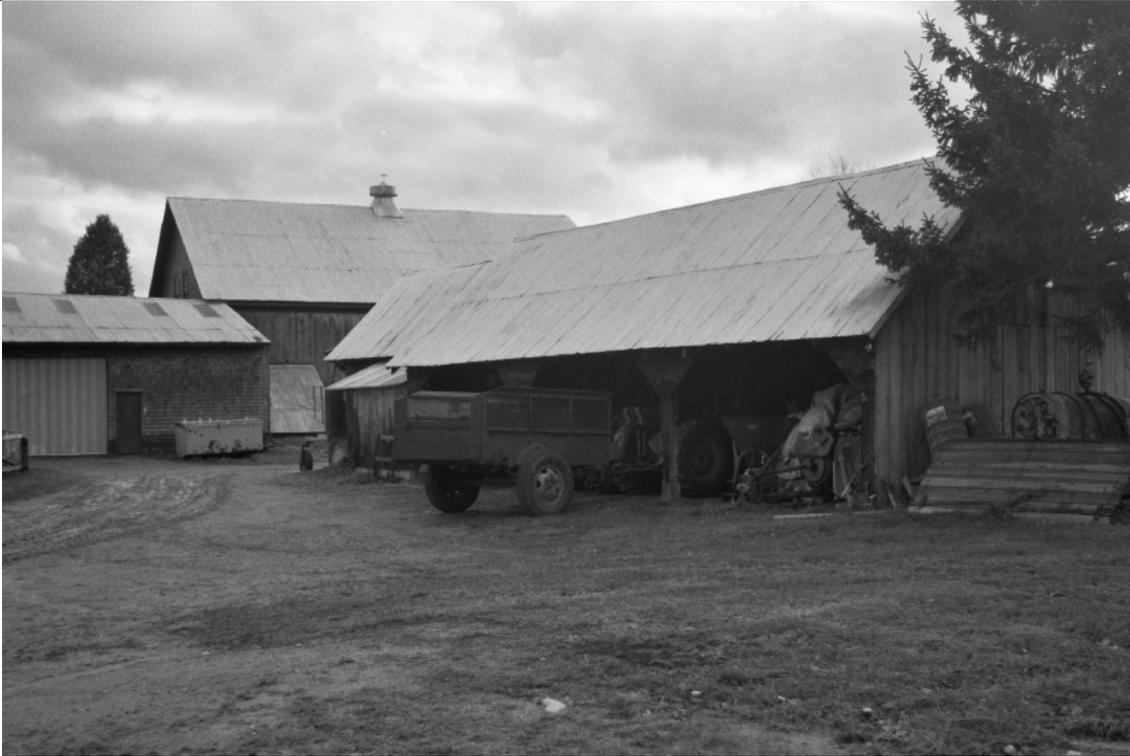
Vehicle Storage Shed (mid-late 20<sup>th</sup> century): North of the main barn is a vehicle storage shed that appears to have been constructed in three stages. The north-south oriented section is the original structure constructed of salvaged large timbers, vertical board siding and a corrugated metal roof. A smaller, corrugated-metal gable-roof pole barn addition was constructed on the south end of the shed. More recently, an additional corrugated metal shed roofed bay has been added to the north end of the addition.

Photo 5 description: Vehicle Storage Shed  
Roll: 9 Frame: 17 Direction: SW

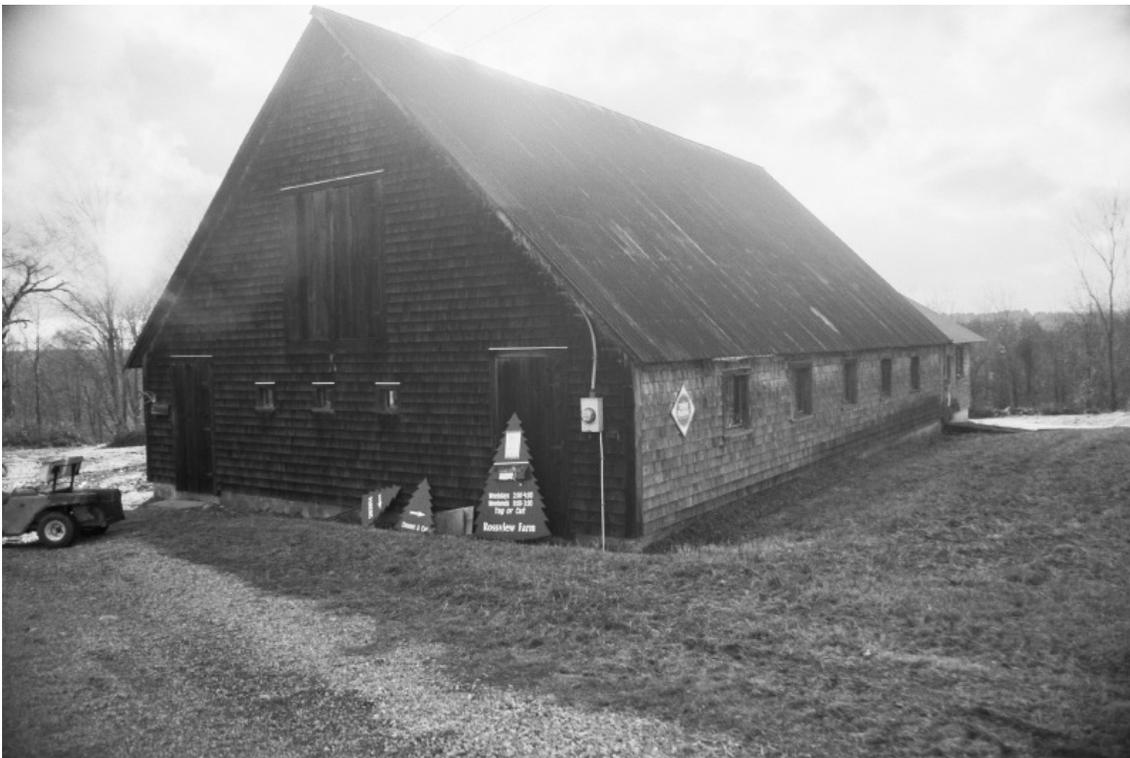
Sugar House: The sugar house is located on the south side of District Five Road, across from the main farmstead. Mr. Ross believes that the main portion of the sugar house (eastern  $\frac{3}{4}$  of building) is the last remaining structure from what had been a dairy barn complex destroyed by fire in the early 1950s. The rough sawn 2x4 and 2x6 construction appears to have been built in the early 20<sup>th</sup> century. The Ross family has made a number of repairs and structural improvements to this structure which is now used as a sales building for summer produce, christmas trees and wreaths. The western quarter of this structure is a 1998

sugar house with a concrete foundation, a roof ridge vent and sugar evaporator. The entire structure has a corrugated metal roof and cedar shingle siding.

Photo 6 description: Sugar House  
Roll: 9 Frame: 12 Direction: SW

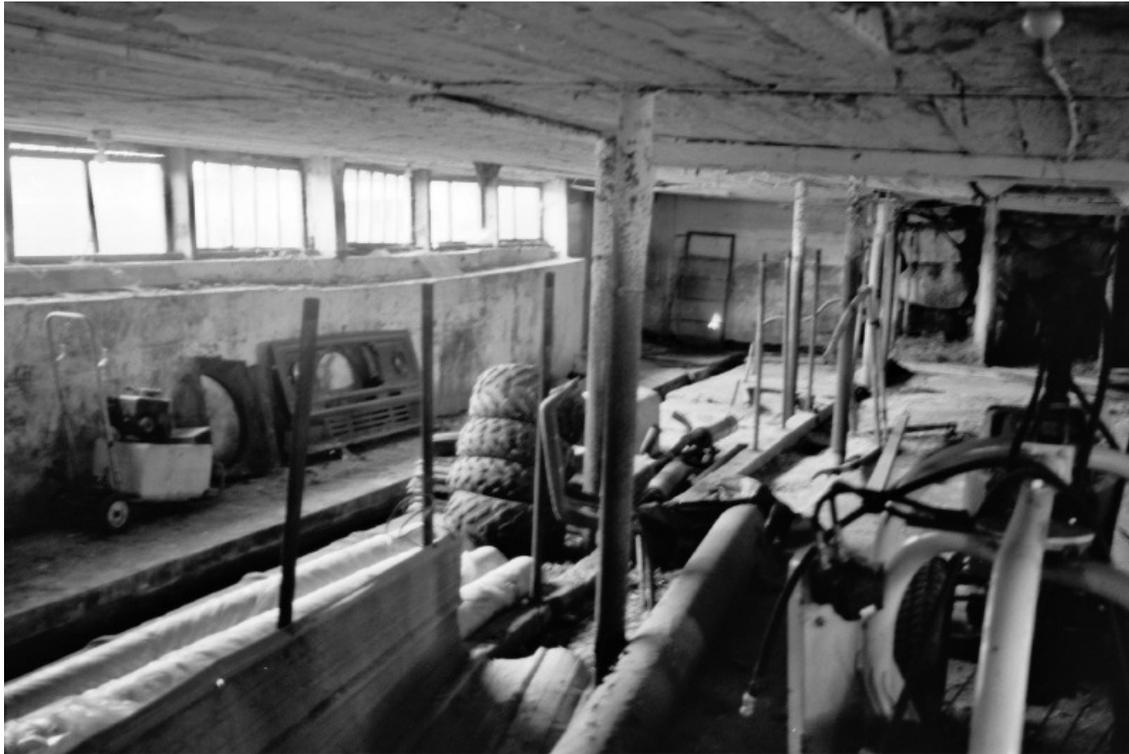
Photo 7 description: Milking parlor in basement of barn  
Roll: 9 Frame: 11 Direction: NE
