**INDIVIDUAL INVENTORY FORM**

**NHDHR INVENTORY NUMBER: CON0174**

- 1. Historic name: \_\_\_\_\_
- 2. District or area: \_\_\_\_\_
- 3. Street and number: 84 Iron Works Rd.
- 4. City or town: Concord
- 5. County: Merrimack
- 6. Current owner: State of NH

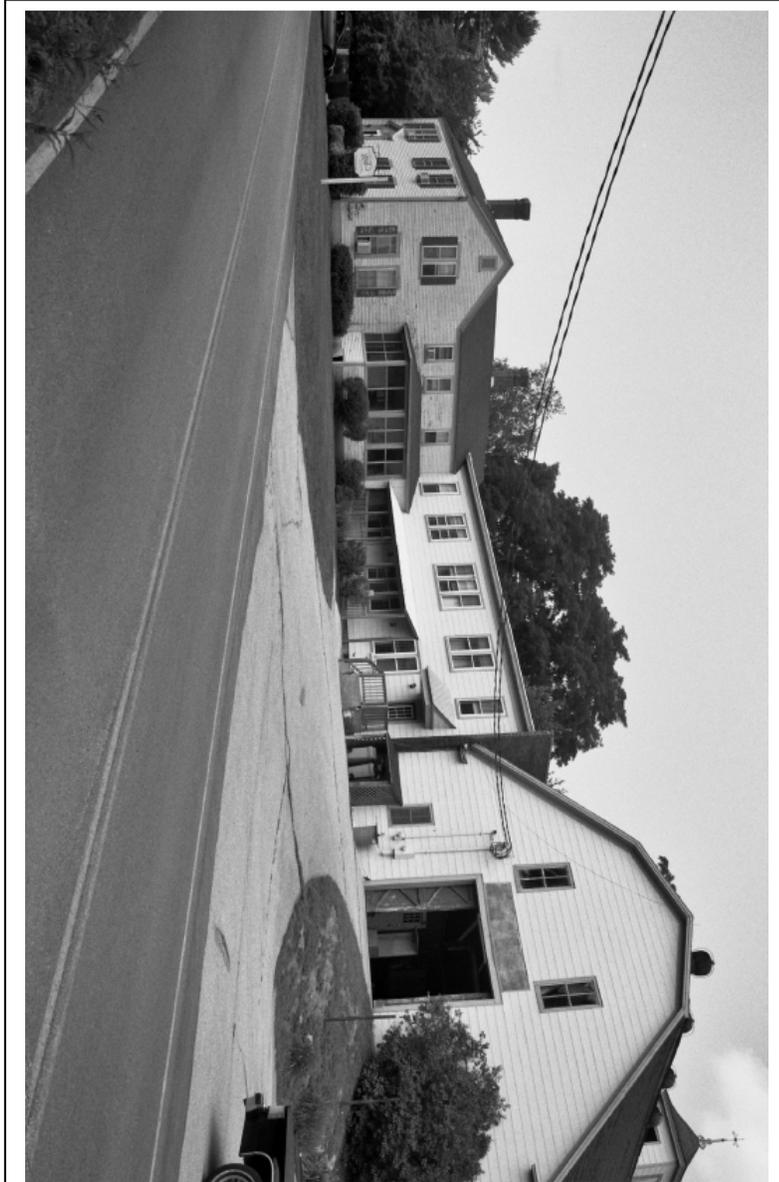
- 35. Photo #1
- 36. Date: 8/18/2008
- 37. Roll # 1      Frame # 14      Direction: NW
- 38. Negative stored at: NHDHR

**Description:** South and east elevations of house and ell, with connector and barn.

House (ca. late 18<sup>th</sup> century): This house is understood to have been standing by 1787, though its current appearance suggests a ca. 1825-40 remodeling. The house is a two story, three bay, side-gable structure with offset center chimney. The foundation is brick with stucco finish. The front door is in the left bay and appears to be a Colonial Revival replacement from the mid-20<sup>th</sup> century. The rear, two story, 19<sup>th</sup> century ell has a ridge chimney and an enclosed single story porch on the east elevation. The house and ell have 2/2 windows (except the windows over the front door, which appear to be 1930s replacements). The house is currently used as office space for the Granite State Independent Living Council.

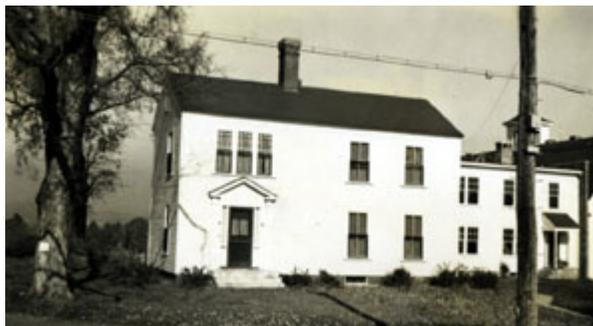
Photographed mid-20<sup>th</sup> century. *From Amsden, Chapter 17, opposite page 11.*

Tradition has it that this house once sat across the road and that its old well was still visible at least in the 1930s-1940s when Amsden researched her history of Concord. Amsden called this "an ancient [house] modernized" and said it was probably built by Joseph Carter, son of Daniel, who settled in a log house in the same vicinity. Joseph's son Nathaniel Haseltine Carter (b. 1787) may have been born in this house and it was his childhood home. Nathaniel H. Carter was a poet and the founder and editor of the periodical *N.Y. Statesman*. Around 1811, Joseph Carter sold the homestead to William Abbott.<sup>1</sup> The 1858 map notes I. & M.B. Abbott here and by 1892, it was H. P. Moore and called "Mooreland" (which included two primary buildings).

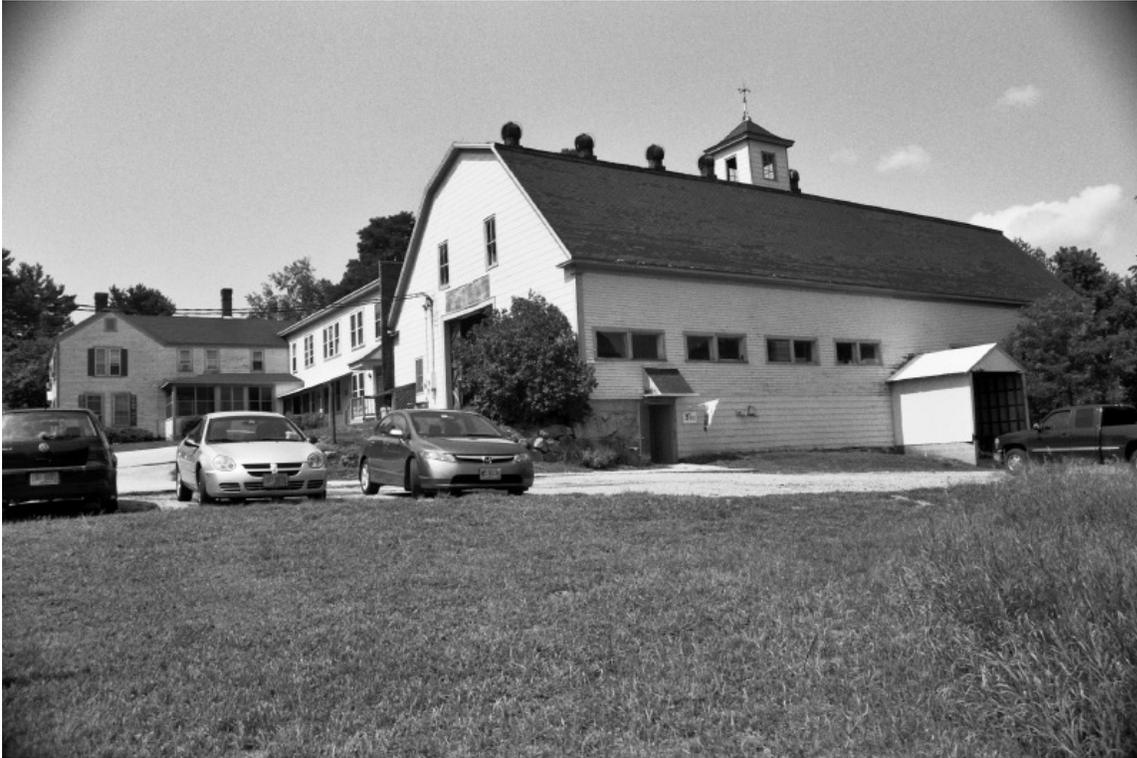
Roll: 1 Frame: 15 Direction: W

Photo 2 description: South and east face of barn showing cupola and ventilators

Barn (early 20<sup>th</sup> century): The gambrel roof bank barn has a queen post construction with turnbuckle reinforcements. The timbers are 6x6 and 8x8, with a balloon frame roof. There are eight bays running the length of the barn (north-south). Paired 2/2 windows provide light to the second floor of the barn on both the south and north gambrel ends. Sliding barn doors are located at both the north and south ends. There is a multi-light transom over the north door. The north entrance has a steep earth and stone vehicle ramp.

A simple cupola with a weathervane is centered on the ridgeline. Five metal roof ventilators are also located on the ridge, four to the south of the cupola and one to the north. These are connected to the basement level via wooden ventilator shafts attached to the interior of the roof and walls. This ventilation system indicates that the lower level was likely used as a milking parlor. The barn foundation is mortared granite block. The basement has been insulated and finished and used for handicapped equipment repair and sales. A gable roof extension is located along the center of the east wall to provide covered access to the basement level.

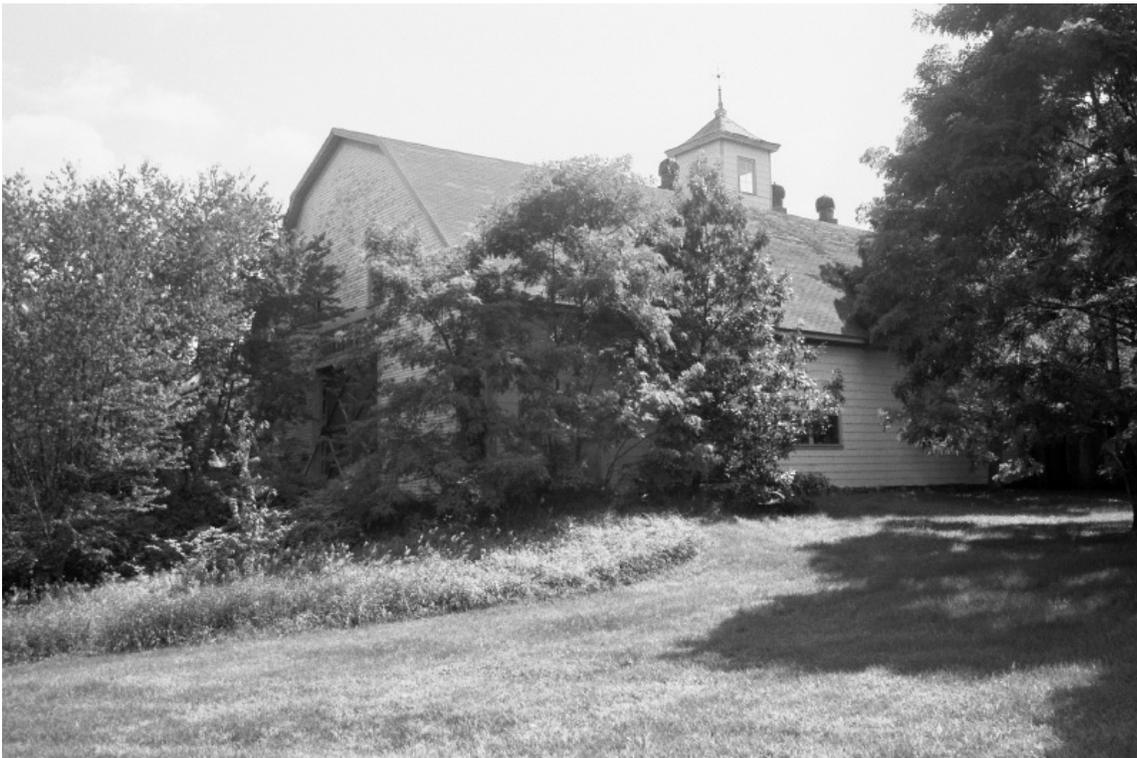
Roll: 1 Frame: 13 Direction: SE

Photo 3 description: North and west elevations of barn
