**INDIVIDUAL INVENTORY FORM**

**NHDHR INVENTORY NUMBER: CON0191**

- 1. Historic name: \_\_\_\_\_
- 2. District or area: Stickney Hill  
Agricultural Neighborhood
- 3. Street and number: 84 Stickney Hill Rd.
- 4. City or town: Concord
- 5. County: Merrimack
- 6. Current owner: Lorraine Hayes Pierce

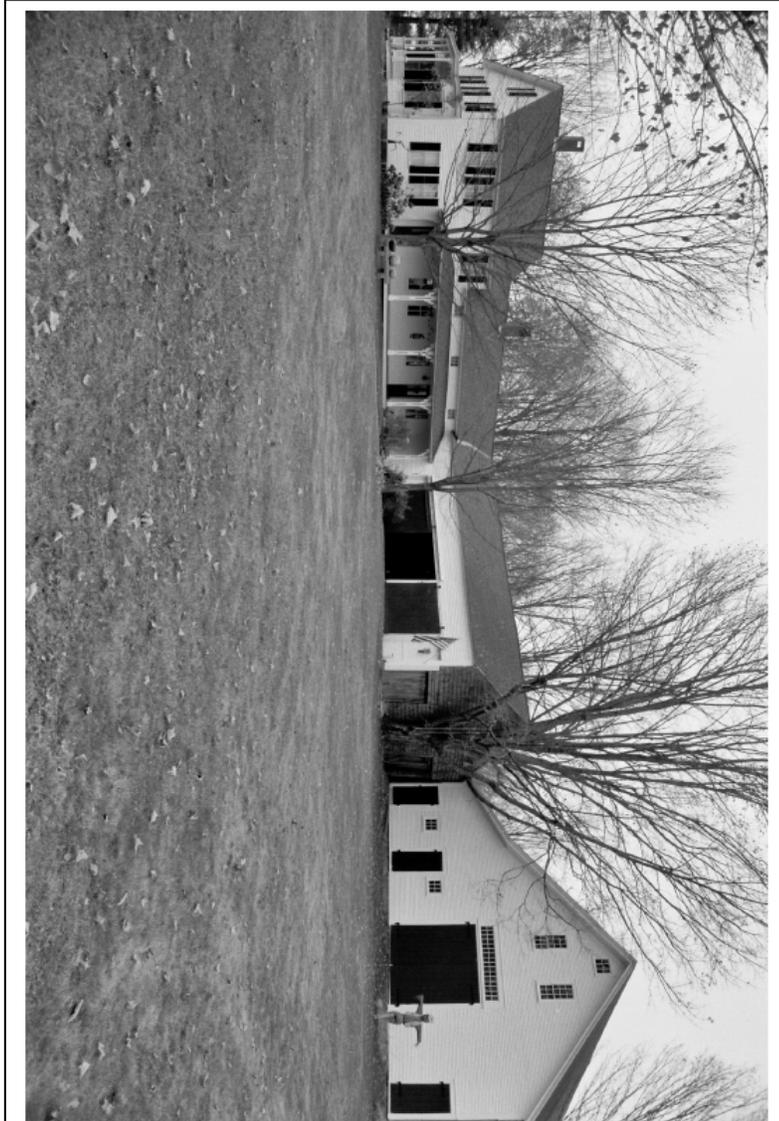
- 35. Photo #1
- 36. Date Fall 2008
- 37. Roll #7    Frame #2    Direction: NW
- 38. Negative stored at: NHDHR

**Description:** View of connected farm buildings

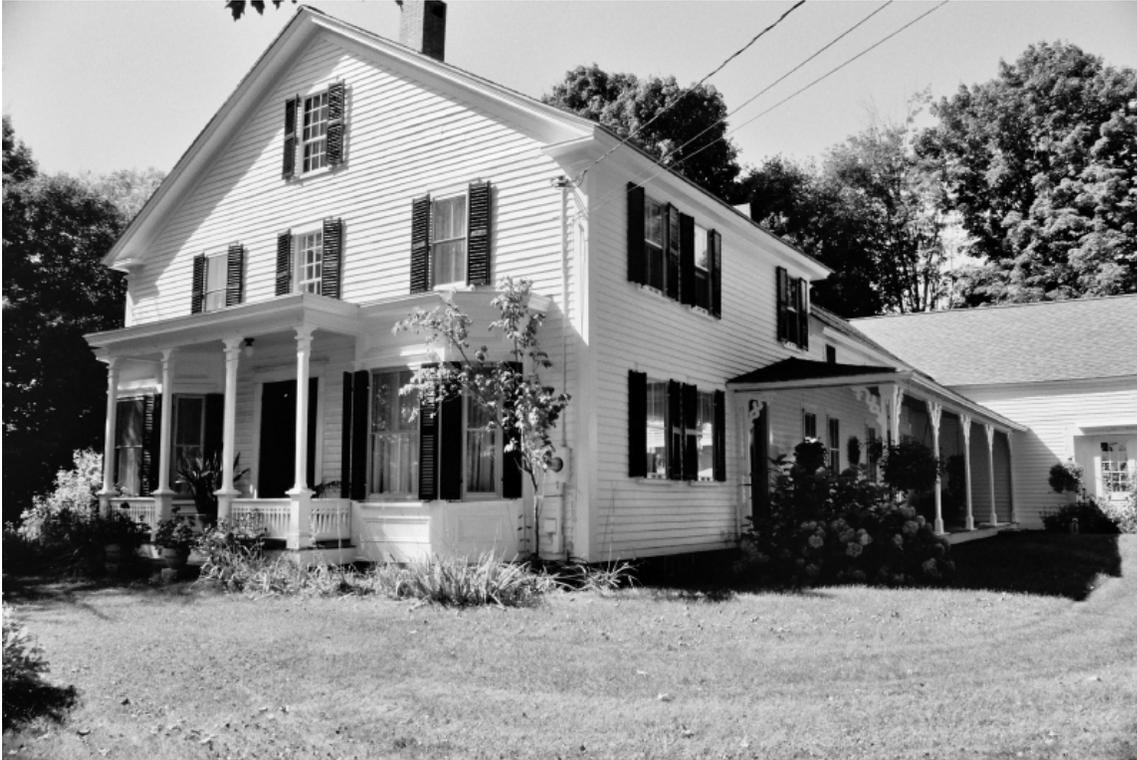
House (ca. early 19<sup>th</sup> c. (?)/1888): This is a 2 ½ story, 3x4-bay, front-gable structure with clapboard siding and a granite block foundation. The main entrance is centered and features a portico with chamfered posts, sawn railing and dressed granite steps. Flanking the entrance are bay windows on brick foundations. Most of the sash is 2/2 (late 19<sup>th</sup> c.), but earlier 9/6 sash is found in the gable. A 1 ½ story ell extends to the rear, also on a granite foundation. Spanning the east elevation is a hip-roof porch with

Photo 2 description: Front (south) and east elevations of farmhouse; rear ell & part of shed in rear  
Roll: 4 Frame: 26 Direction: N

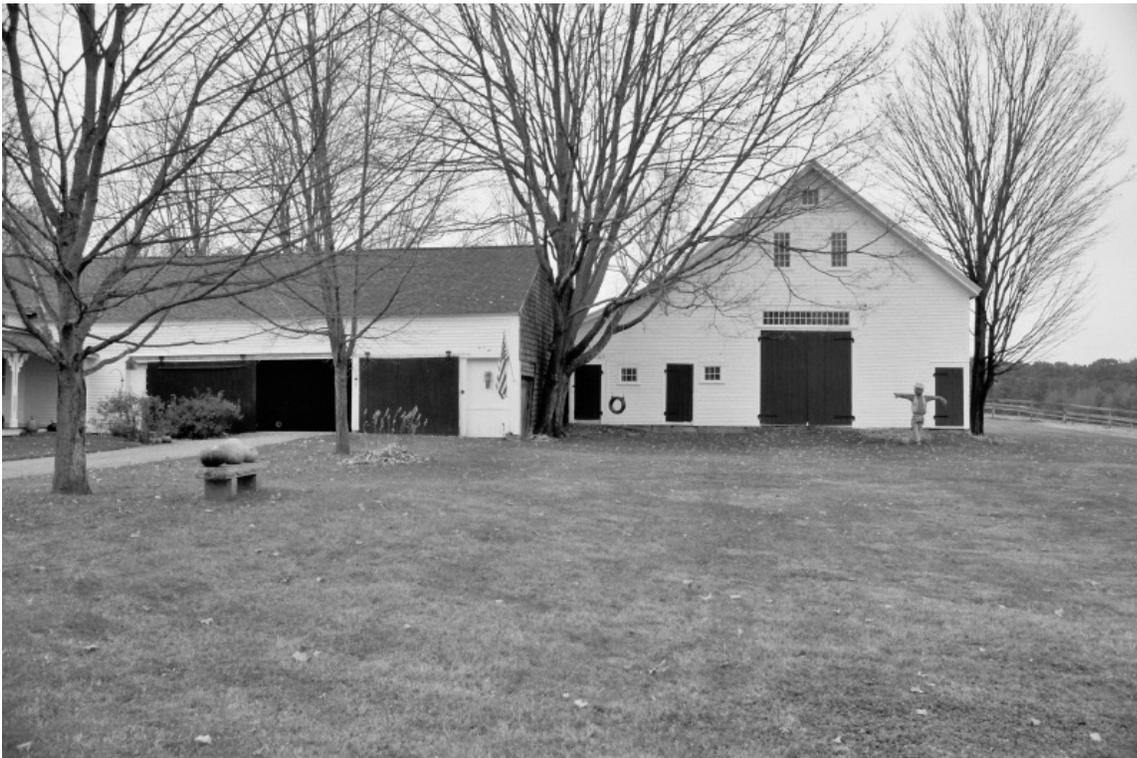
Wagon shed (19<sup>th</sup> c.): The wagon shed is a lengthy 1 ½ story structure than is attached, and perpendicular to, the ell. It has clapboard siding on the front (south) elevation and shingles elsewhere. Rolling vertical-board doors are on the multiple wagon openings along the south wall. A low, shed-roof addition on a concrete foundation spans the north elevation.

Barn (ca. 1800-1820/1888): The barn is a gable-front, timber-frame structure that connects to the east end of the wagon shed via a lean-to extension. The main barn was built in two phases.

Photo 3 description: Wagon shed & barn  
Roll: 7 Frame: 1 Direction: N

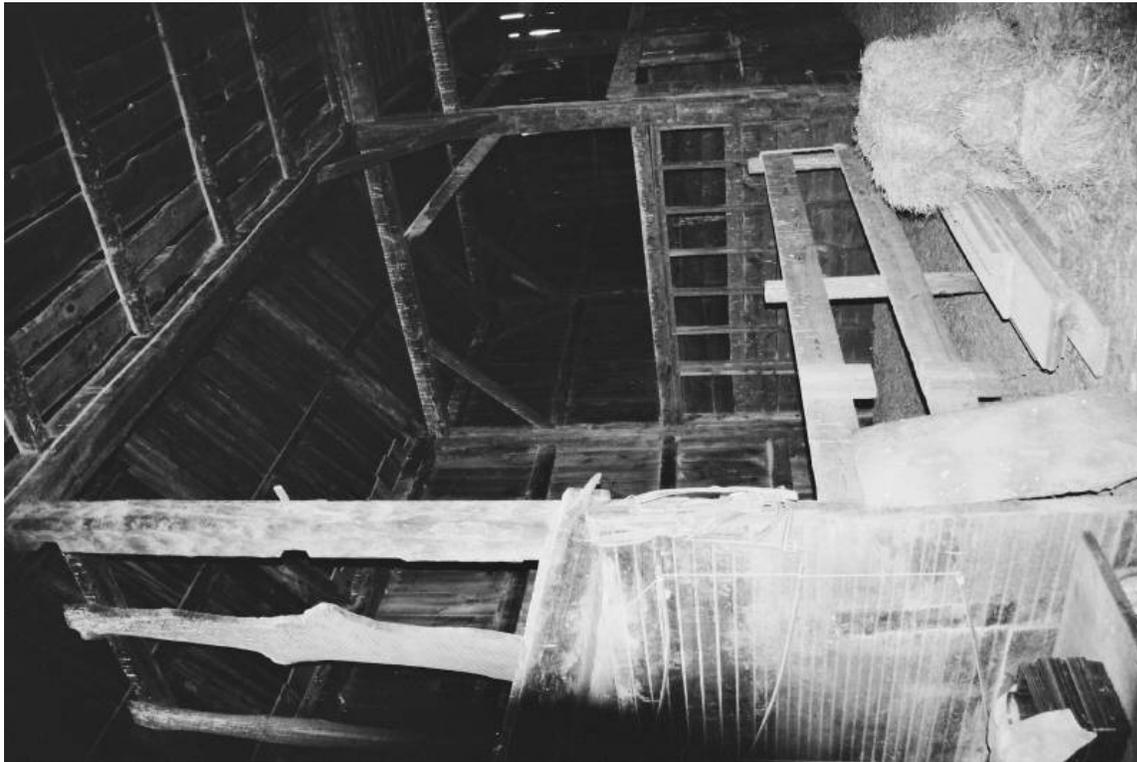
The earlier section—the south three bays—has a scribe-rule frame with gunstock posts, hewn major timbers and sawn braces. The roof frame of this section is original, consisting of principle rafters, five rows of log purlins and vertical sheathing. Based on the frame construction, it dates from the first two decades of the 19<sup>th</sup> c. (If hand-wrought nails are found, it could be even earlier.)

The later section—the north two bays—is framed similarly to the earlier section, but all of the timber has circular saw marks. The bays are slightly smaller. On the north wall girt there is a chalk inscription: “The barn was \_\_\_\_\_ in 1888.”

Photo 4 description: Barn frame, showing juncture between original (left) and 1888 addition  
Roll: 7 Frame: 4 Direction: NW

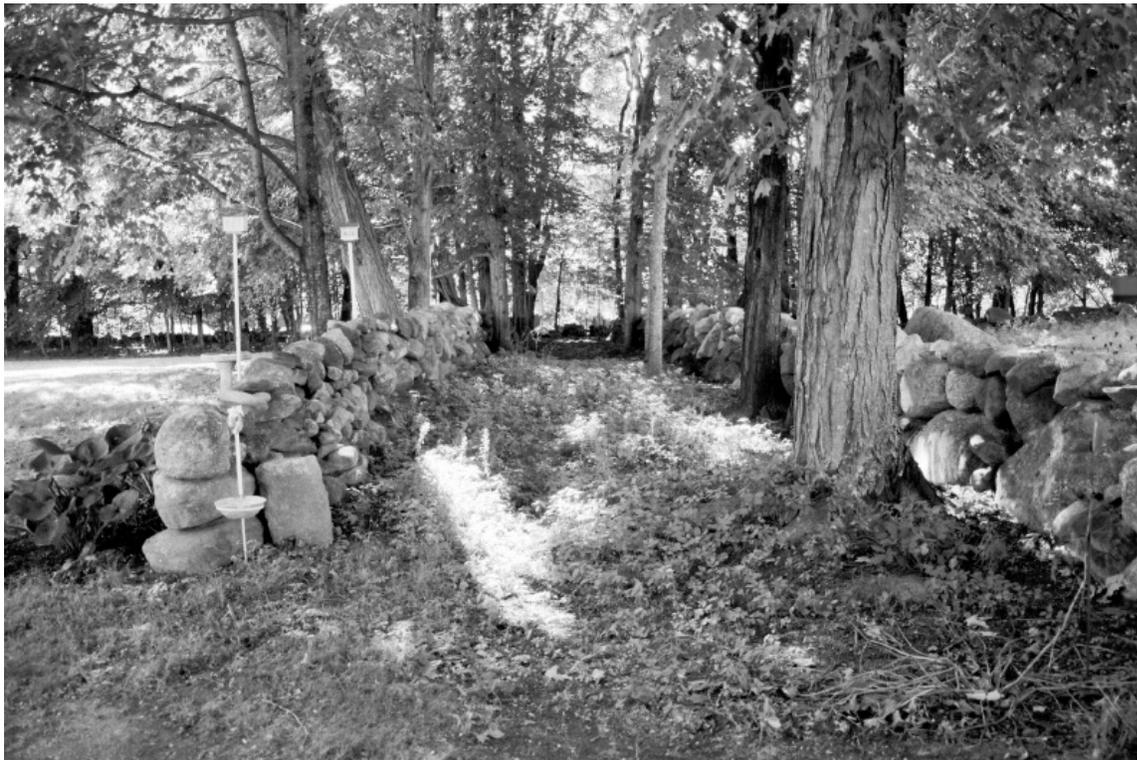
This farm includes an extensive complex of connected agricultural buildings on 22 acres that is mostly hayfield and pasture. Stone walls define the lot lines, as well as edge a cow path that extends westerly from the barn.

Photo 5 description: Cow path  
Roll: 4 Frame: 27 Direction: W
