INDIVIDUAL INVENTORY FORM

NHDHR INVENTORY NUMBER: CON0176

- 1. Historic name: _____
- 2. District or area: _____
- 3. Street and number: 87 Mountain Rd.
- 4. City or town: Concord
- 5. County: Merrimack
- 6. Current owner: Mary Ellen Snow

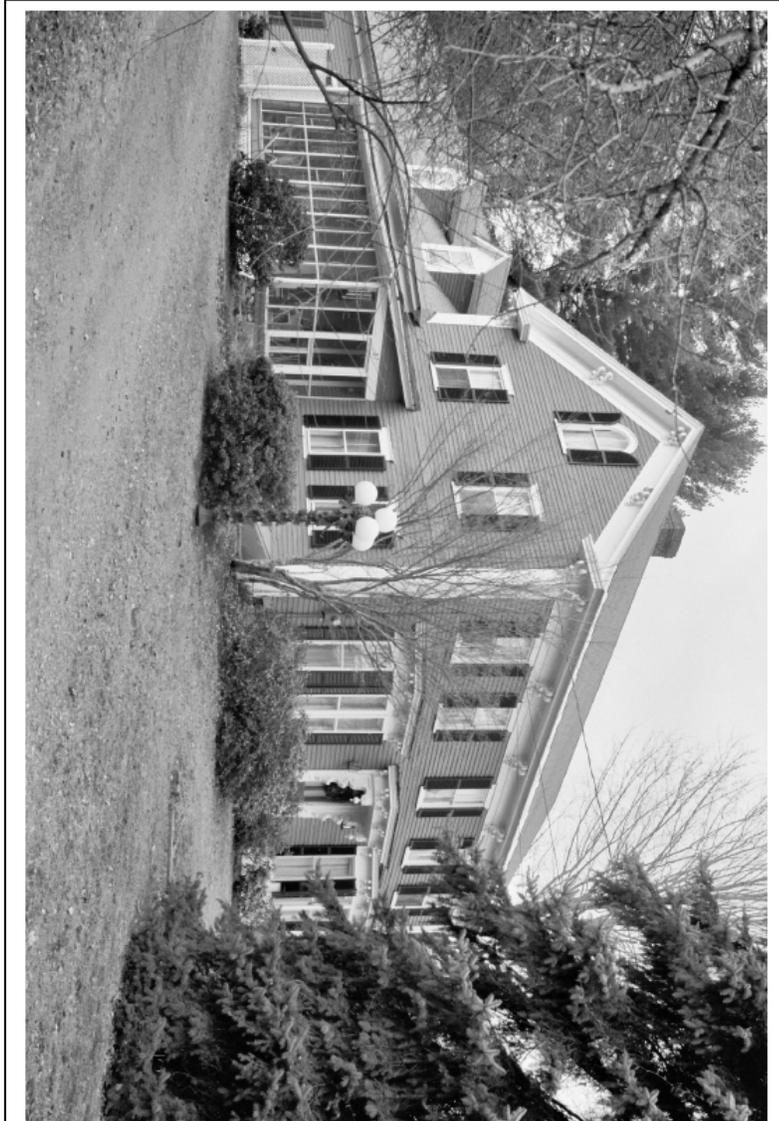
- 35. Photo #1
- 36. Date Fall 2008
- 37. Roll #7 Frame #17 Direction: NW
- 38. Negative stored at: NHDHR

Description: Farmhouse & rear ell

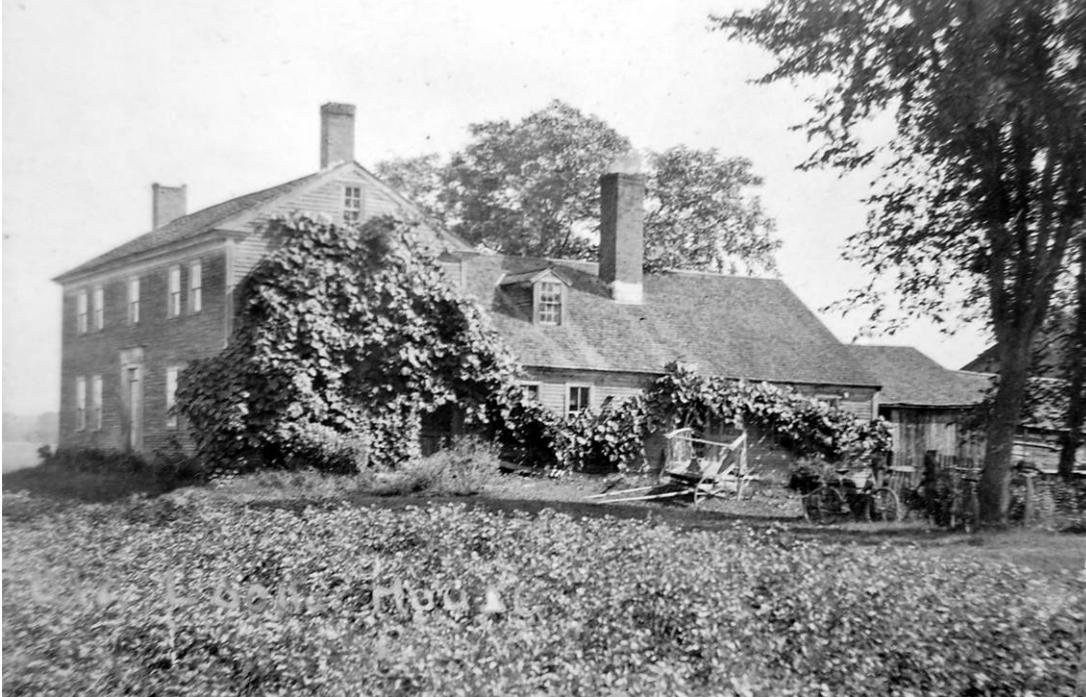
“Old Locke House.” Photograph taken from the north, showing farmhouse prior to Italianate renovations undertaken ca. 1870s. *Courtesy Snow family.*

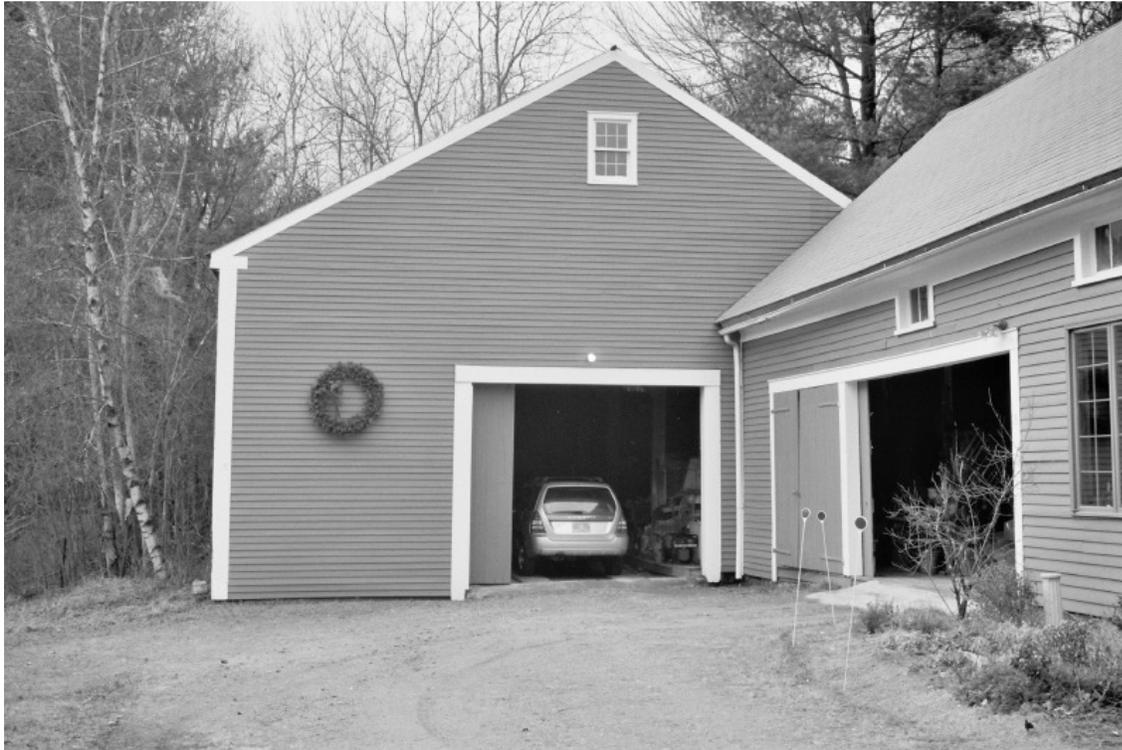
Photo 2 description: South elevation of shed & east gable front of barn
Roll: 7 Frame: 20 Direction: W

Ell/Shed (ca. 1810): A 1½ story ell/shed extends to the rear. The east end, which once held a summer kitchen and woodshed, was extensively renovated in the latter part of the 20th c. The west end is a wagon shed and has a wide opening with both a rolling door and hinged doors on the south elevation.

The front (east) gable end has a centered wagon opening with an interior vertical-board rolling door. That wall is clad with clapboards, the south wall with T1-11 siding, and the rear wall with vertical boards. The barn rests on a granite foundation. In the rear, granite posts indicate the barn either had a west addition or additional bays.

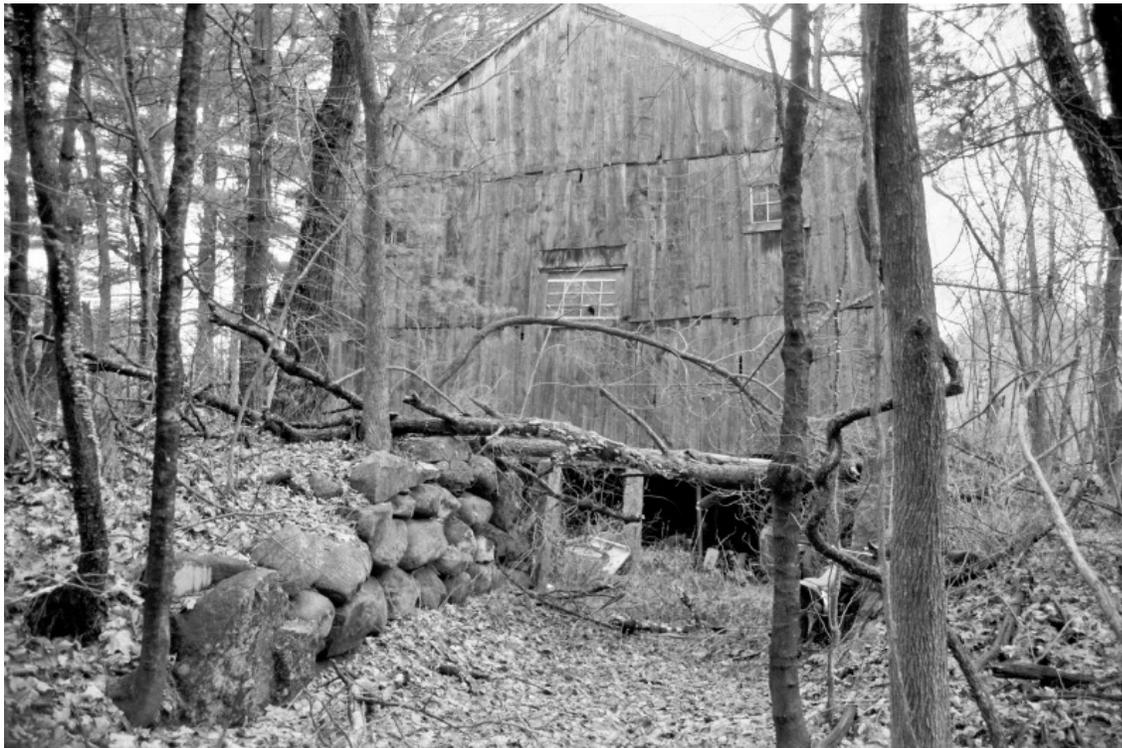
Photo 3 description: Rear (west) elevation of barn. Note granite foundation posts indicating removed section.
Stone retaining wall marks cow path to rear pasture.
Roll: 7 Frame: 19 Direction: E
