INDIVIDUAL INVENTORY FORM

NHDHR INVENTORY NUMBER: CON0192

- 1. Historic name: _____
- 2. District or area: Stickney Hill
Agricultural Neighborhood
- 3. Street and number: 90 Stickney Hill Rd.
- 4. City or town: Concord
- 5. County: Merrimack
- 6. Current owner: Hope Zanes

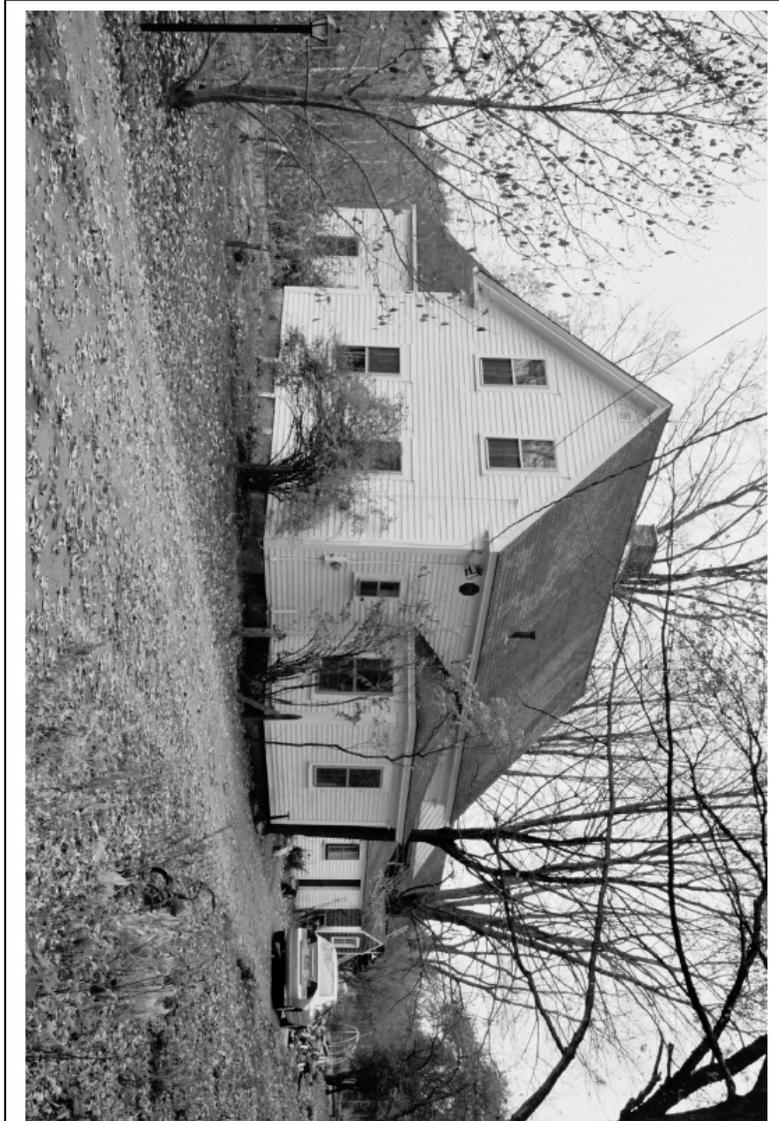
- 35. Photo #1
- 36. Date Fall 2008
- 37. Roll #6 Frame #23 Direction: NW
- 38. Negative stored at: NHDHR

Description: View of house

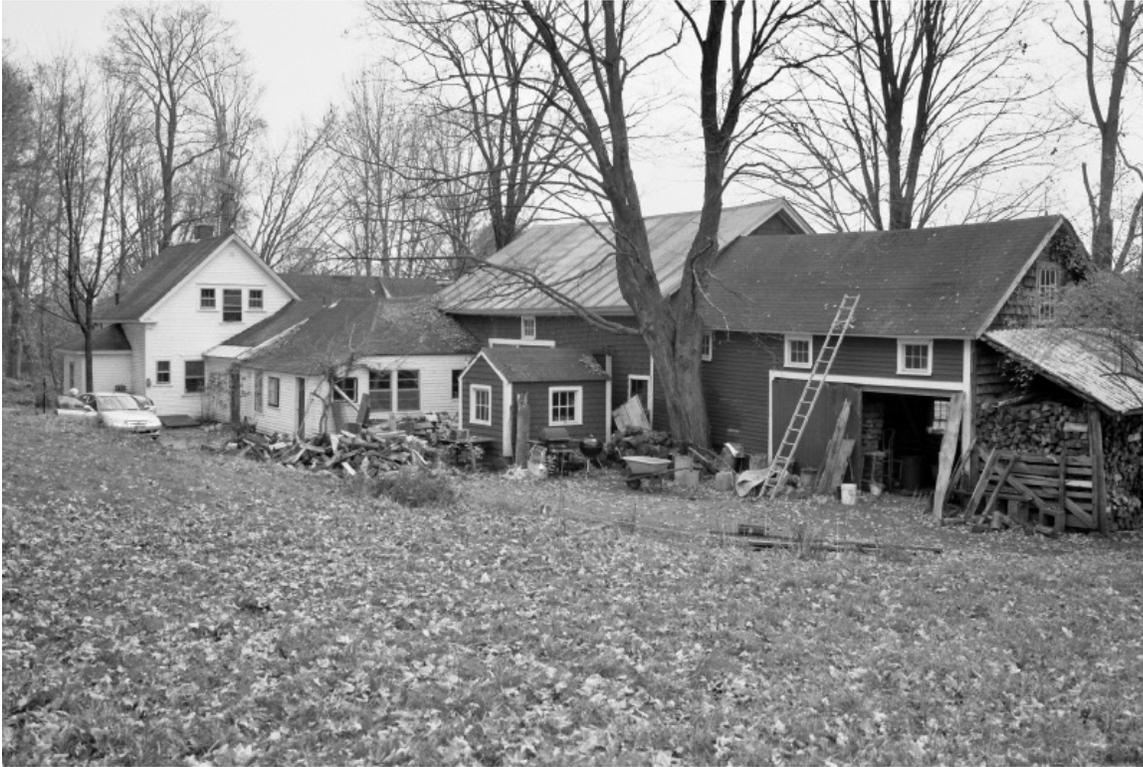
Photo 2 description: View of farm buildings. From left: farmhouse, ell, barn & milk house, wagon shed
Roll: 6 Frame: 24 Direction: SW

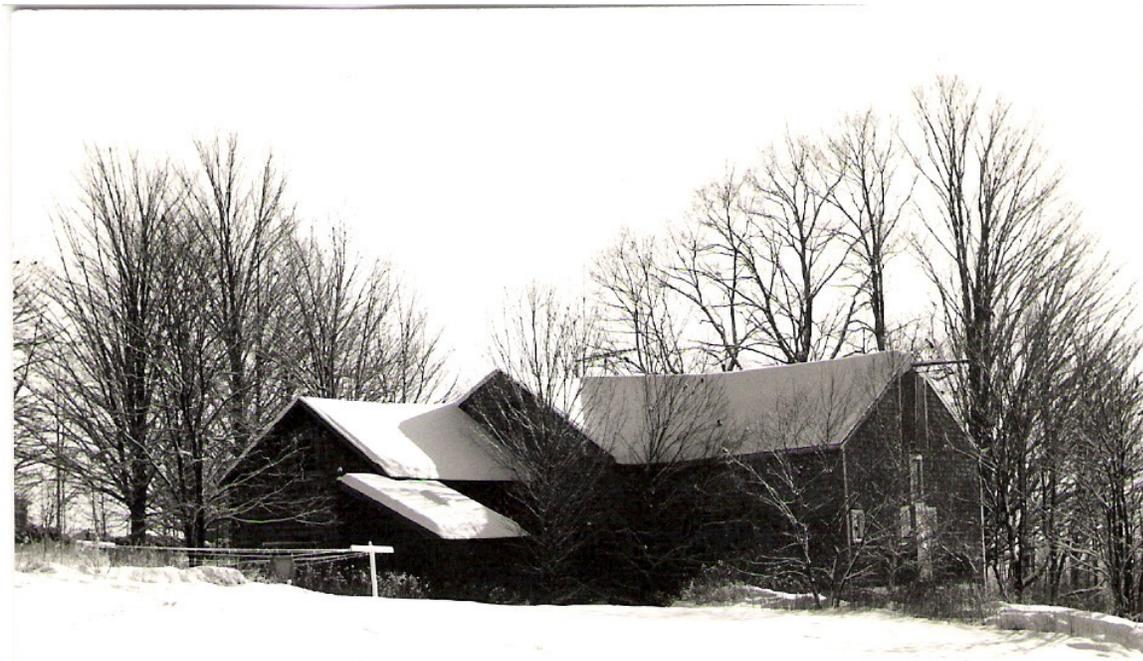
Barn (ca. mid-19th c.): The barn is a three-bay, square-rule, English barn with a mix of hewn and straight-sawn framing members. The interior has been much altered, and the roof entirely reframed. The exterior is clad with shingles, and the roof with channel metal. It rests on a granite foundation. Until the late 1970s, the barn had a lengthy, full-height, gabled extension to the rear (see photo #3). It is unclear how its construction related to the extant barn.

Photo 3 description: Looking SE at original barn that collapsed from snow, late 1970s. (Wagon shed is at left)
