INDIVIDUAL INVENTORY FORM**NHDHR INVENTORY NUMBER: CON0159****Name, Location, Ownership**

1. Historic name: Jordan Farm
2. District or area: n/a
3. Street and number: 102 Little Pond Rd.
4. City or town: Concord
5. County: Merrimack
6. Current owner: Sylvia Miskoe

INDIVIDUAL INVENTORY FORM**NHDHR INVENTORY NUMBER: CON0159****Methods and Purpose**

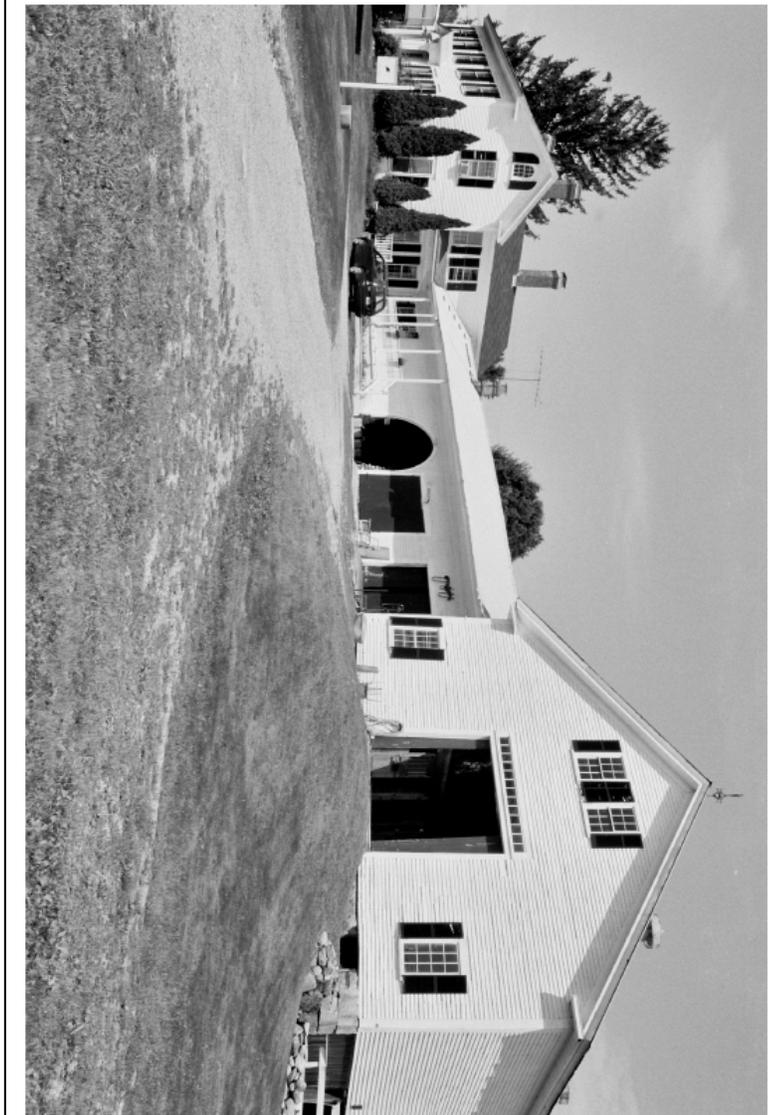
35. Photo #1
36. Date Fall 2008
37. Roll #4 Frame #5 Direction: NW
38. Negative stored at: NHDHR

**Description** View of connected farm buildings.

Jordan Farm consists of a connected farmstead (house with ell, wing-shed and barn with attached carriage shed) sited laterally to the road. Other outbuildings include a 19th c. corn crib-blacksmith shop, 19th c. or early 20th c. wood shed (since altered), ca. 1930s garage, and early 21st c. woodshop and goat house; most of the buildings are visible from the road. Behind the house is a small pond (originally built for swimming) fed by an outlet from Little Pond. An ice house once stood nearby; ice was cut from Little Pond and stored there during summer months. Further to the north is an extensive hay field, with woodlot beyond. An additional hay field lies across the road. Stone walls abut both sides of the road, as well as define the field perimeters.

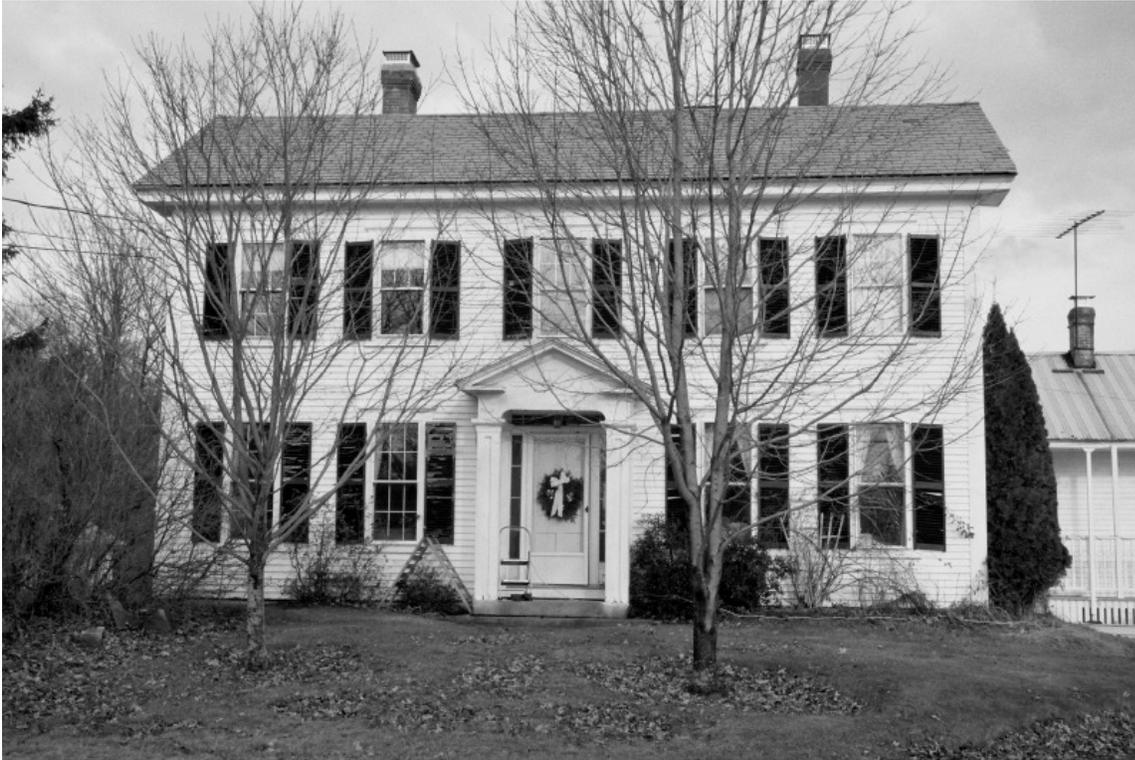
Photo 2 description: Farmhouse
Roll: 7 Frame: 6 Direction: N

House (ca. 1855): The house is a 2 ½ story, side-gable, 5x1 bay building with a rear ell. It rests on a granite block foundation and is sided with clapboards. Italianate stylistic features include arched window sash (6/6) and blinds in the gable peaks, and the front entrance: portico on paneled posts and original four-panel door flanked by narrow sidelights and transom. The entrance also features a granite stoop. According to the owner, the builder of the house also built the farmhouse at the State Prison at 312 North State Street.

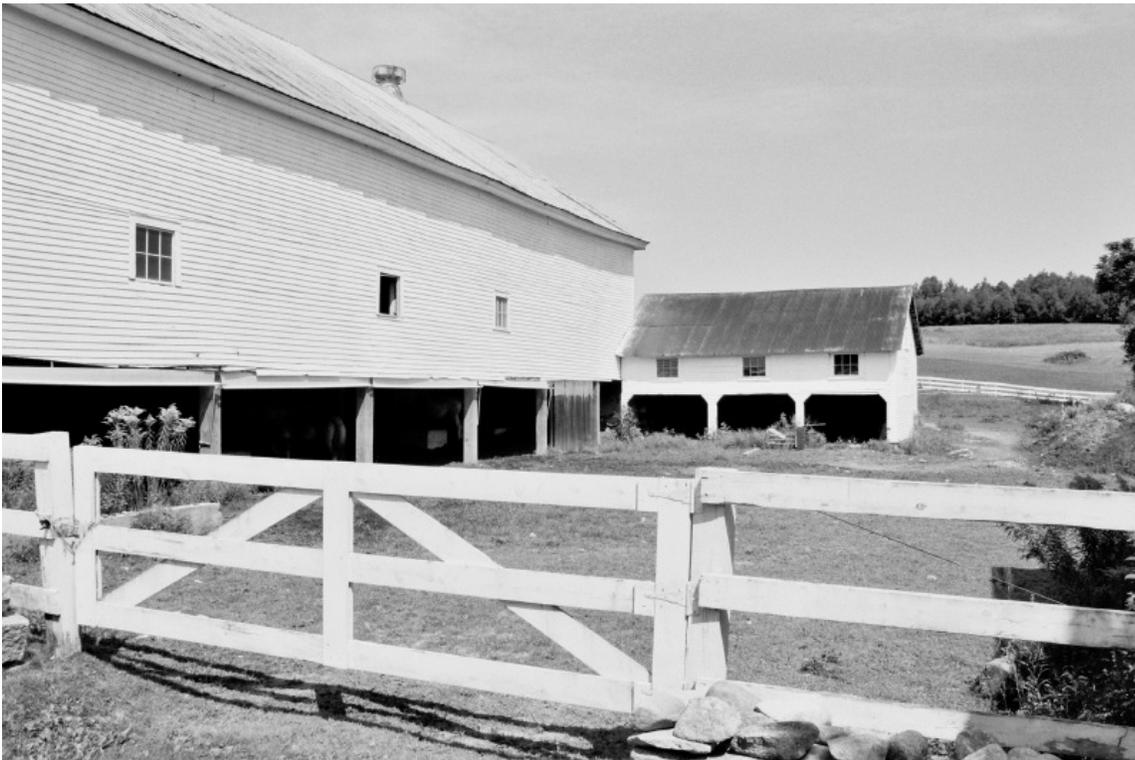
Photo 3 description: East elevation of barn and attached carriage shed
Roll: 4 Frame: 3 Direction: N

Barn (ca. 1866¹): The barn is gable-front, facing toward the road, and rests on a field granite foundation. It measures 100' x 40'. Two metal cupolas and a weathervane rise from the ridge. The main entrance is centered and has sliding, paneled doors on both gable ends; above them are transom windows. Windows with 6/6 sash are found on the front and rear gable ends, and six-light windows along the side elevations.

The barn has a post and beam framing system; the roof frame consists of principal and common rafters. The interior is divided into six bays, all but one 15' x 15'. Horses occupied the front (south) bays (recently rebuilt), and the cow tie up (since removed, though white-washed walls remain) was along the west side. The side bays have an upper loft, and the center bay has a high lot at each end.

Carriage shed (ca. late 19th c.): This is a gable-roof structure with clapboard siding, three arched openings with clipped corners, and six-light windows above. It extends from the northeast corner of the barn.

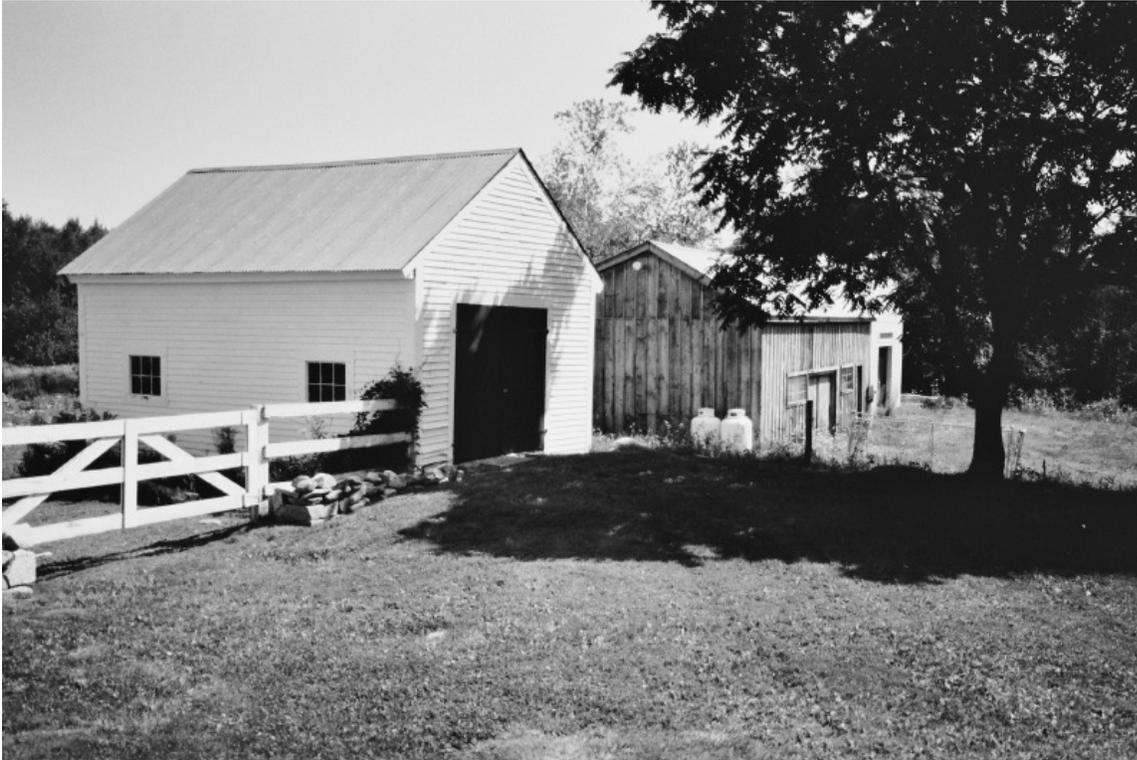
Photo 4 description: From left: corn crib/blacksmith shop & woodshed
Roll: 4 Frame: 1 Direction: NE

Corn crib/blacksmith shop (ca. mid-19th c.): This approx. 16' x 22', post and beam structure faces gable-front to the road. It sits on wood posts, has clapboard siding, a vertical-board door, and six-light windows on the sides. According to the owner, it was originally used as a corn crib and later as a blacksmith shop; there is evidence on the interior where the vertical slats were to hold the corn.

Wood shed (ca. late 19th/early 20th c.): This small structure is clad with board and batten siding and a standing-seam metal roof. Fairly recent renovations include raising the roof, and replacing doors and windows.

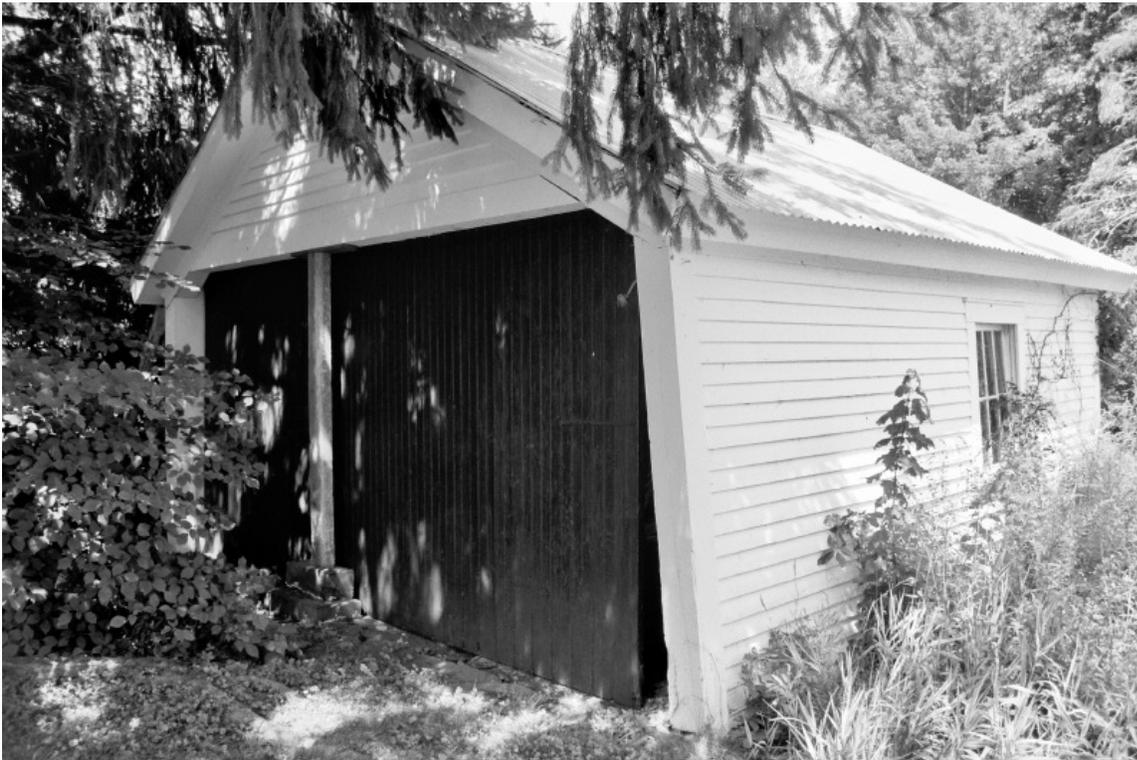
Photo 5 description: Garage
Roll: 4 Frame: 7 Direction: NW

Garage (ca. 1930s): Located west of house, the garage sits gable-front to the road. It is sided with clapboards and has a corrugated metal roof. The two vehicular bays each have a beaded-board sliding door. Sic- light windows are found on the side walls.
