**INDIVIDUAL INVENTORY FORM****NHDHR INVENTORY NUMBER: CON0157*****103 Old Loudon Road***

*This property was listed on the National Register of Historic Places in 1982. The following information updates that nomination, with a focus upon the agricultural history and outbuildings. The original nomination is on file at NHDHR.*

This form was completed as part of a survey of rural agricultural properties within the City of Concord, a project sponsored by the Heritage Commission. The overall purpose of the project was to raise public awareness of the city's rich agricultural legacy through a combination of identification, education, public policy and preservation planning tools.

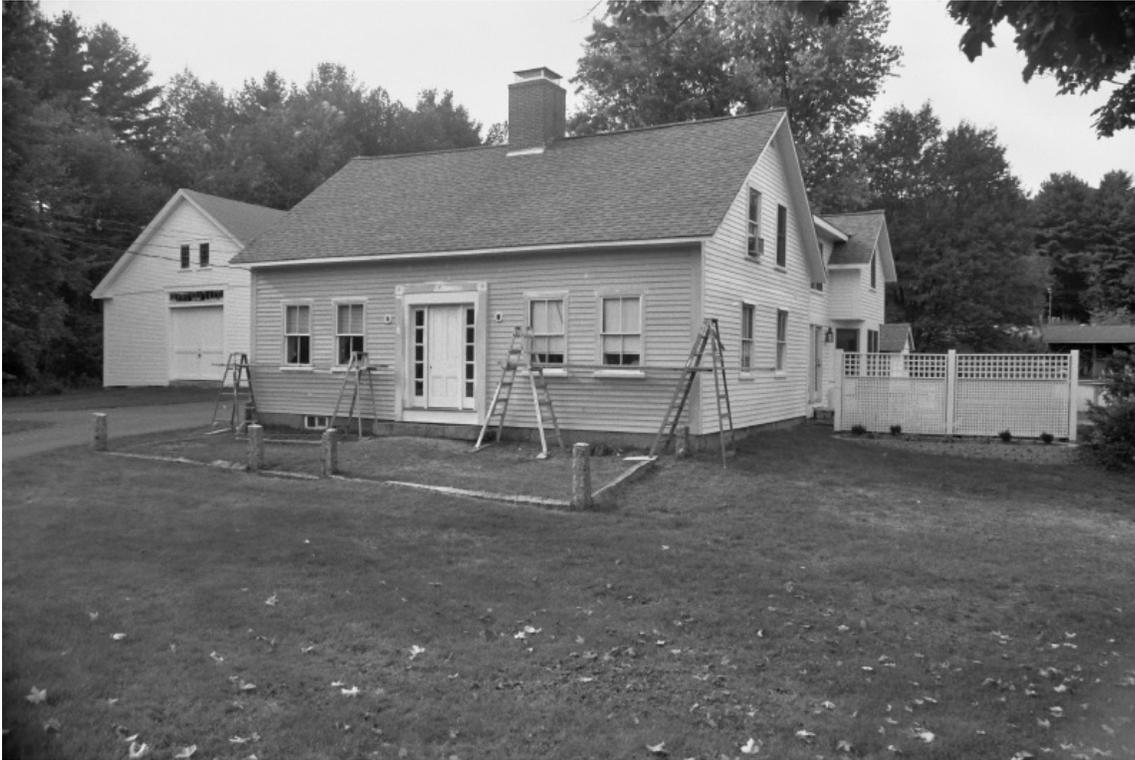
Photo 1 description: Front (southeast) elevation of house  
Roll: 3      Frame: 15      Direction: NW

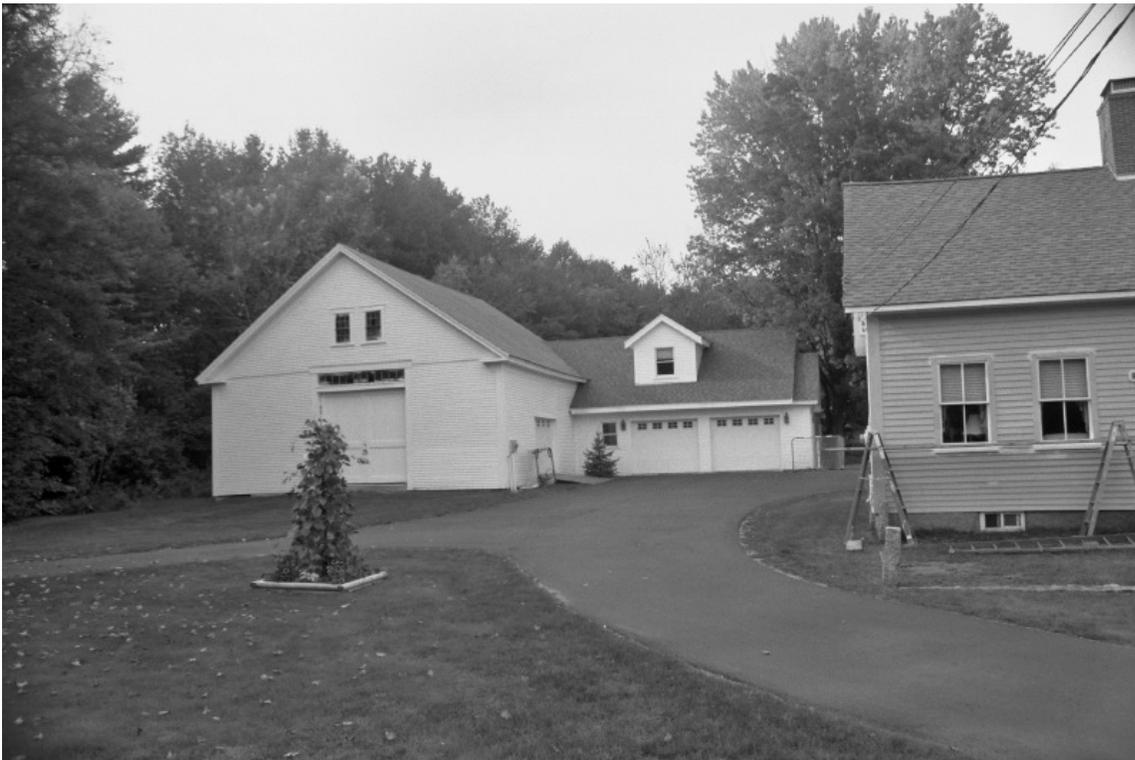
The earlier "L" wing on the northeast side of the barn has been reconstructed and expanded to include a new dormer and overhead doors (see photo #2). The current owner explained that the father of Jim Burdett reportedly moved this earlier "L" wing to this site from a location on Mountain Road in

Photo 2 description: Front (southeast) face of barn showing recent new garage addition  
Roll: 3      Frame: 16      Direction: NW

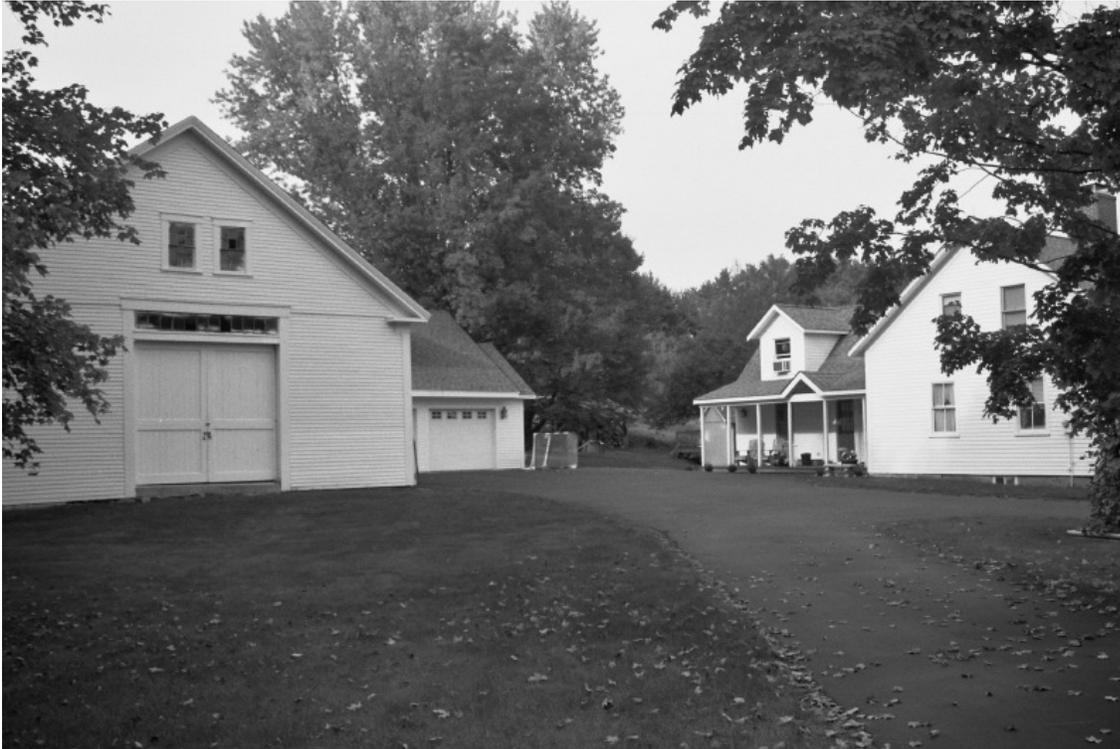
House: The current owner has been repairing and replacing the weathered clapboards and stripping/renovating the front door. The original rear wing has had a full length porch added to the southeast side along with a dormer (photo #3). During the renovations to this portion of the house it became apparent that the original wing of the house only projected to the outside door nearest the house. The wing was extended further to the rear at a later date, A new two story "L" extension has been added to the rear wing on the northeast side (see photo #6).

Photo 3 description: Front of barn and renovated rear wing of house

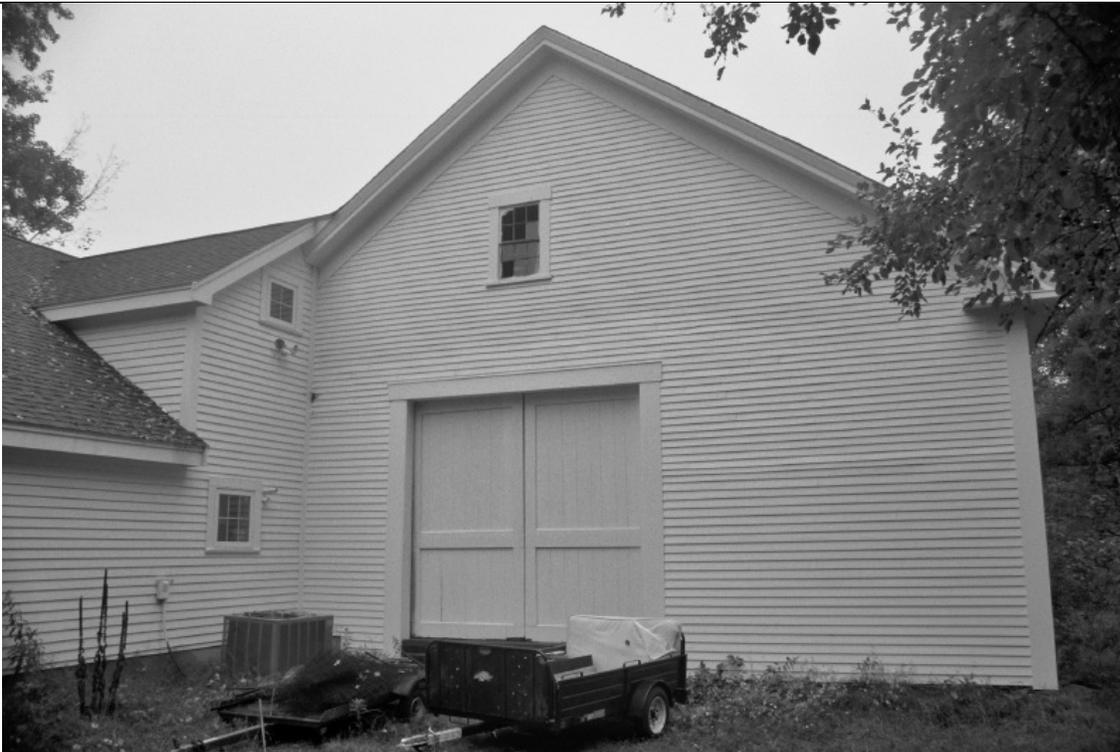
Concord in the mid-20<sup>th</sup> century. A large photographic studio has been added to the rear of the renovated "L" (see photos 4 & 5). This new addition is of contemporary wood frame construction with clapboard siding and asphalt shingle roof. The foundation is poured concrete.

Photo 4 description: Northwest end of barn

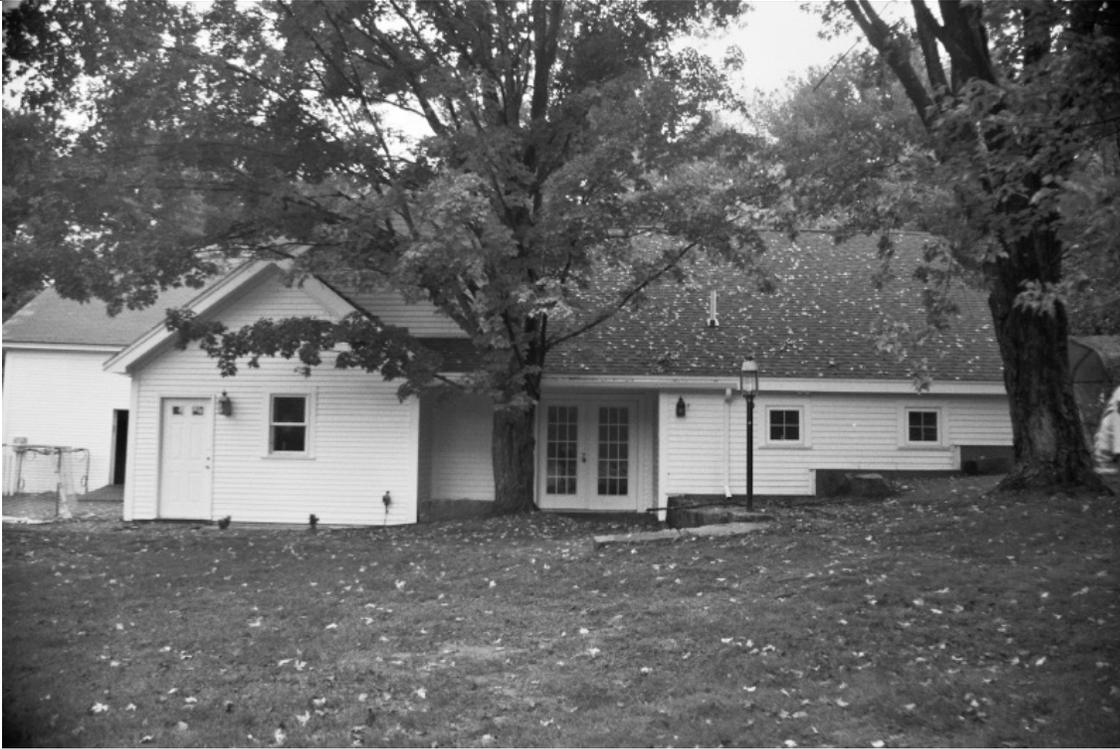
Photo 5 description: New Garage and studio addition on northeast side of barn  
Roll: 3 Frame: 21 Direction: SE

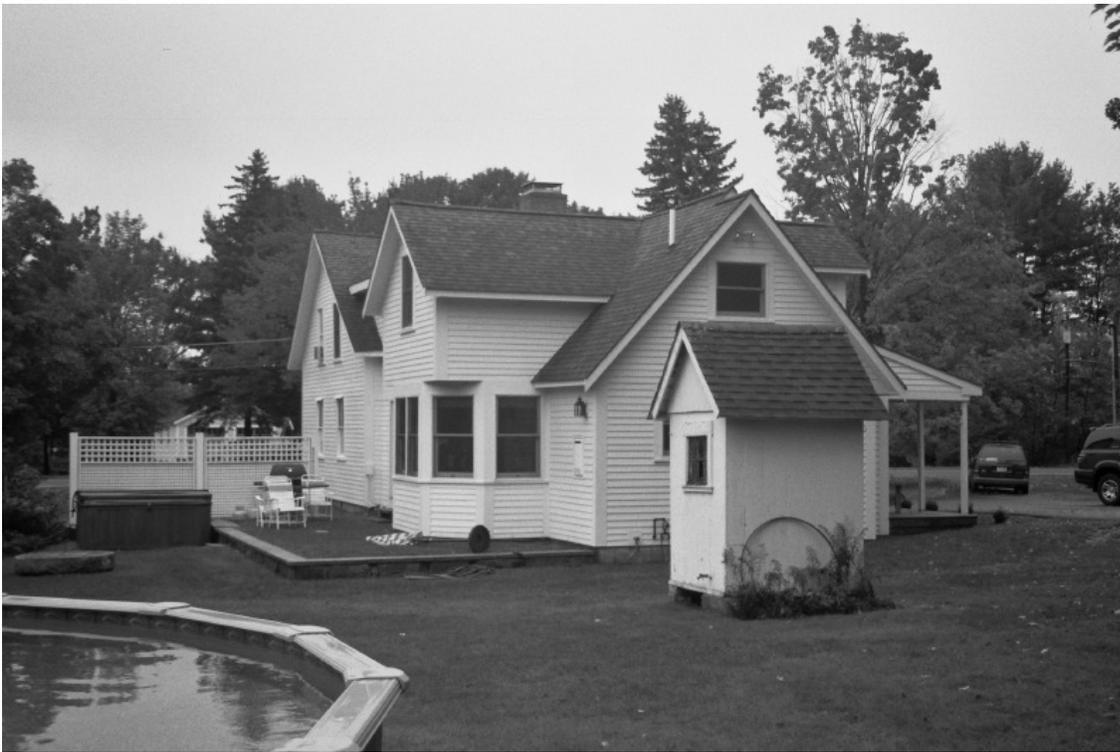
Photo 6 description: Rear (northwest) elevation of house with recent additions and privy  
Roll: 3 Frame: 20 Direction: S

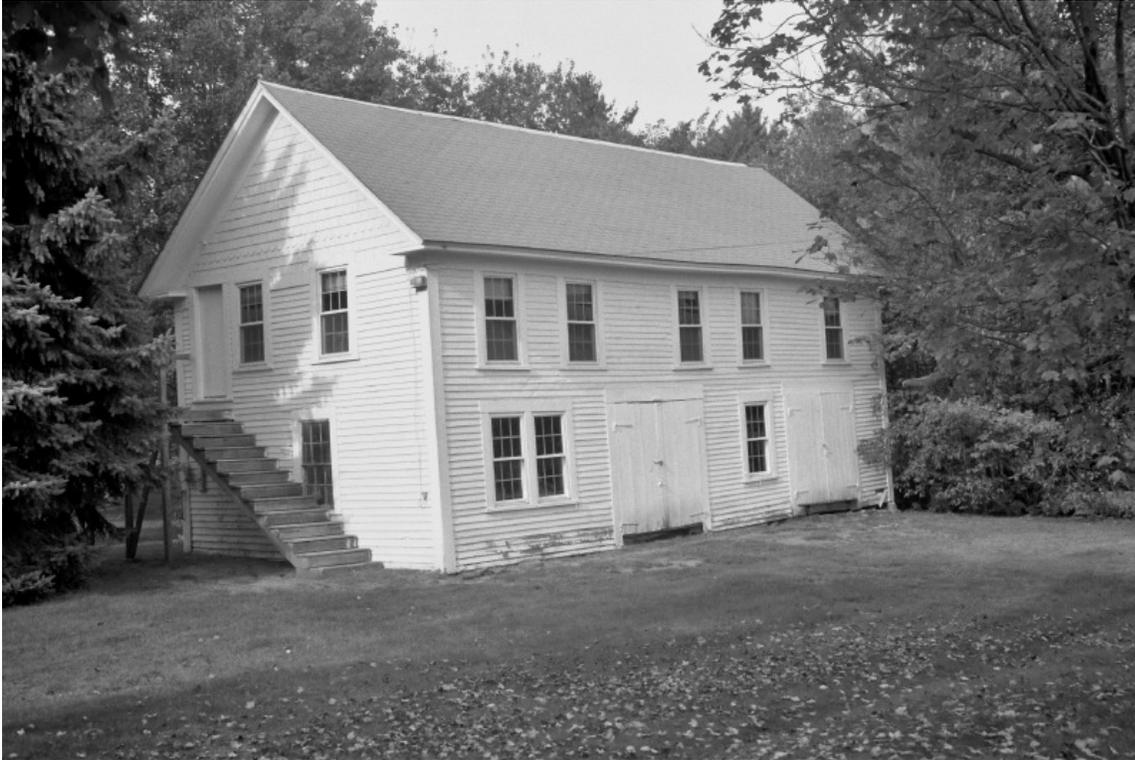
Shop: The shop building appears unchanged from the 1983 NR nomination form. However the property owner pointed out that the northwest (back) side of the structure is settling and beginning to lean to the north and he is concerned that he may be unable to maintain it. One feature not previously described is shown in photo #8; a second story barn door is still intact on the northeast side of the shop. According to the owner, and suggested by the use description in the 1983 NR nomination, this door was reportedly used to move a piano into the dance hall in the spring and remove it to a warmer location during the winter months.

Photo 7 description: Shop building

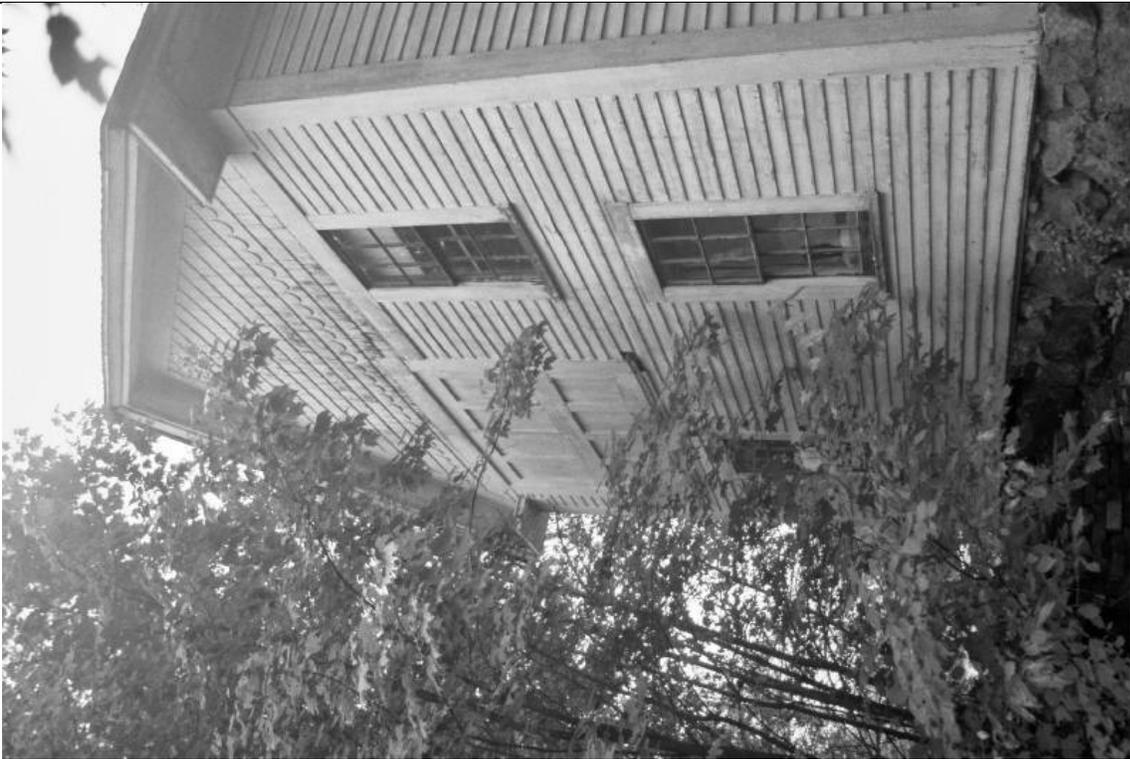
Photo 8 description: Northeast elevation of blacksmith shop, showing second floor barn doors used to

remove the piano during winter months
