INDIVIDUAL INVENTORY FORM

NHDHR INVENTORY NUMBER: CON0166

- 1. Historic name: White Farm Barns
- 2. District or area: _____
- 3. Street and number: 144 Clinton St.
- 4. City or town: Concord
- 5. County: Merrimack
- 6. Current owner: State of New Hampshire

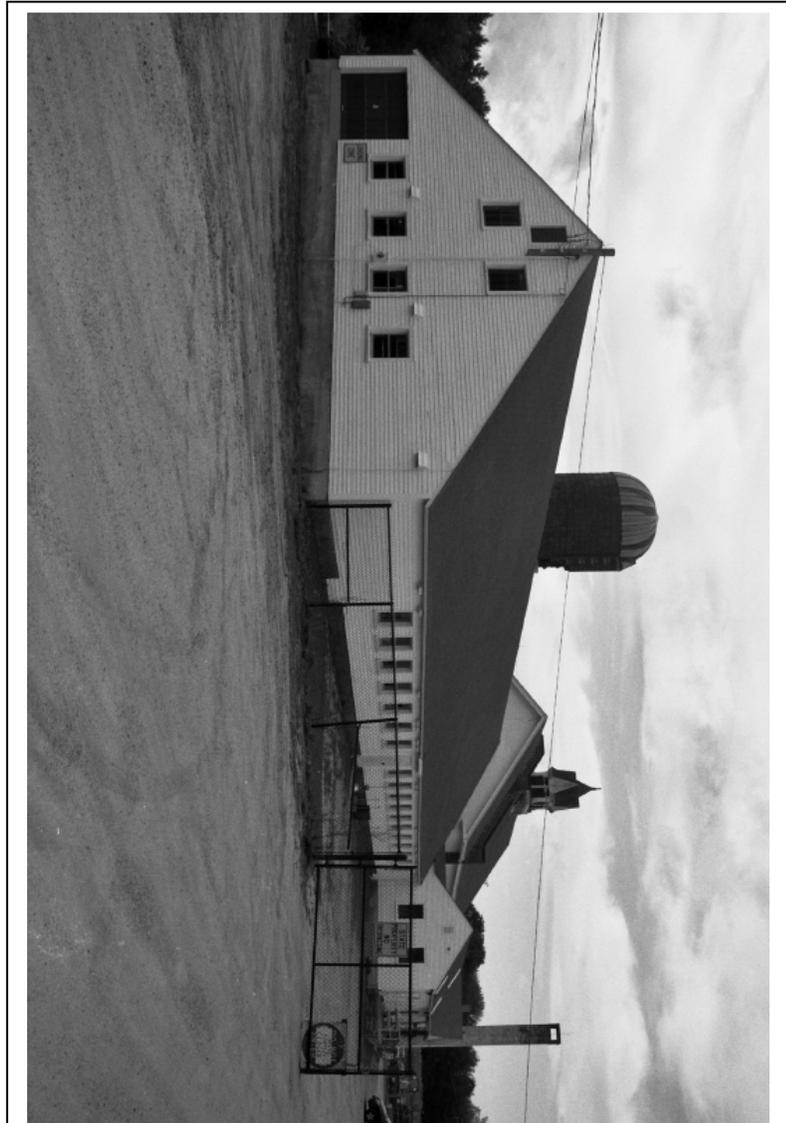
- 35. Photo #1
- 36. Date: Sept.16,2008
- 37. Roll #2 Frame #22 Direction:
- 38. Negative stored at: NHDHR

Description: Main Barn Complex: milking barn, with silo behind, office to the right and main barn in the rear with cupola.

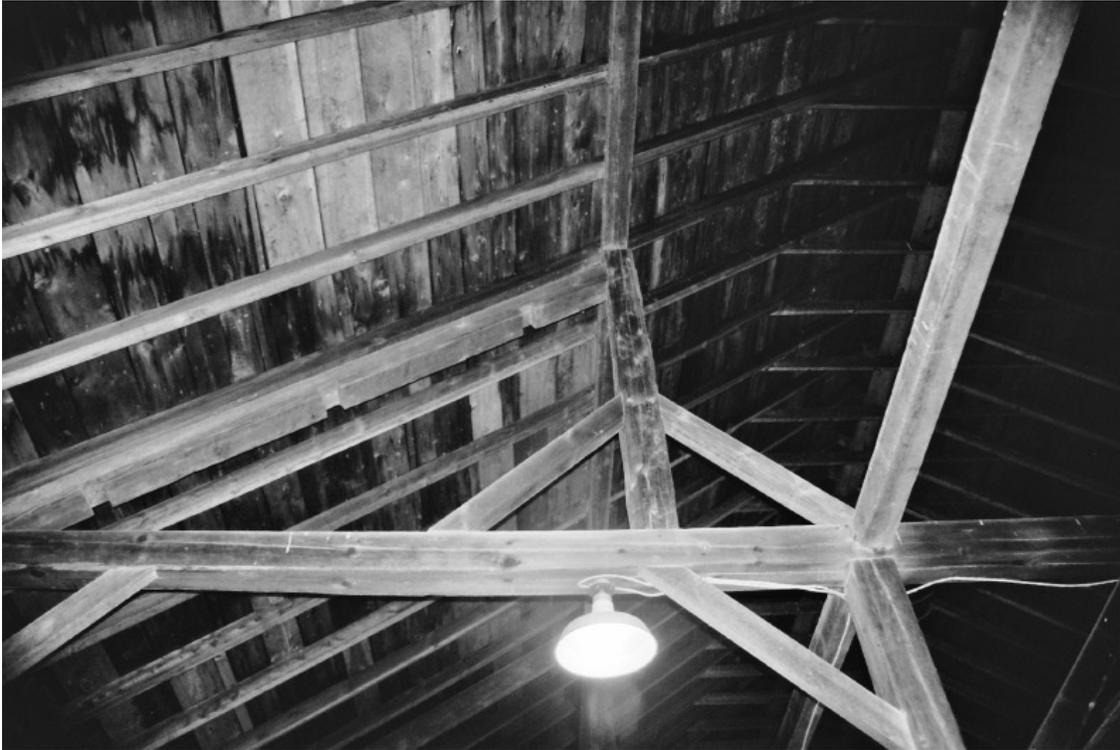
The post and beam structure is a combination of older re-used hand hewn timbers on the roof structure which supports 4" x 6" roof rafters and horizontal pine board sheathing. The main post and beam structure below the roof line is constructed of 8" x 8" beams, all of which have circular saw marks. A full length hay track and hay fork are still intact. The hay track extends outside the northerly wall through sliding hay loft doors that have their slider tracks sloped to match the roof pitch.

Photo 2 description: Framing detail – main barn interior
Roll: 2 Frame: 17 Direction: S

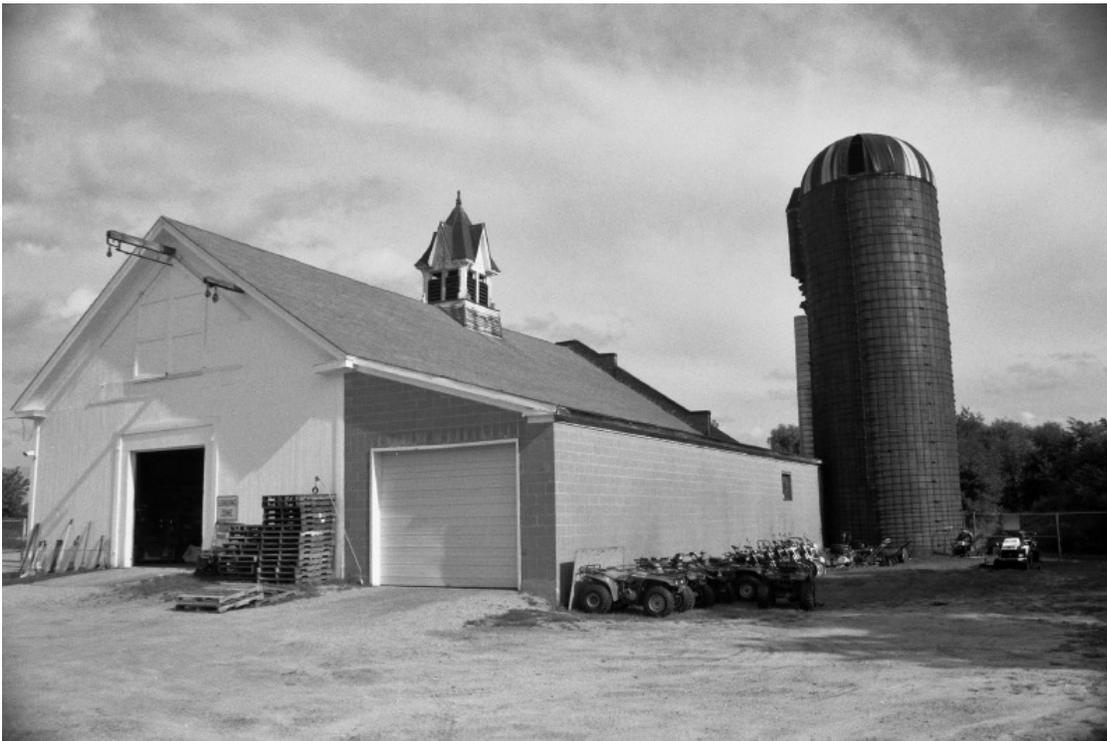
A single story shed roof addition has been added to the southwest side of the main barn. It is constructed of concrete block walls and a poured concrete foundation. According to the on-site Surplus Property manager, this addition was constructed for sawdust storage use for dairy cow bedding in the second half of the 20th century.

Silo (ca. early 20th century): A silo is situated on the southerly corner of the main barn. It is constructed of pre-cast interlocking concrete blocks held together by steel rods, spaced vertically every 1.5-2 feet, running the entire circumference of the structure.

Photo 3 description: Main Barn with shed roof addition in foreground and silo
Roll:2 Frame: 19 Direction: SE

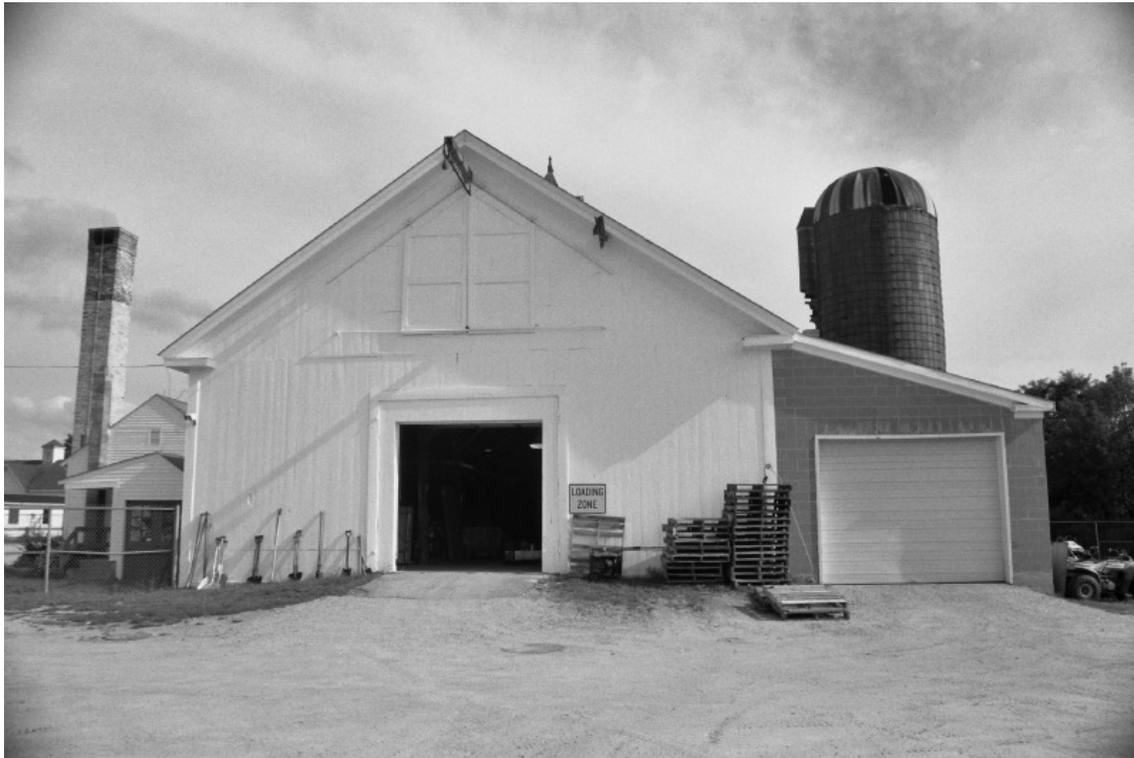
Main Barn (1870-1890): The barn is a gable front, seven bay, queen post design with asphalt shingles, tongue and groove vertical siding and a centrally positioned Eastlake era cupola. The wide roof overhang includes gable returns and a wide freeze board. The foundation is constructed of rubble stone material. Wide projecting vertical corner boards are also present. The interior has seen many renovations since it has been taken over by the Surplus Property Division of the NH Department of Administrative Services. On the interior, a concrete floor has been added (ca.1980); a steel structure second level storage mezzanine has been inserted on both bays flanking the central passageway. The south-easternmost bay (nearest Clinton Street) has been separated from the remainder of the barn area by a brick fire wall that extends above the roof line and is visible from the building exterior. Insulation and an interior finish wall has been installed on all sides up to a height of approximately 6 feet. The original hinged barn door on the north-west face has been partially blocked in to accommodate a contemporary overhead door.

Photo 4 description: Northwest face of main barn showing boxed in main door & sloping track hay door.
Roll: 2 Frame: 18 Direction: SE

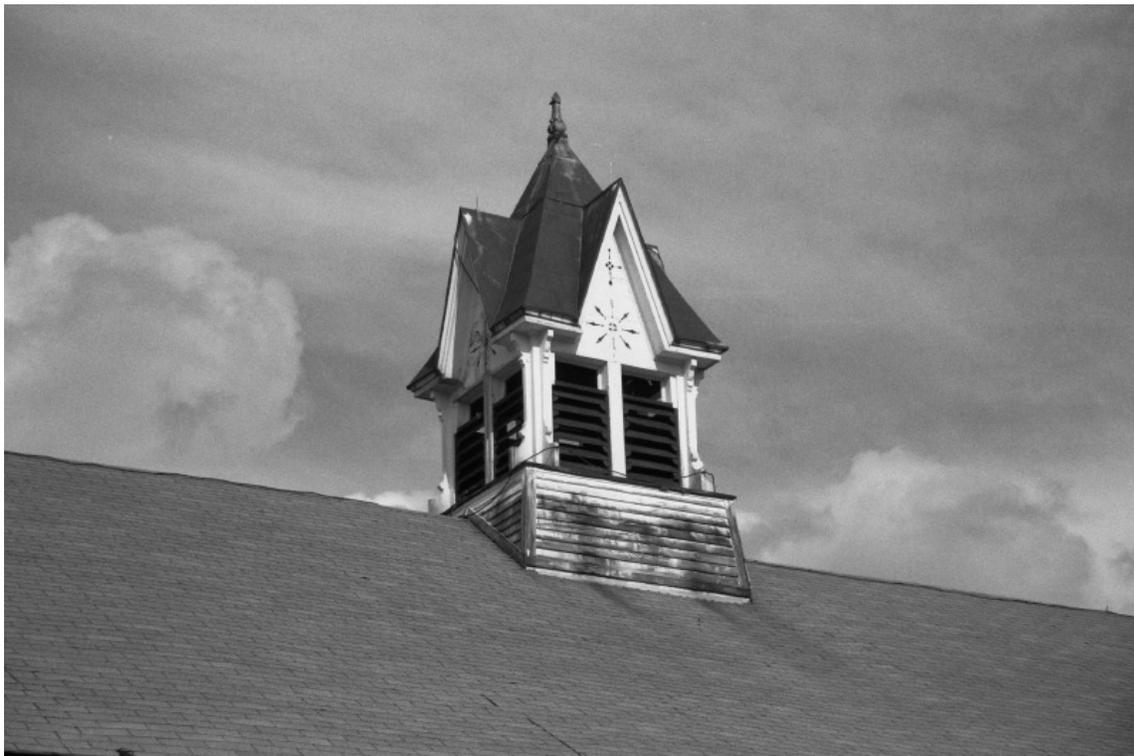
Photo 5 description: Detail -Eastlake cupola on Main Barn
Roll: 2 Frame: 21 Direction: E

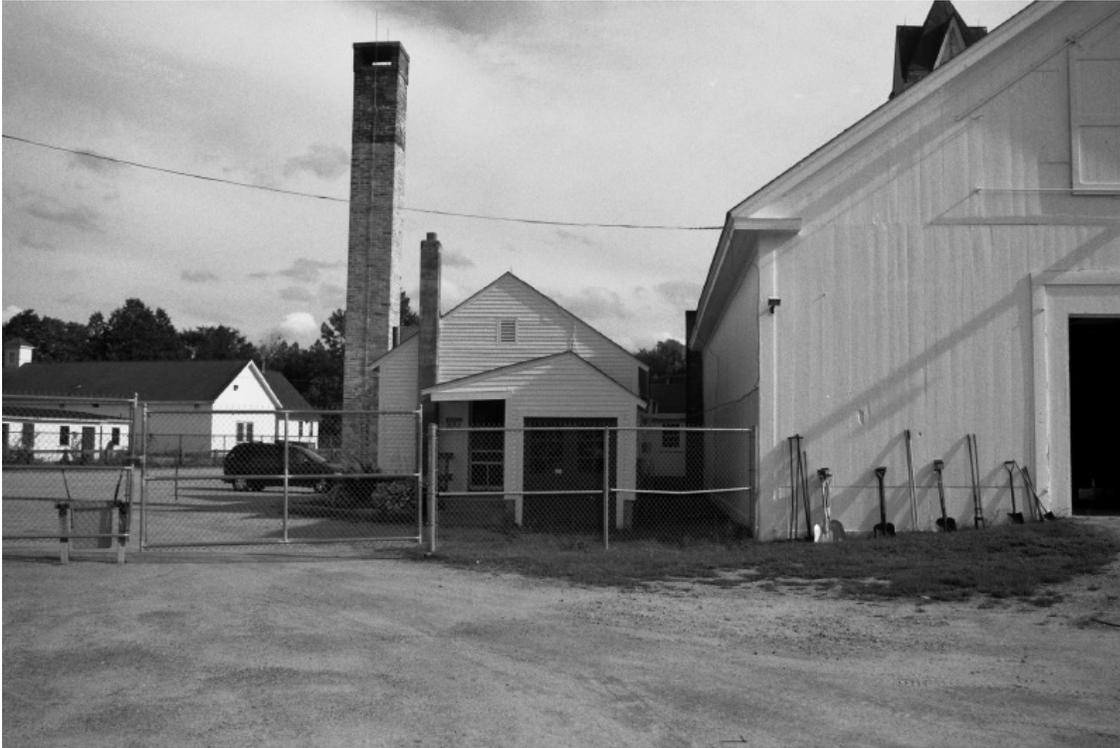
Office Addition: On the northeast side of the main barn is situated a wood frame gable roof structure with a gable dormer centered over the main entrance. This mid-20th century building originally contained a milk processing area, an electric generator and office. The generator was located in a basement area lying under the northerly portion of the building. Clapboards cover the building's exterior. Asphalt shingles cover the roof. The foundation is poured concrete except for the loading dock which is granite block with a poured concrete cap that serves as the loading dock floor. This building is connected to the main barn and the milking barn only by a passageway at its southwest corner. 6 over 6 double hung windows are in place along the eastern side of this structure.

Photo 6 description: Northwest end of main barn and office showing narrow separation between.
Roll: 2 Frame: 20 Direction: SE

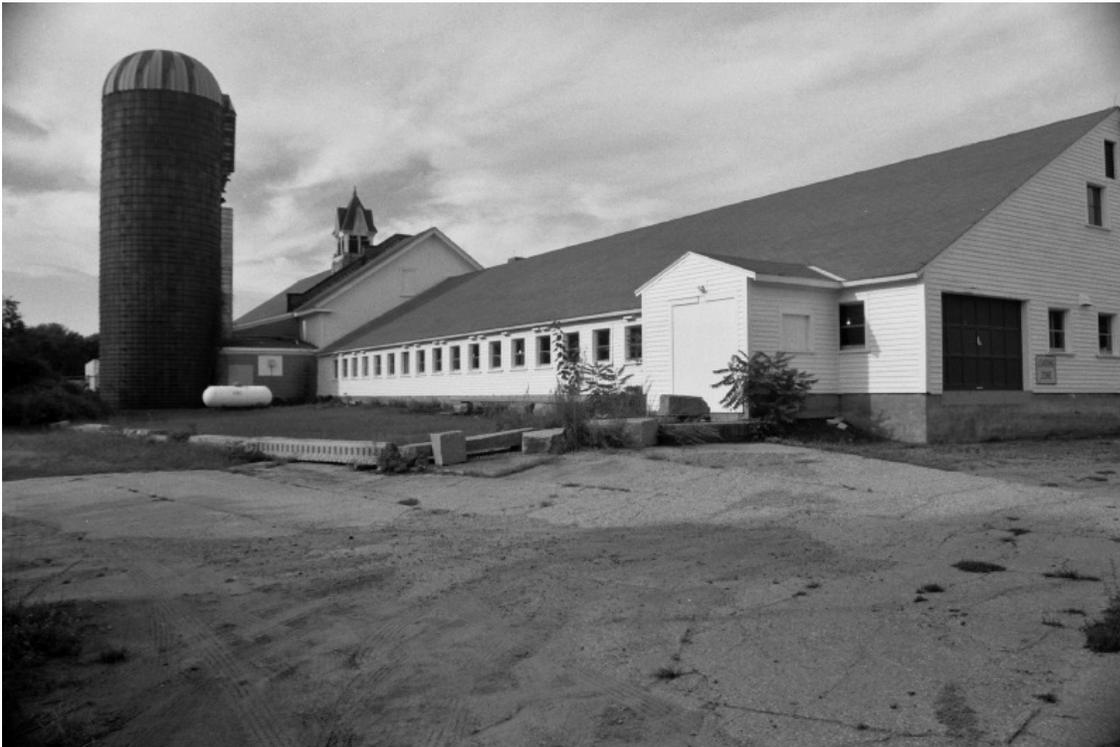
Milking Barn (1940s): This is one of two mid-20th c. cow barns in Concord built by the State of New Hampshire (the other was built for the State Prison and stands at 314 North State Street: see CON0178.). This 1½ story, gable roofed building was constructed for milking the State Hospital dairy

herd. It has a poured concrete foundation and floor and three rows of columns support carrying beams running parallel to the roof ridge. Both the easterly and westerly walls have small double hung windows running the length of each side. An overhead door/loading dock is situated in on the southwest corner of this strucutre. The interior walls and ceiling are finished with painted wood beadboard.

Photo 7 description: Southwest side of milking barn & silo with main barn behind
Roll: 2 Frame: 23 Direction: N
