INDIVIDUAL INVENTORY FORM

NHDHR INVENTORY NUMBER: CON0189

- 1. Historic name: Blake's Turkey Farm
- 2. District or area: _____
- 3. Street and number: 178 Silk Farm Rd
- 4. City or town: Concord
- 5. County: Merrimack
- 6. Current owner: Charles E. & Sarah E. Blake Rev.Trust

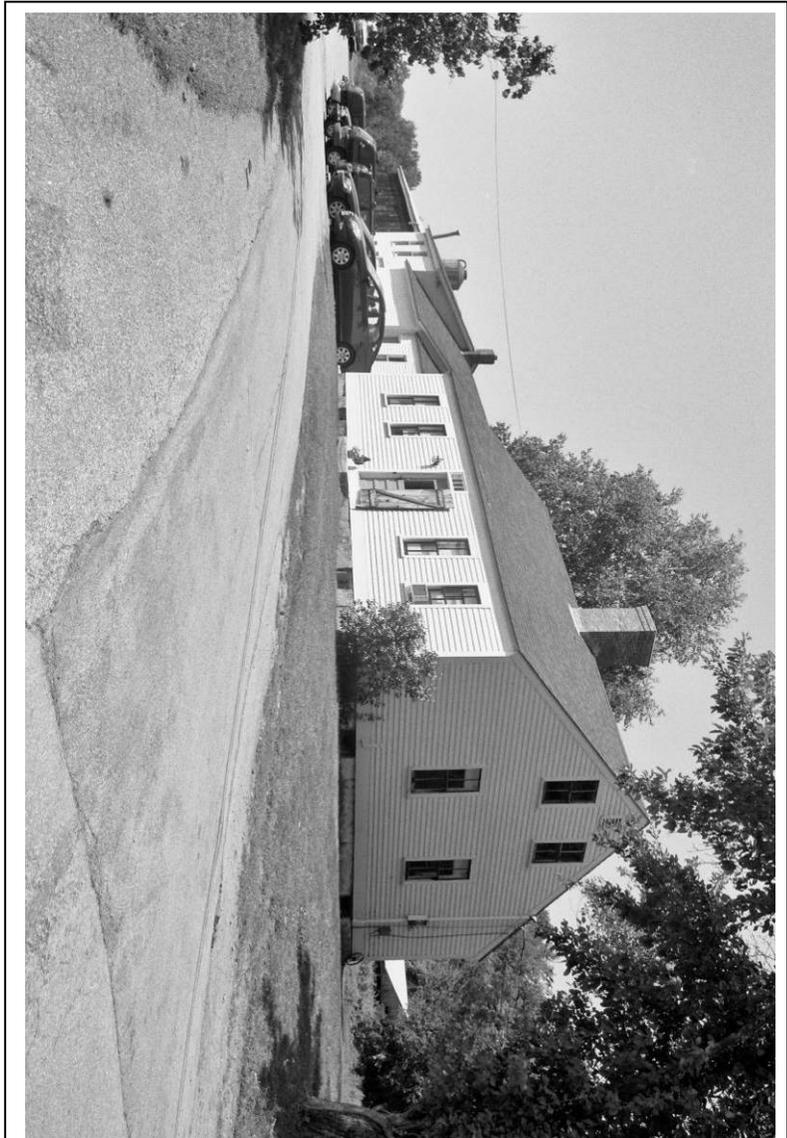
- 35. Photo #1
- 36. Date 8-22-2008
- 37. Roll #2 Frame #4 Direction: W
- 38. Negative stored at: NHDHR

Description : Southeast elevation (front) of house and slaughterhouse (rear)

House (ca. late 18th c.): Sally Blake has researched this property in the registry of deeds and has documented the house back to prior to 1800. The house is a 1½ story, center chimney cape on a granite block foundation. It has clapboard siding and an asphalt shingle roof. The chimney was reconstructed from above the first floor fireplaces in 2000. The building is presently used as the offices for the commercial operation.

Slaughterhouse (ca. mid-20th century): This structure has both 1 ½ and 2 ½ story sections with clapboard siding and asphalt roofing. Presently used for storage, the building is constructed of standard 2x dimensional lumber and retains the racks and other features associated with poultry processing.

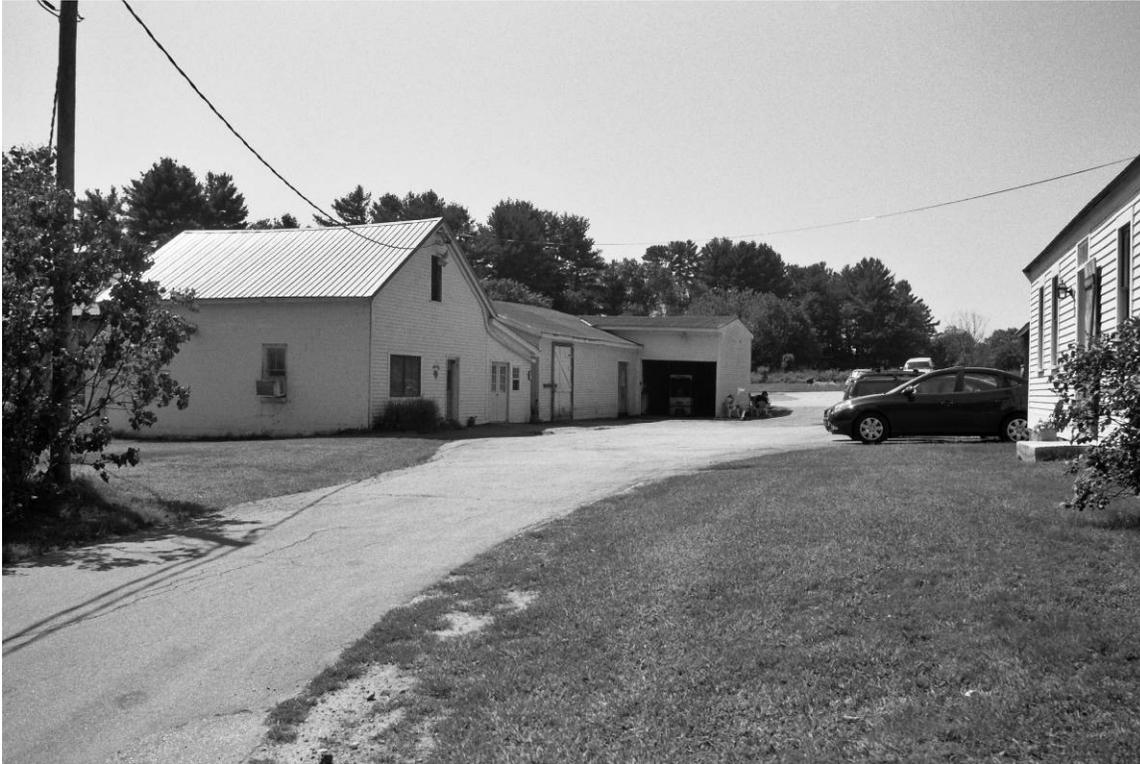
Photo 2 description: Former hatchery (foreground) with coolers to the rear
Roll: 2 Frame: 5 Direction: SW

Hatchery (1940s): This 1½ story concrete block structure has a ribbed metal gable roof and is presently used as an office and work area for the production building. It has a single story shed roofed extension on its southwest side that connects it to the cooler building.

Coolers (ca. late 1970s): This utilitarian structure has a corrugated metal roof and clapboard siding on the northwest face of the building and vertical board siding on the other building faces.

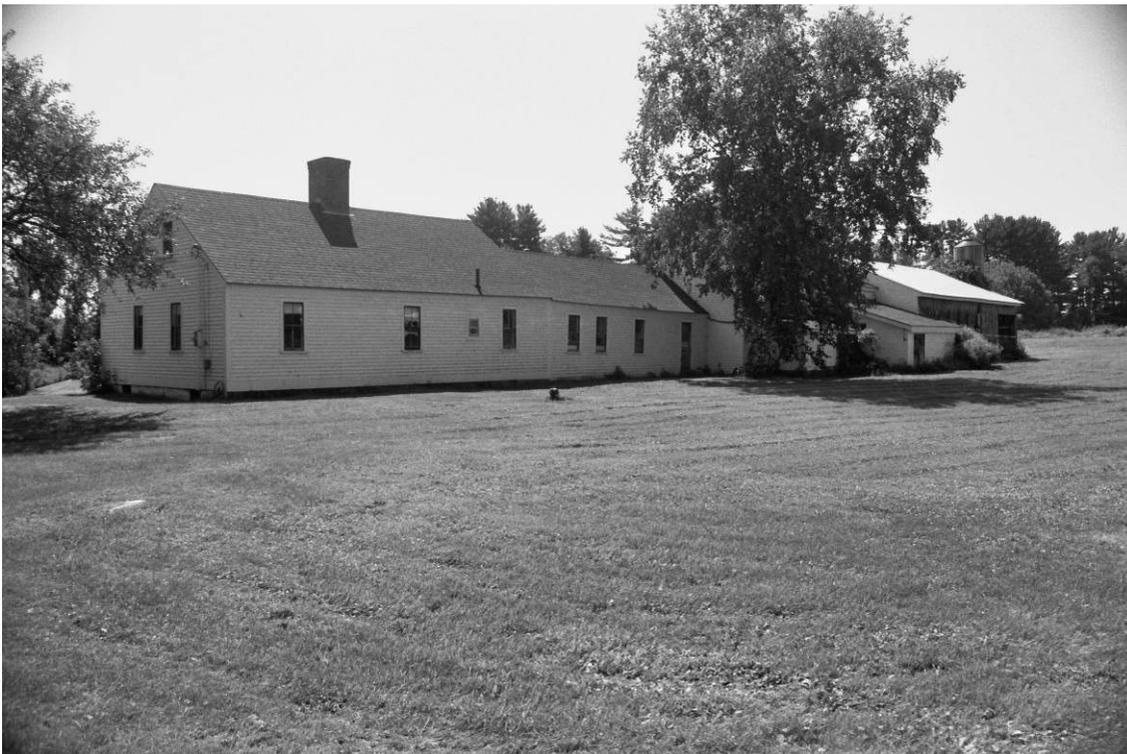
Photo 3 description: Northwest elevation of farmhouse and barns
Roll: 2 Frame: 6 Direction: S

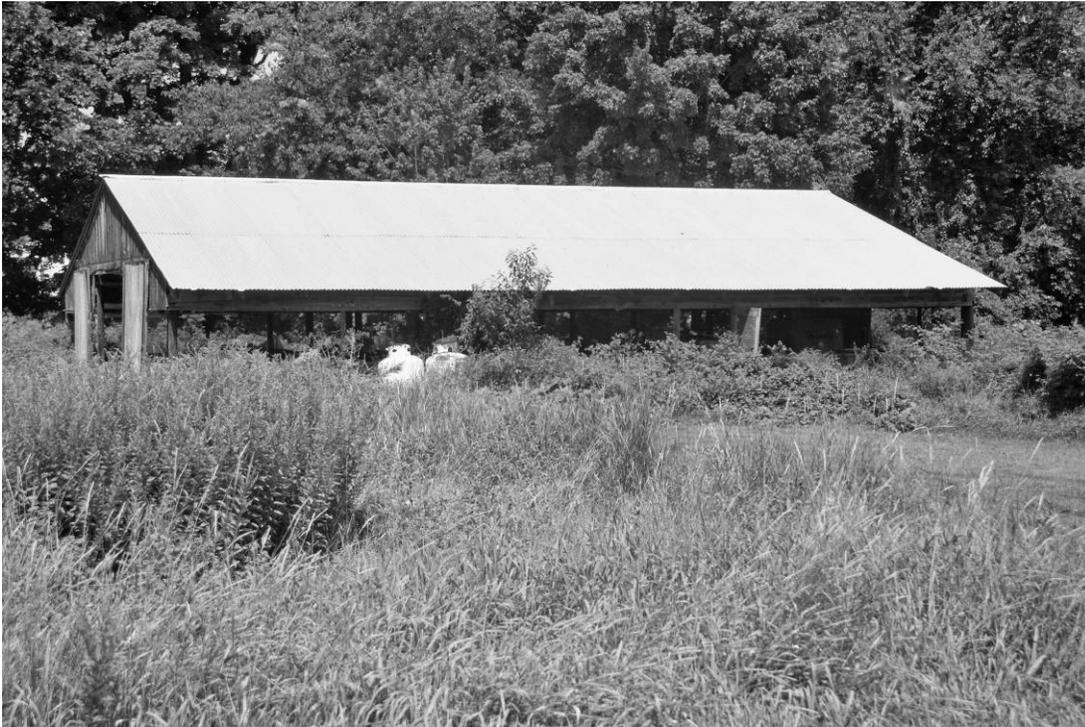
Roll: 2 Frame: 7 Direction: N

Photo 4 description: Brooding house

Brooding House (ca. 1950s): This simple corrugated metal roofed, vertical board sided, pole frame structure dates to the 1950s and is currently not in use. This is the last surviving brooding house of the several that existed between this structure and the barn to the southeast.

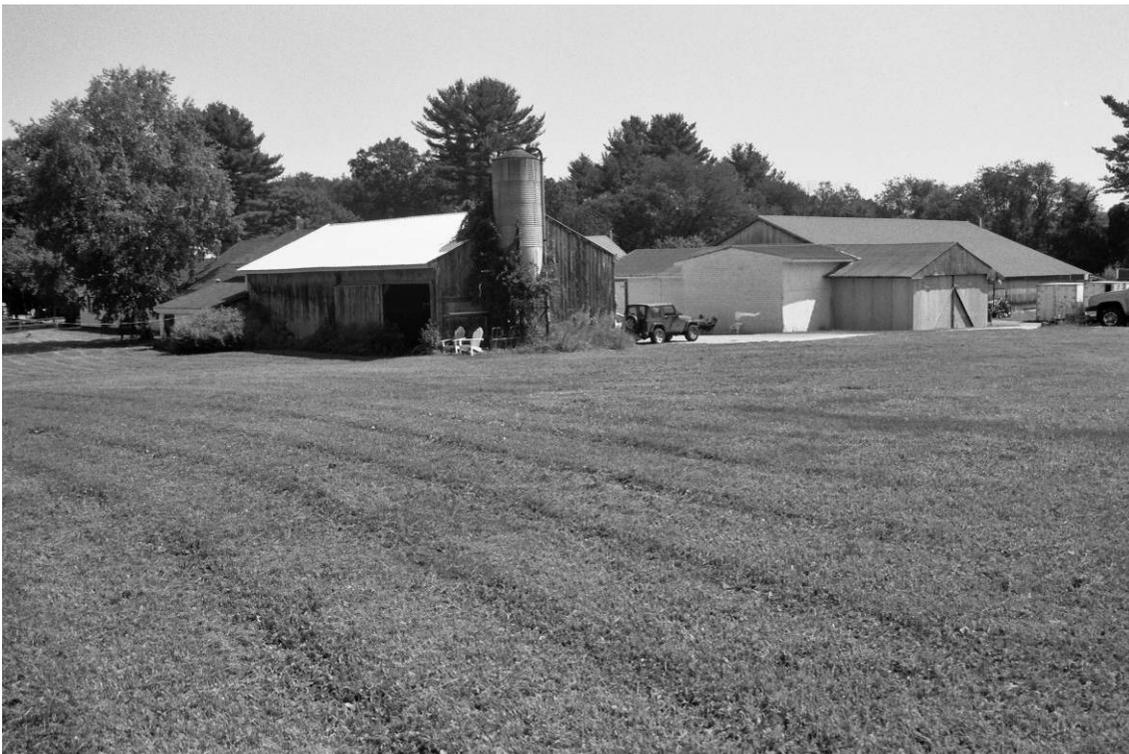
Roll: 2 Frame: 8 Direction: SE

Photo 5 description: West elevation of barn (left) with coolers and production building beyond

Pole Barn (ca. early 1970s): This corrugated aluminum roofed pole structure has an earth floor and 2x4 roof truss framing. The walls are sheathed with vertical boards. A 6” diameter metal silo is situated at the southwest end of the barn. This structure replaces an earlier barn that sat in approximately the same spot and dated from about 1900.

Production Building (2000): This new structure is the center of the company’s production operation. It was constructed in 2000 and rests on a poured concrete foundation. It has vertical board siding and raised rib roofing.

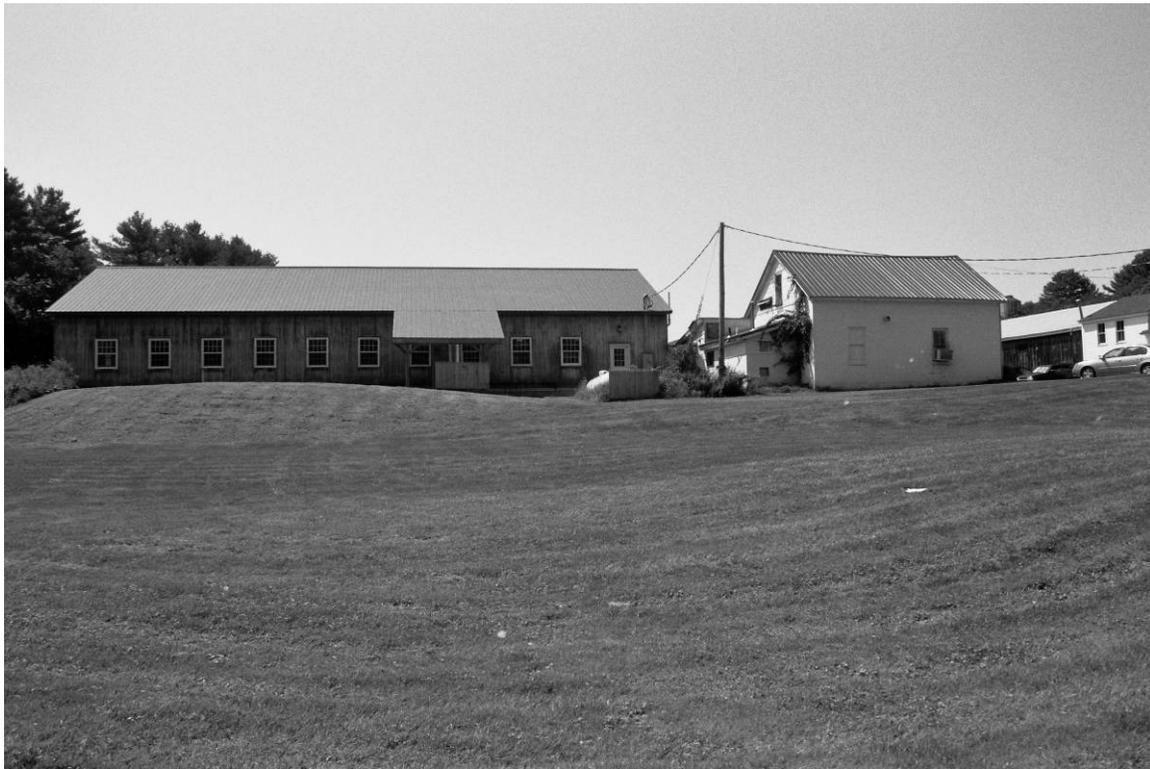
Photo 6 description: Northeast elevation of former hatchery (right) and new production building
Roll: 2 Frame: 9 Direction: NW
