INDIVIDUAL INVENTORY FORM**NHDHR INVENTORY NUMBER: CON0188****Name, Location, Ownership**

1. Historic name: Maple View Farm
2. District or area: _____
3. Street and number: 183 Shaker Rd
4. City or town: Concord
5. County: Merrimack
6. Current owner: Elizabeth E. Terrell

INDIVIDUAL INVENTORY FORM**NHDHR INVENTORY NUMBER: CON0188****Methods and Purpose**

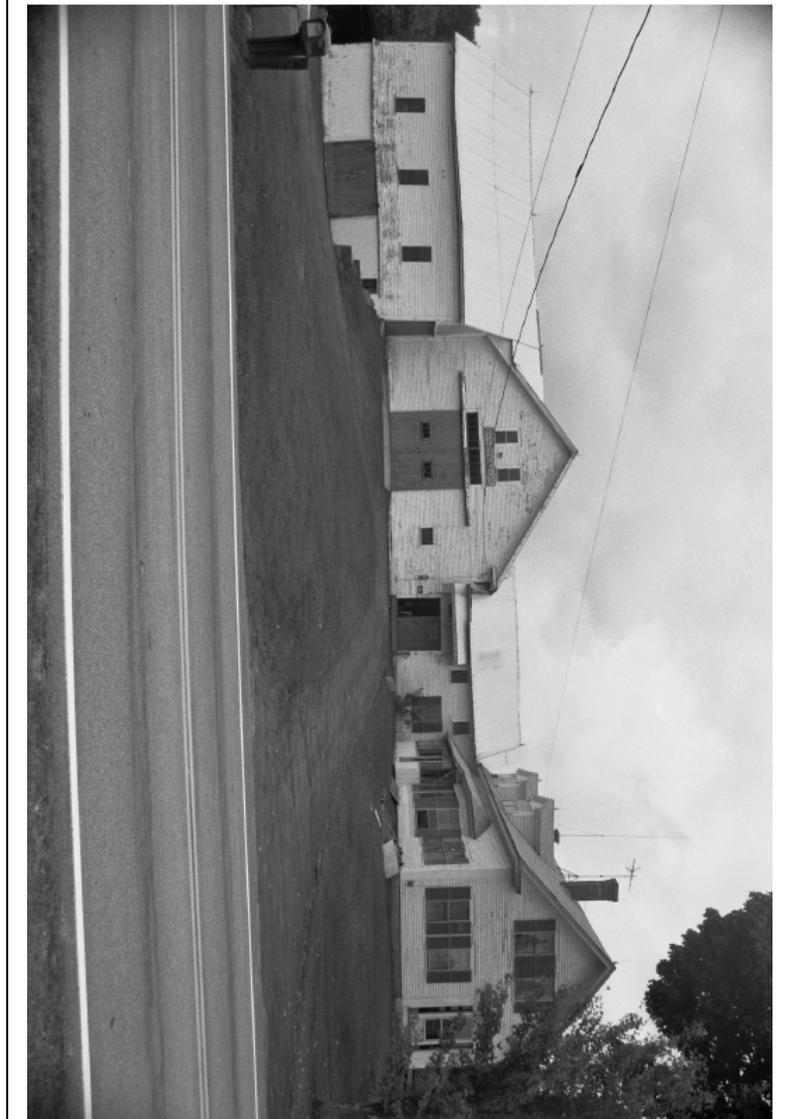
35. Photo #1
36. Date 9-30-2008
37. Roll #3 Frame #34 Direction: W
38. Negative stored at: NHDHR

**Description:** View of farmstead and connected barns

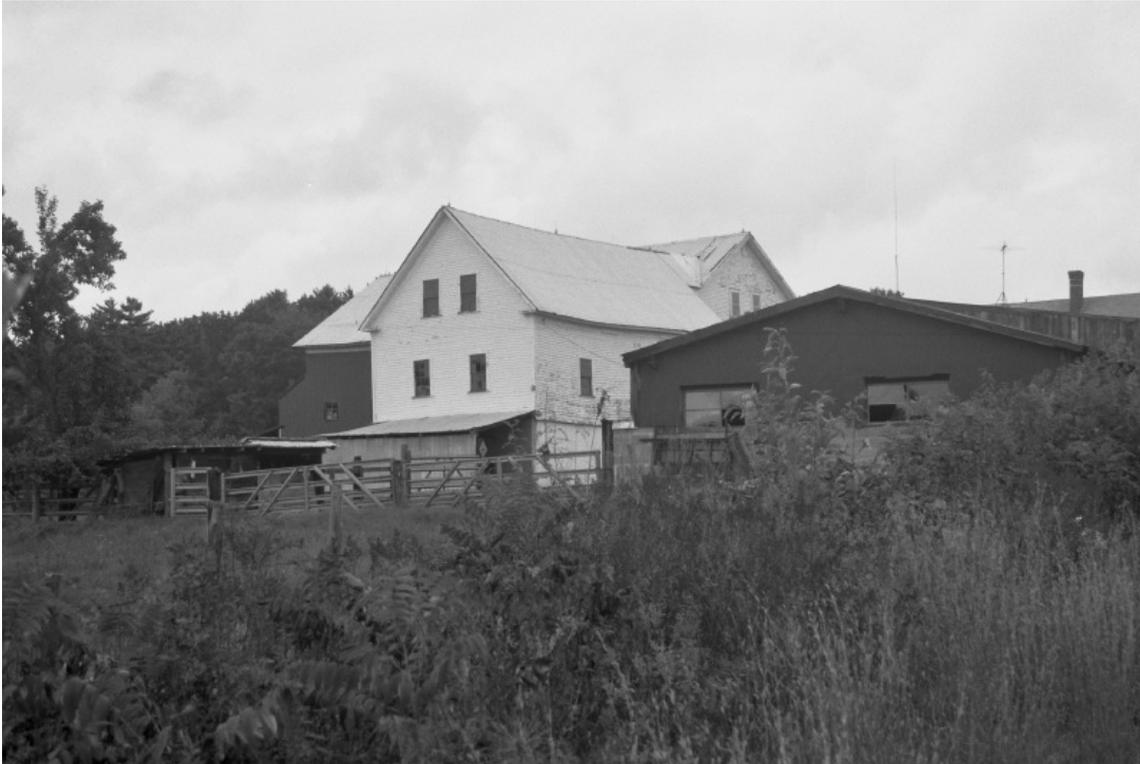
Photo 2 description: Equipment Shed (foreground) and barn addition
Roll: 3 Frame: 31 Direction: NW

Barn Addition (ca. mid-19th century): This bank barn extension to the south of the main barn has an interior sliding barn door on its north face, providing access to its main level at the same elevation as the doors to the main barn. There is also a slider door providing access to the lower level on the east side. Windows all appear to be 6/6 double hung units. The addition has a corrugated metal roof and clapboard siding on the east and south faces. A one-story shed-roof addition is attached to the south face.

Sheds (ca. early 20th century): Two connected equipment sheds are situated to the east of the barn addition and back up to the Shaker Road street frontage. The sheds appear to have been constructed at different times. They both have low-pitched gable roofs. The north shed has a corrugated metal roof and the southern one is asphalt roll roofing. They both sit on concrete block foundations and have asphalt shingle siding. On the east side of Shaker Road from the main building complex is a small corrugated metal shed that appears to have been a shelter for animals.

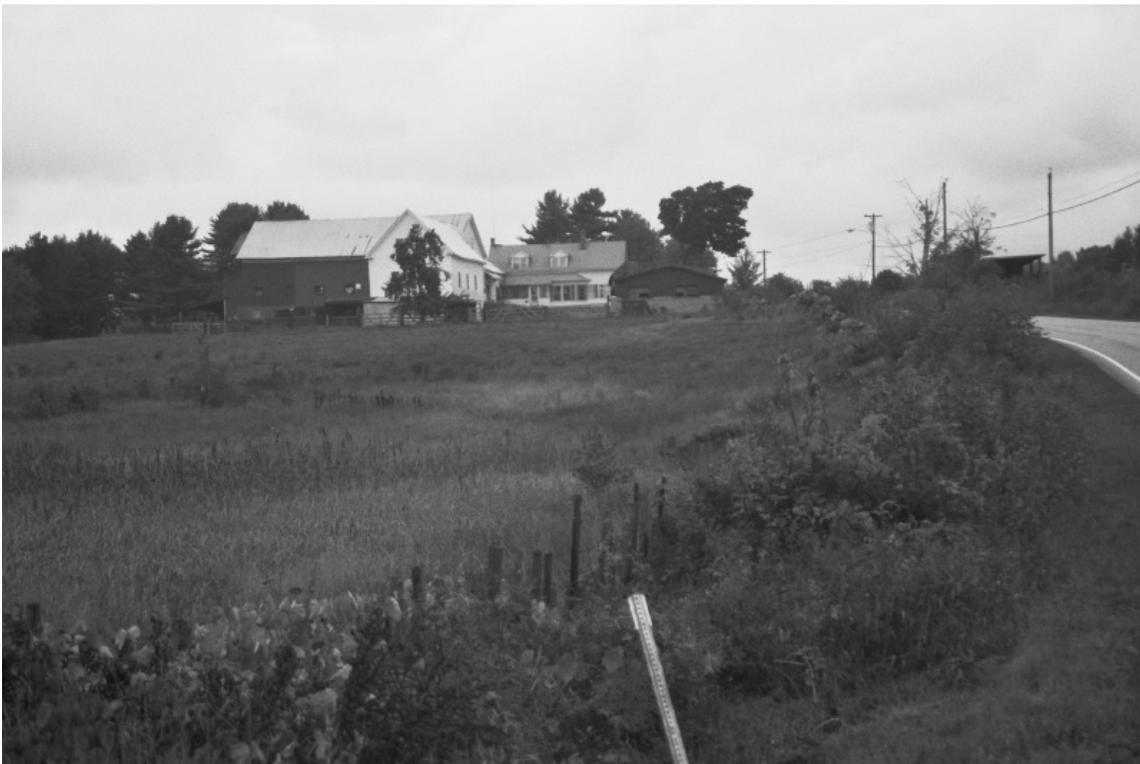
Photo 3 description: Farmstead and outbuildings
Roll: 3 Frame: 30 Direction: N

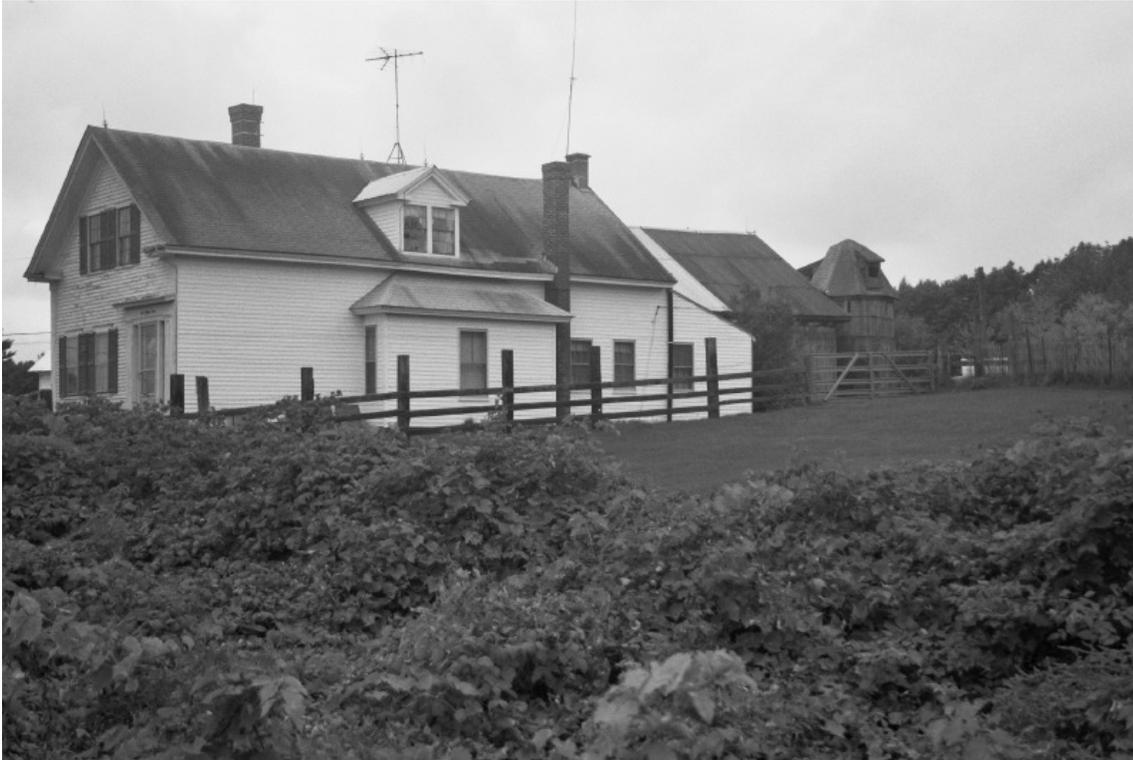
Photo 4 description: North face of house, barn ell and silo
Roll: 3 Frame: 32 Direction: SW

House (ca. 1850s): This 1 ½ story Greek Revival house retains much of its original character. The front entry has sidelights and a simple entablature. Wide corner boards support the gable returns at each corner. The front of the house has 6/6 double hung windows as do the (likely later) dormers on the north and south roof faces. The bay extension on the north wall has 2/1 windows suggesting that this projection may be a later addition. The bay window on the south face also appears to have 2/1 windows. The foundation is granite block and the roof is asphalt shingle.

Ell Connector (likely pre-1900): A 1 ½ story extension of the barn connects the house to the barn. The ell has an interior slider door, 6/6 windows on the grade level and 3/6 on the second level. A shed roof hood is situated over the barn door.

Barn (ca. mid-19th century): The 6-bay gable front bank barn is sided with clapboards on the east face and vertical boards on the other sides. The barn is roofed with corrugated metal. The sliding barn doors have a 10-light transom above. Wide corner boards and gable returns suggest that the barn was likely constructed at about the same time as the house. Two second floor windows are 1/1 double hung. A one-story shed-roof addition is located on the west end of the main barn. A grain silo is situated in the corner between this shed addition and the northwest corner of the barn.

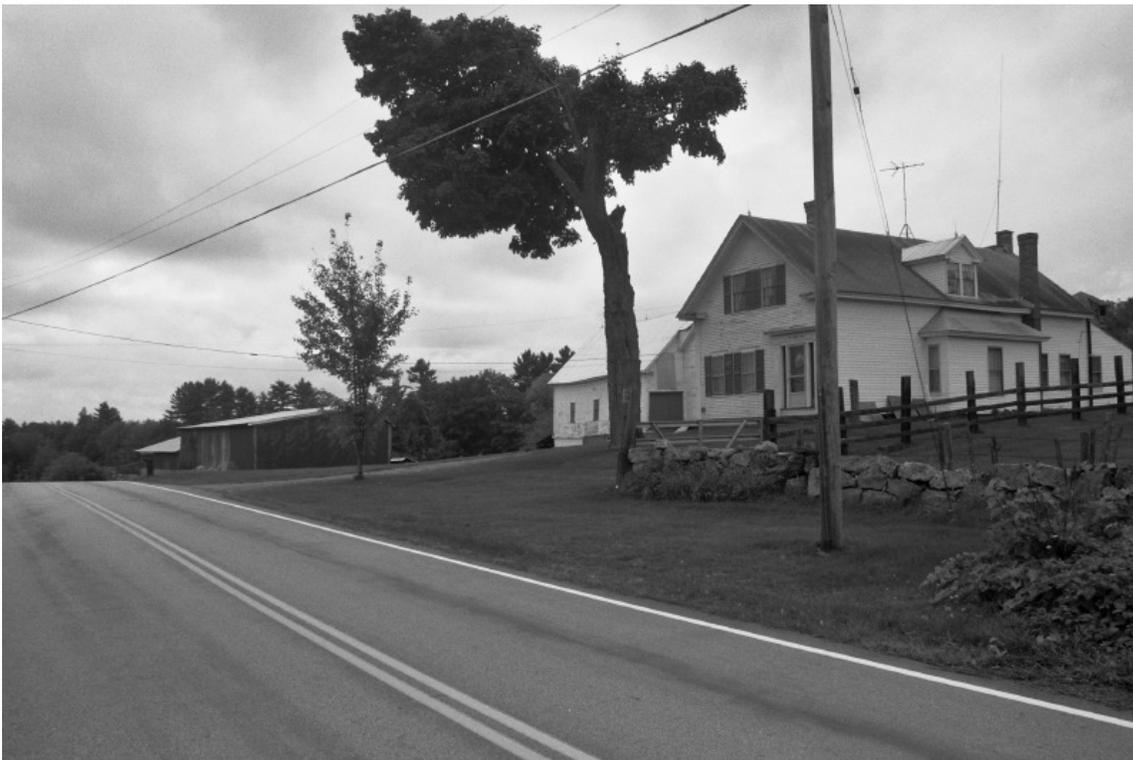
Photo 5 description: North and east side of house
Roll: 3 Frame: 33 Direction: S
