INDIVIDUAL INVENTORY FORM

NHDHR INVENTORY NUMBER: CON0184

- 1. Historic name: Ephraim Potter Farm
- 2. District or area: Oak Hill Agricultural Neighborhood
- 3. Street and number: 283 Oak Hill Rd.
- 4. City or town: Concord
- 5. County: Merrimack
- 6. Current owner: Daniel Potter

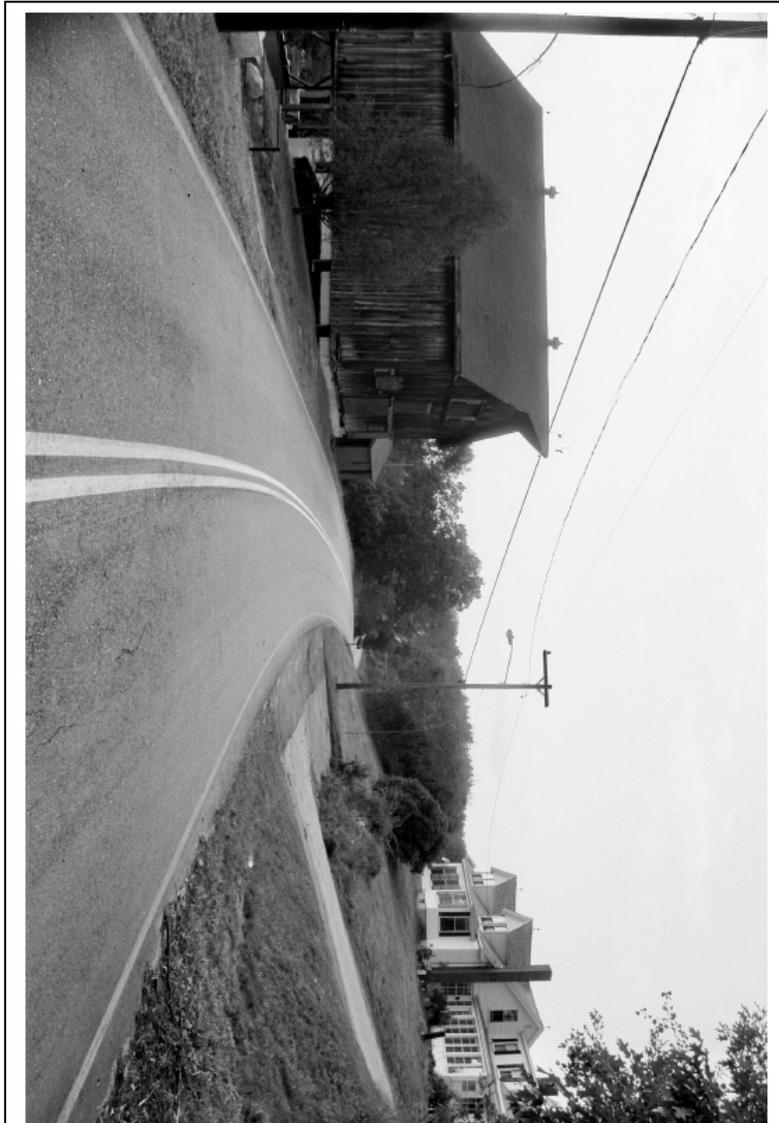
- 35. Photo #1
- 36. Date Fall 2008
- 37. Roll #5 Frame #5A Direction: W
- 38. Negative stored at: NHDHR

Description: View of farmhouse (right) & barn and milk house (left)

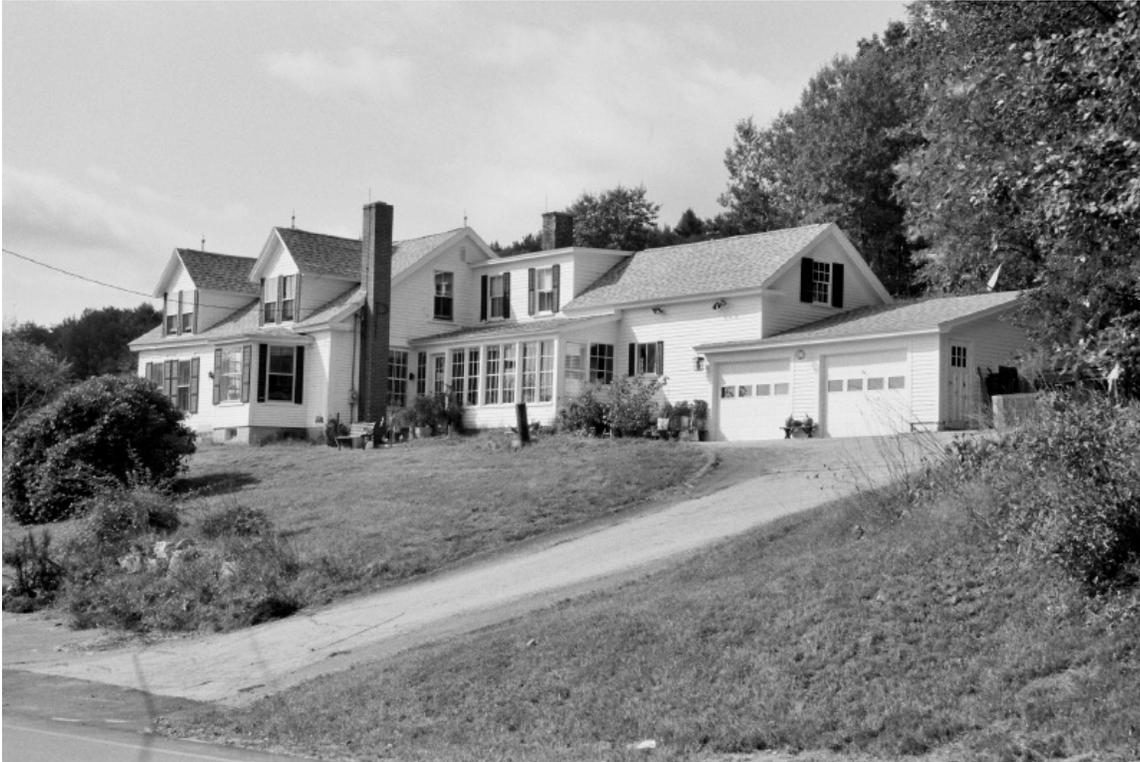
House (1925): The farmhouse is a 5x2-bay cape that sits on a granite foundation with plug drill marks, remnants of the original house on this site that burned in 1924. Dressed granite steps, also from the original house, lead to the front entrance. Walls are now clad with vinyl siding. Two gabled dormers puncture the front roof slope. Extending to the east is a lengthy wing, with a sunporch on the south (road). The wing is attached to a two-bay garage that appears to be a late 20th c. addition.

Photo 2 description: View of ca. 1925 house
Roll: 5 Frame: 1A Direction: NW

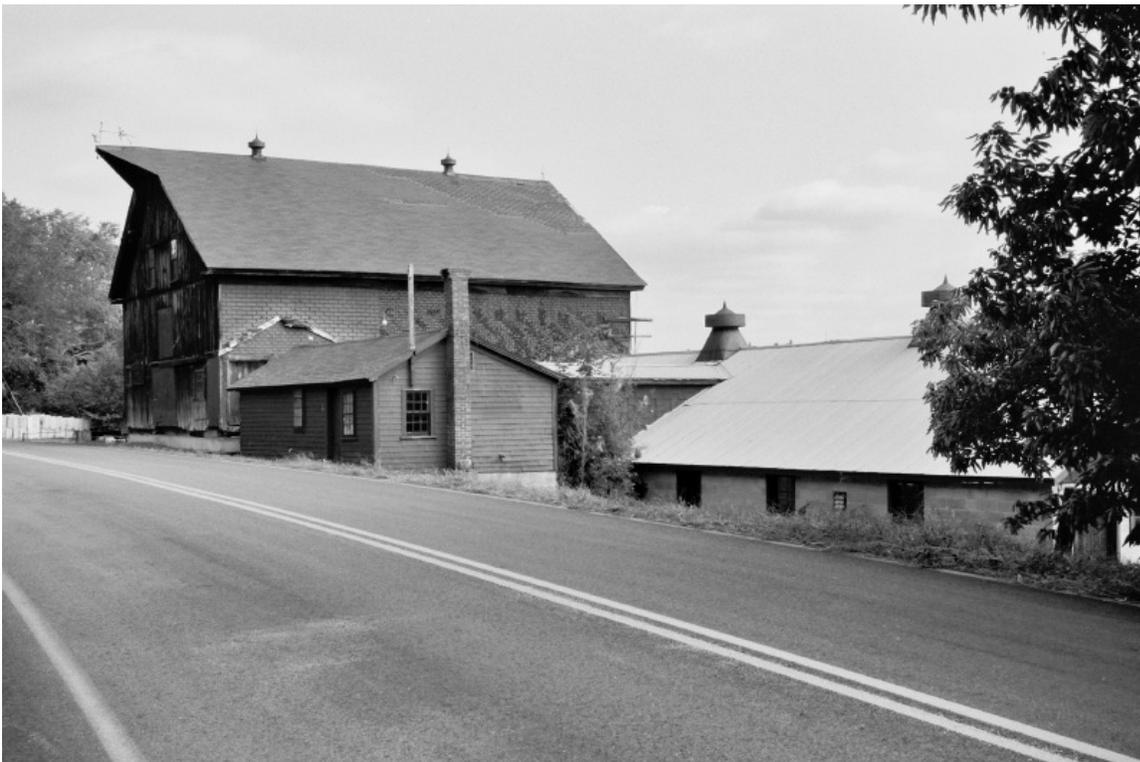
Barn (ca. 1840-70): *[NB: Without an interior inspection, it is not possible to date this barn more closely. Furthermore, the only visible exterior framing, the basement floor framing, was almost entirely replaced in 2005, although some log joists and floor boards with up and down saw marks are left.]* It is a gable-front bank barn that stands close by the road on a new poured concrete foundation. The roof has a projecting ridgepole in the front (north) gable end and a hay door beneath. Two metal vents rise from the ridge. Walls are clad with a mix of asphalt shingles and board and batten siding; the roof is covered with asphalt shingles. The main entrance has a rolling vertical-board door flanked by six-light-sash windows and 6/6 windows above.

Photo 3 description: View of primary outbuildings, from left: barn, milk house, milking parlor
Roll: 5 Frame: 2A Direction: SE

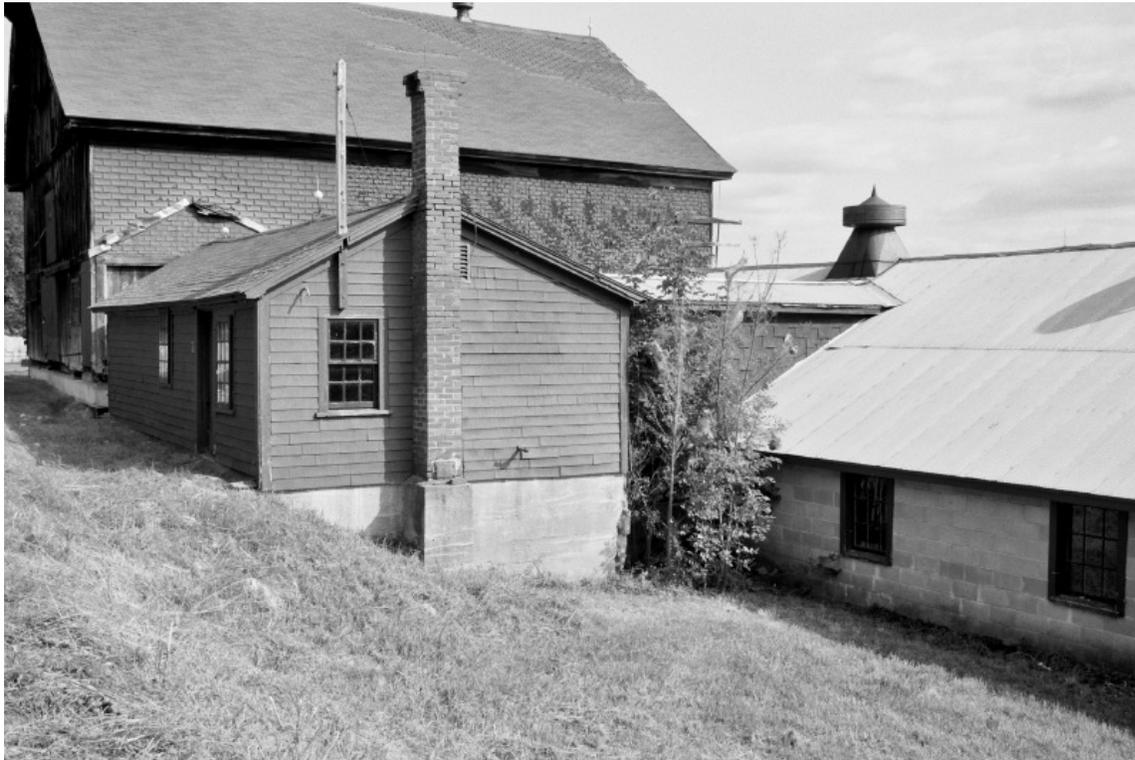
Milk room (ca. 1930-40s): The milk room also stands close by the road, on a concrete block foundation. It has clapboard siding, a mix of 6/6 and 9-light sash windows (likely salvage), a 19th c. four-panel door on the road side, and a brick chimney on the west gable end. It connects to the milking parlor and, until the barn was jacked up, to it, as well.

Milking parlor (ca. 1930-40s): Made of concrete block, this 1 ½ story structure stands behind the milk room to which it is connected. The corrugated metal roof has two metal ventilators. Rolling doors are found on the west gable end and nine-light sash punctures the walls.

Photo 4 description: Detail of milk house (left) and east end of milking parlor (right)
Roll: 5 Frame: 3A Direction: SE

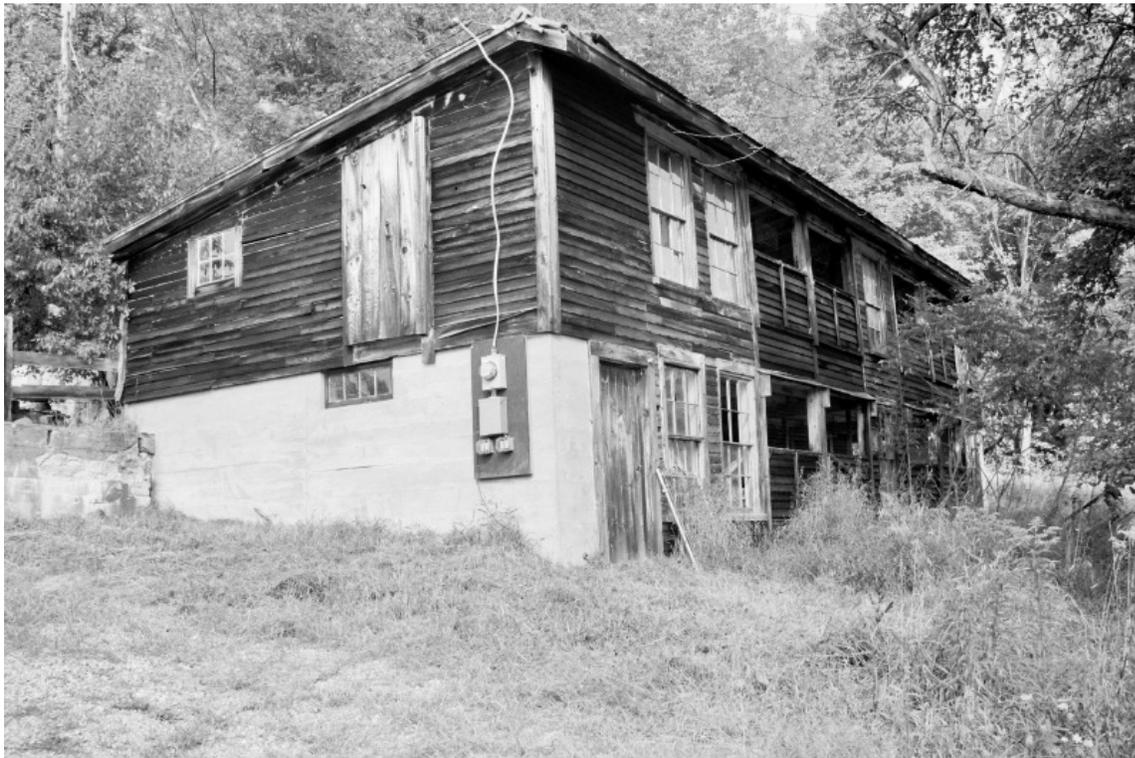
Hen house (1940s): The hen house is a two-story structure built into the hillside with a poured concrete wall on the lower level of the west side and clapboard elsewhere. It has a band of 6/6-sash windows on both levels along the south-facing side, in addition to openings enclosed with chicken wire. The interior is white-washed. The roof is covered with channeled metal.

Photo 5 description: Hen house
Roll: 5 Frame: 4A Direction: NE
