**INDIVIDUAL INVENTORY FORM**

**NHDHR INVENTORY NUMBER: CON0177**

- 1. Historic name: \_\_\_\_\_
- 2. District or area: \_\_\_\_\_
- 3. Street and number: 393 Mountain Rd.
- 4. City or town: Concord
- 5. County: Merrimack
- 6. Current owner: H. Byers & Marian B. Smith Trust

**Description:** Farmhouse

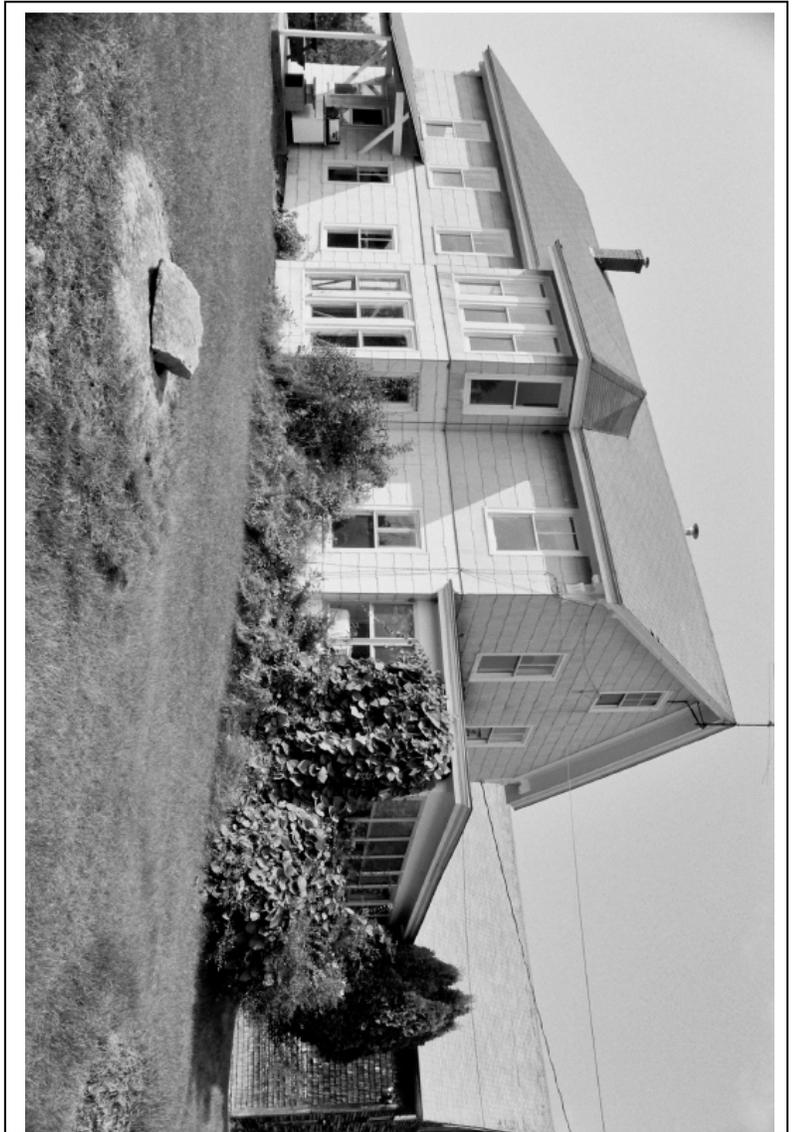
- 35. Photo #1
- 36. Date Fall 2008
- 37. Roll #4      Frame #34      Direction: NW
- 38. Negative stored at: NHDHR

House (ca. 1890): The farmhouse is perched on a knoll overlooking the road. The 2 ½ story, gable-front structure has raking eaves with scroll corner brackets, asbestos siding (likely covering clapboards) and primarily 2/1 window sash. A full-height bay window projects from the south elevation. The facade has

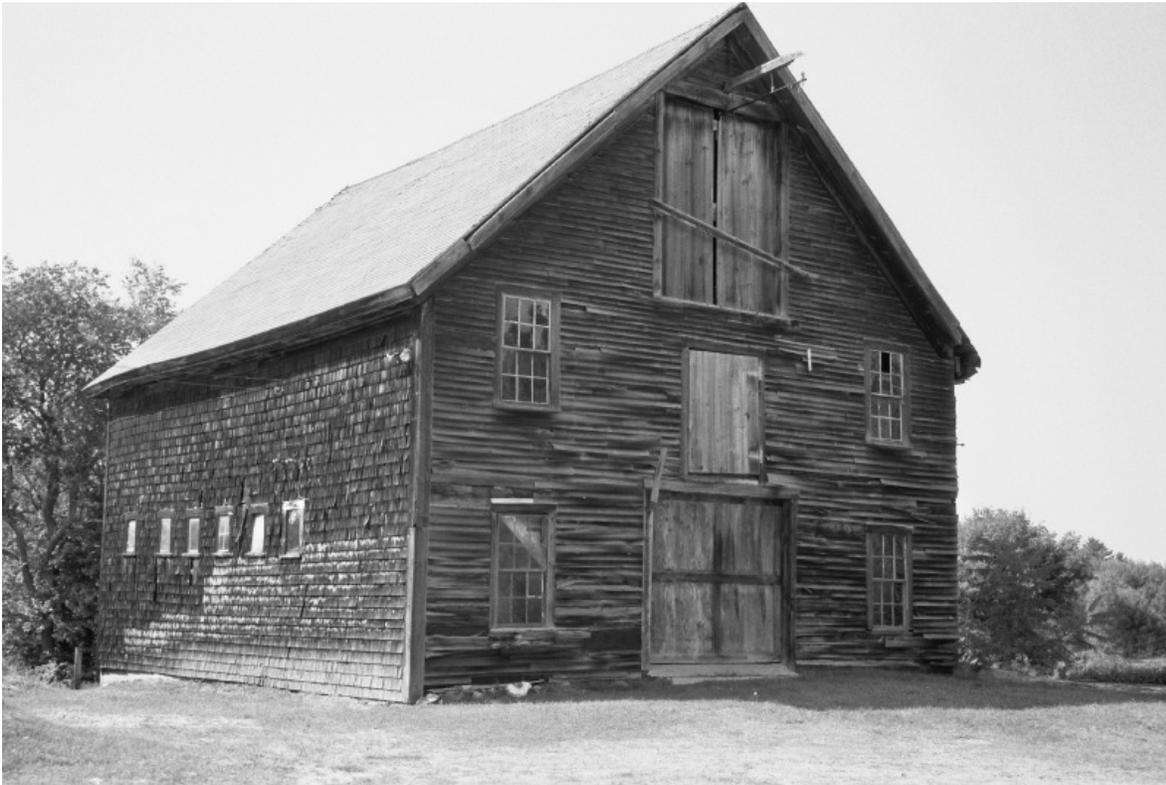
Exterior walls are clad with clapboard on the front (east) elevation and wooden shingles elsewhere. The wagon door is centered on the facade and has an interior, rolling plywood door. Above it are two hay doors and, protruding from the peak, a hay track. A window with 6/6 sash flanks the doors on each level. The south wall is lit with four-pane stall windows, and the north wall with 9/6-sash windows.

Photo 2 description: East gable front of barn  
Roll: 4 Frame: 33 Direction: NW

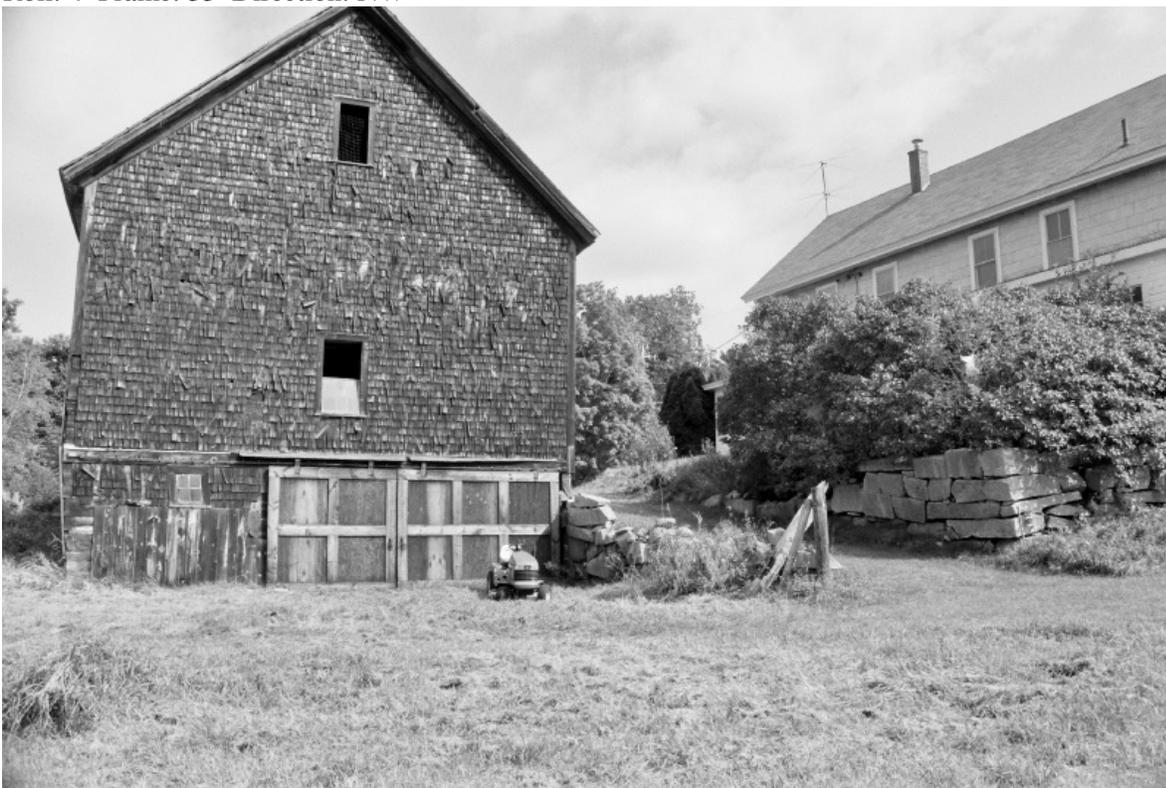
Off the southeast corner of the house, there is a well, capped with a surface granite slab secured by a stone. Between the house and barn, a path (likely a cow path) is defined by a granite block retaining wall on the south and an more informal stone wall on the north. Another granite block retaining wall is found by the northeast corner of the barn, as is what appears to be a former storage area with poured concrete and board walls.

Photo 3 description: Rear (west elevation) of barn. Path defined by retaining wall & stones to right of barn likely a cow path.  
Roll: 4 Frame: 35 Direction: E

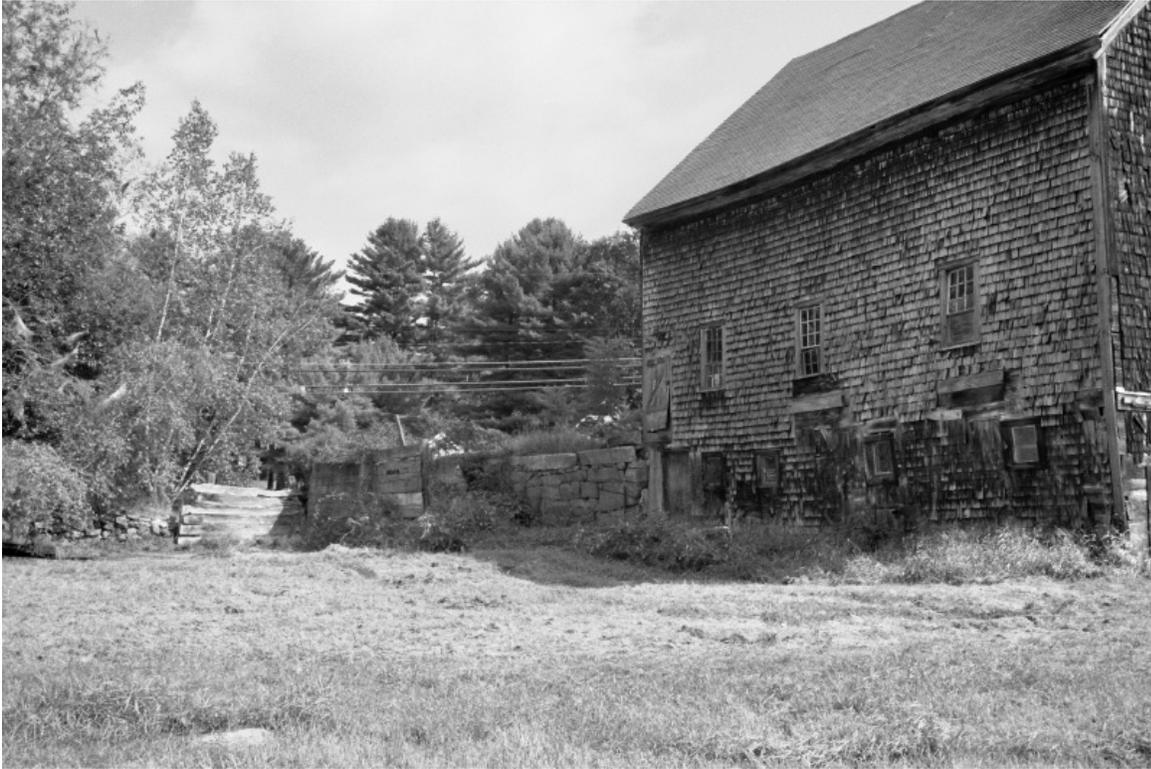
Photo 4 description: North elevation of barn & foundation wall suggesting outbuilding since removed  
Roll: 4 Frame: 36 Direction: E
